# FLASH REPORT

GOLDEN STAR (BOGOSO/ PRESTEA) LTD

<u>Report number</u> <b>007</b>	<u>Date of incident:</u> <b>13/11/2009</b>	<u>Time of incident:</u> <b>10:45hrs</b>
<b>INJURY</b>	<b>PROPERTY DAMAGE/LOSS</b>	<b>ENVIRONMENTAL</b>
<b>SECURITY</b>	<b>NEAR MISS</b>	
<u>Department Manager</u>	<u>Department</u> <b>Mine Maintenance</b>	<u>Supervisor</u>
<u>Nature and type of Injury/Illness</u> <b>Traumatic Amputation Right Arm</b>	<u>Equipment Type / No.</u> <b>EX10</b>	<u>Incident Location</u> <b>Buesichem Pit Collar</b>
<u>Person involved</u>	<u>Company ID</u>	<u>Name of witness</u>
<u>Injury Classification:</u> <b>MAJOR</b> MINOR                  NEAR MISS		
<u>Loss Classification:</u> Electrical/power outage   -   Fire   -   Equipment failure   -   Explosion		
<u>Estimated Cost of Impact:</u>		
<b>DETAILED DESCRIPTION OF INCIDENT</b>	EX10 cylinder was taken out and secured on a wooden block on top of the stick for the welder to take off the bushings. The first bushing was taken off and just as the second was being washed, the cylinder came off the wooden block, dropping on the right arm of the welder. He suffered a traumatic amputation and rushed to the site clinic.

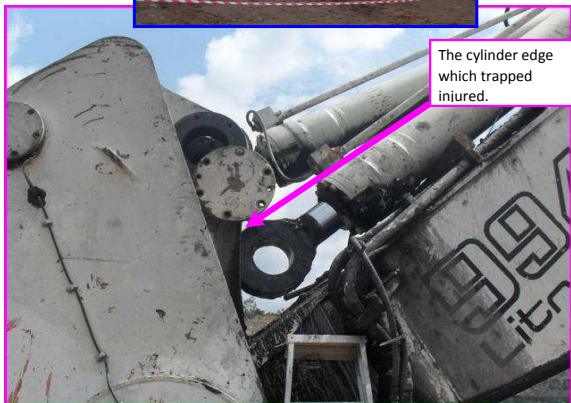
A close shot of the cylinder edge which trapped injured.

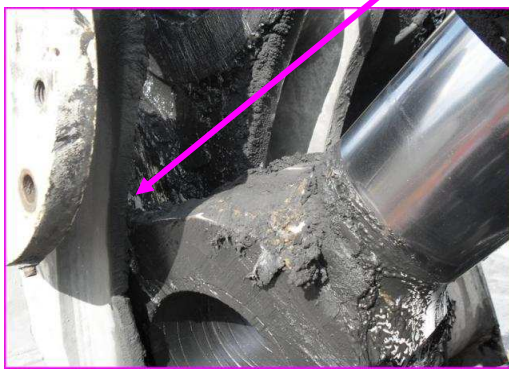
The cylinder edge which trapped injured.
