# FATAL CRANE INCIDENT 22<sup>nd</sup> October 2007

Germano Construction Site Brazil

## LESSONS LEARNED

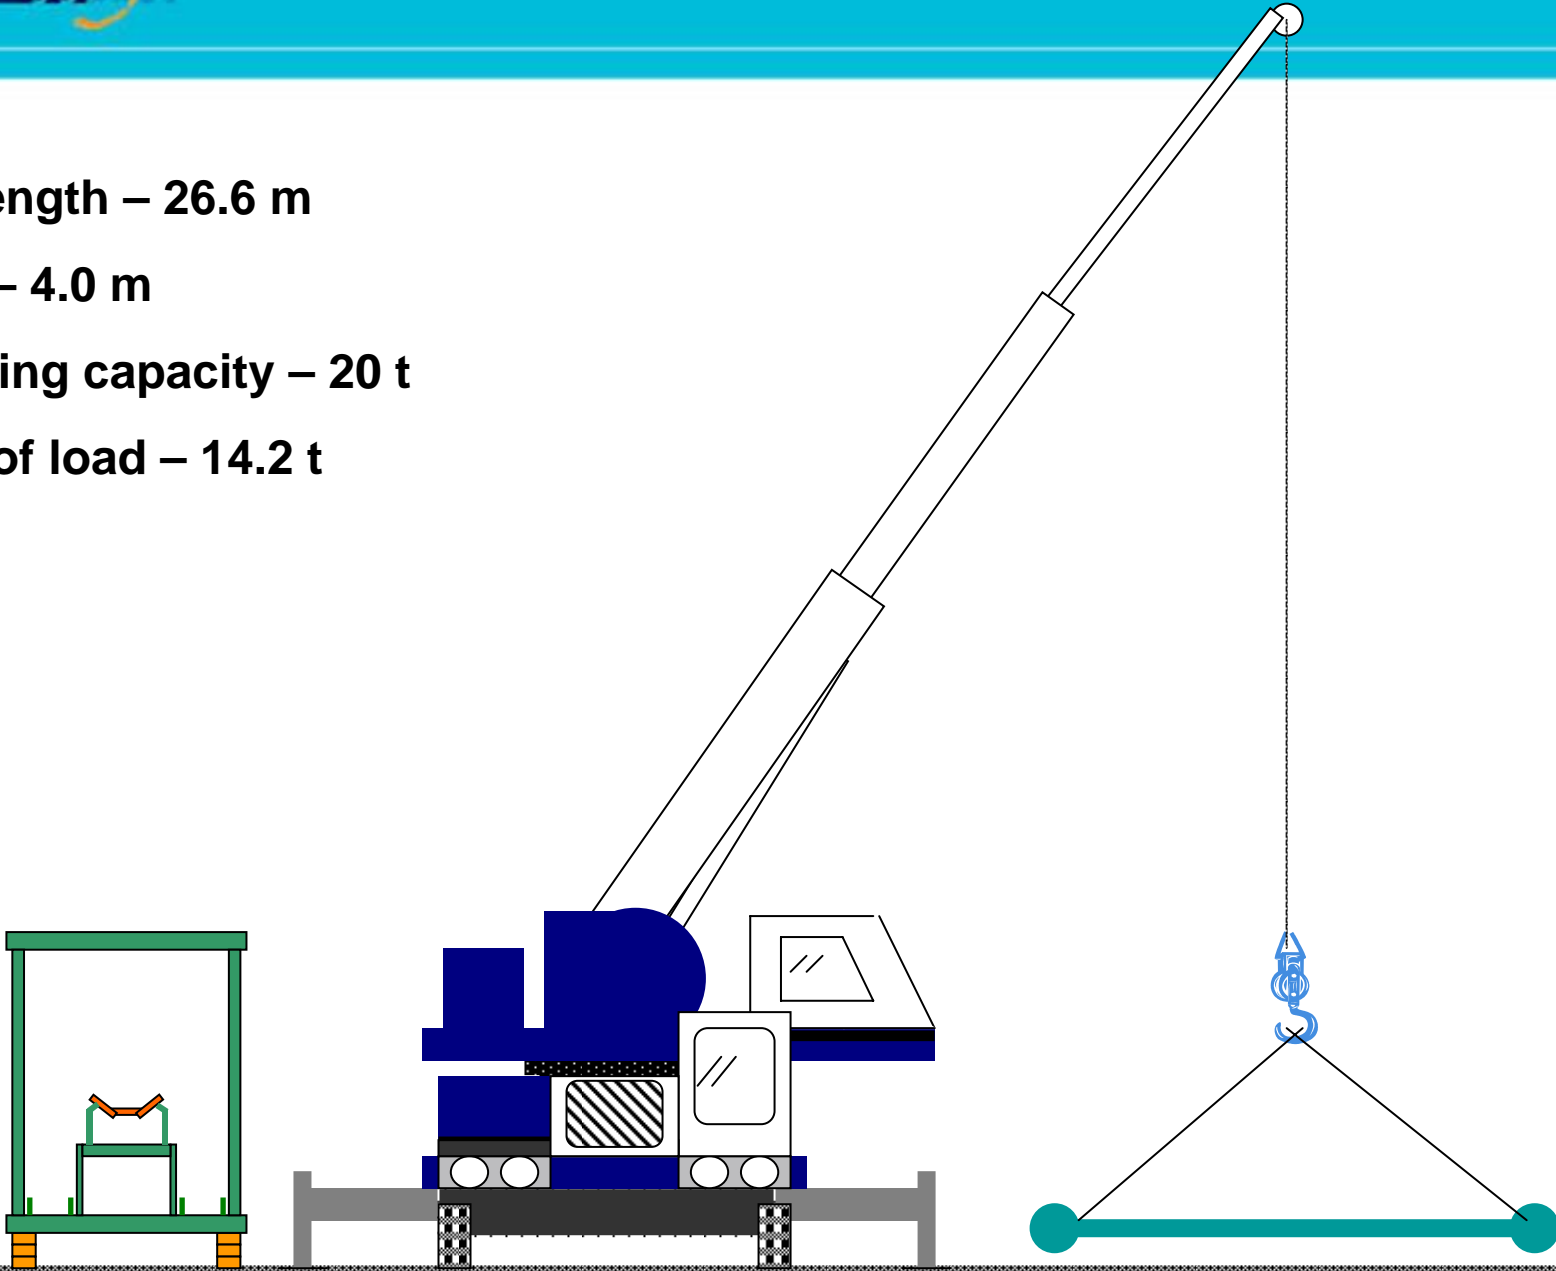
**Boom length – 26.6 m**

**Radius – 4.0 m**

**Max Lifting capacity – 20 t**

**Weight of load – 14.2 t**

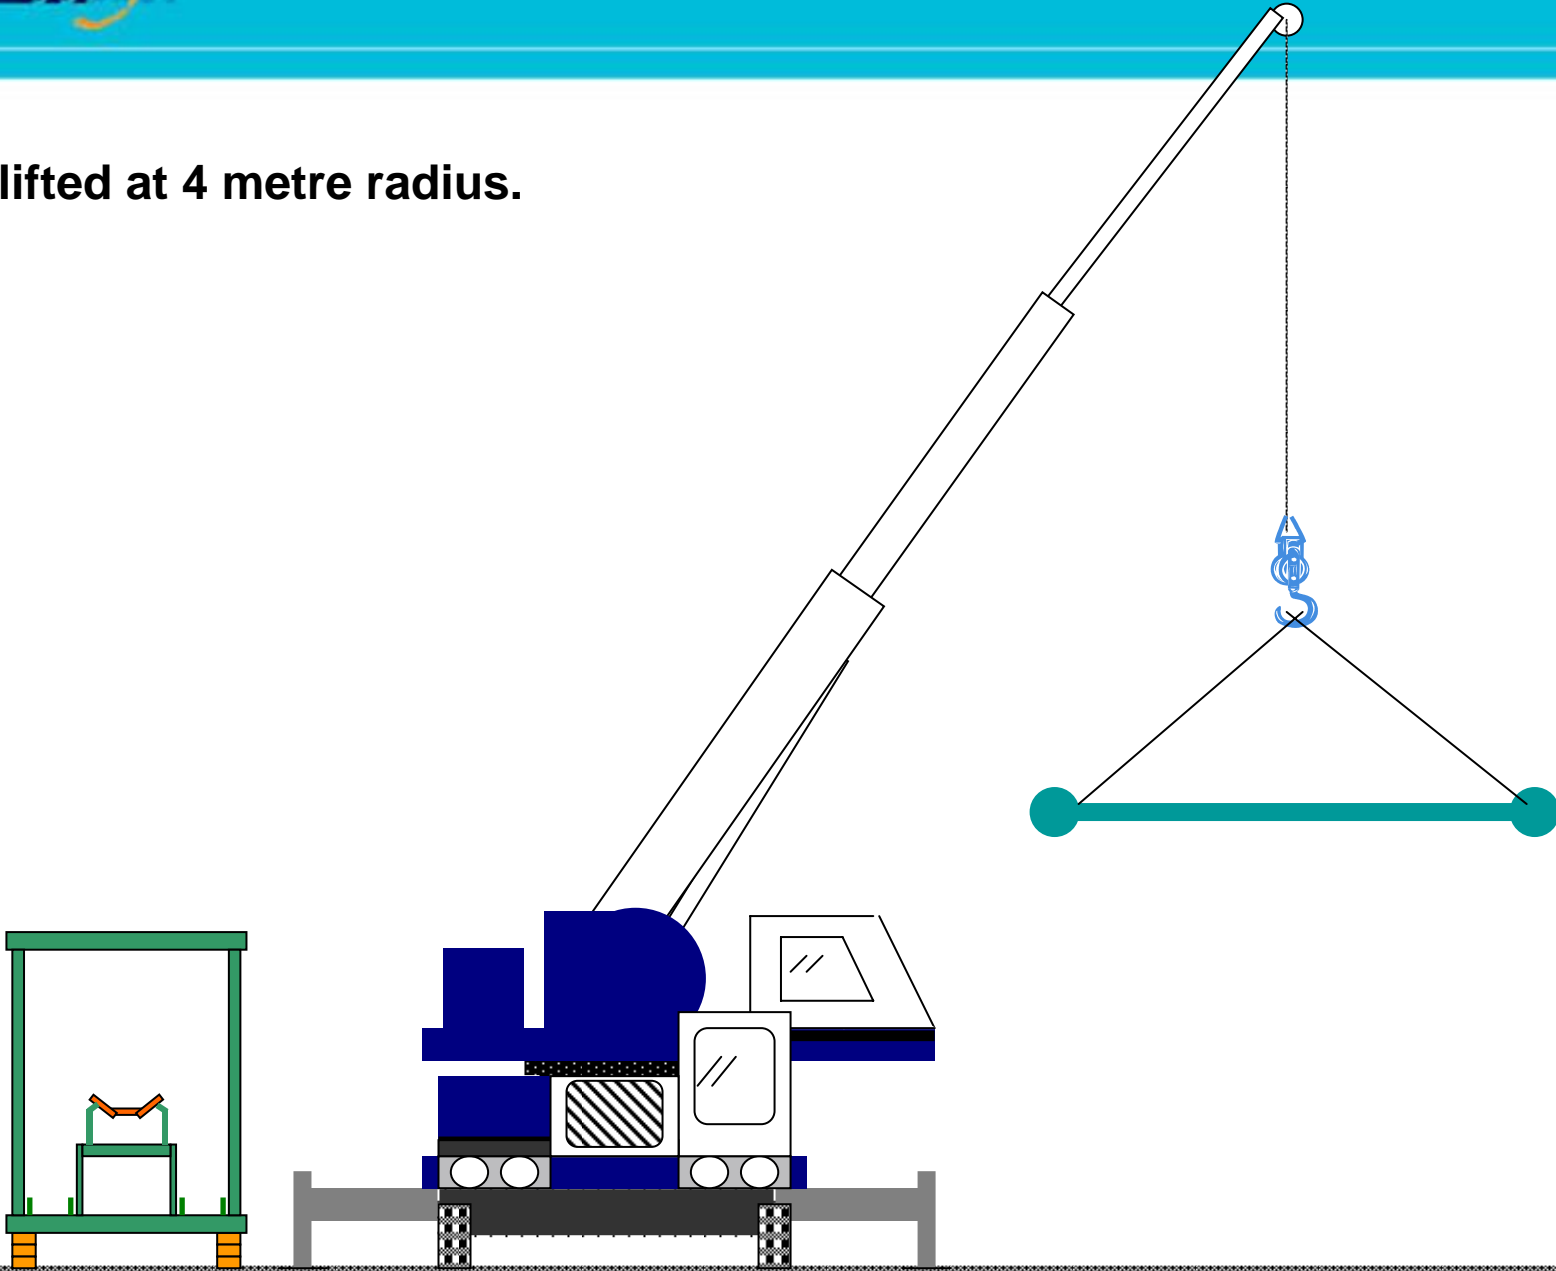
Load is lifted at 4 metre radius.

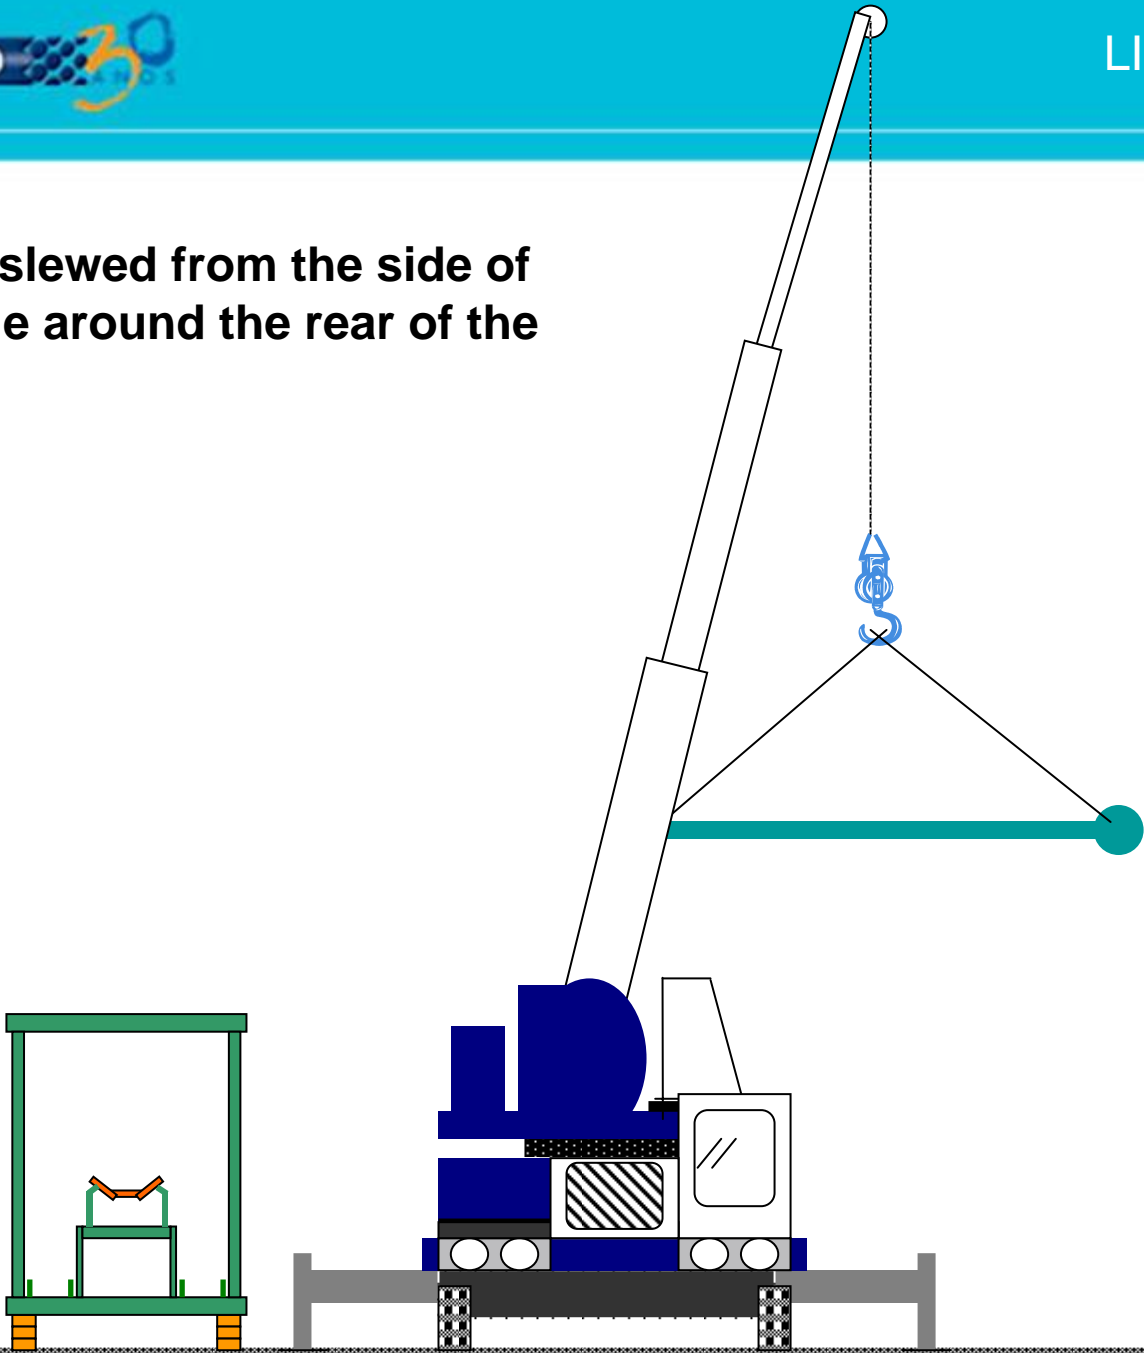
**Load is slewed from the side of the crane around the rear of the crane.**

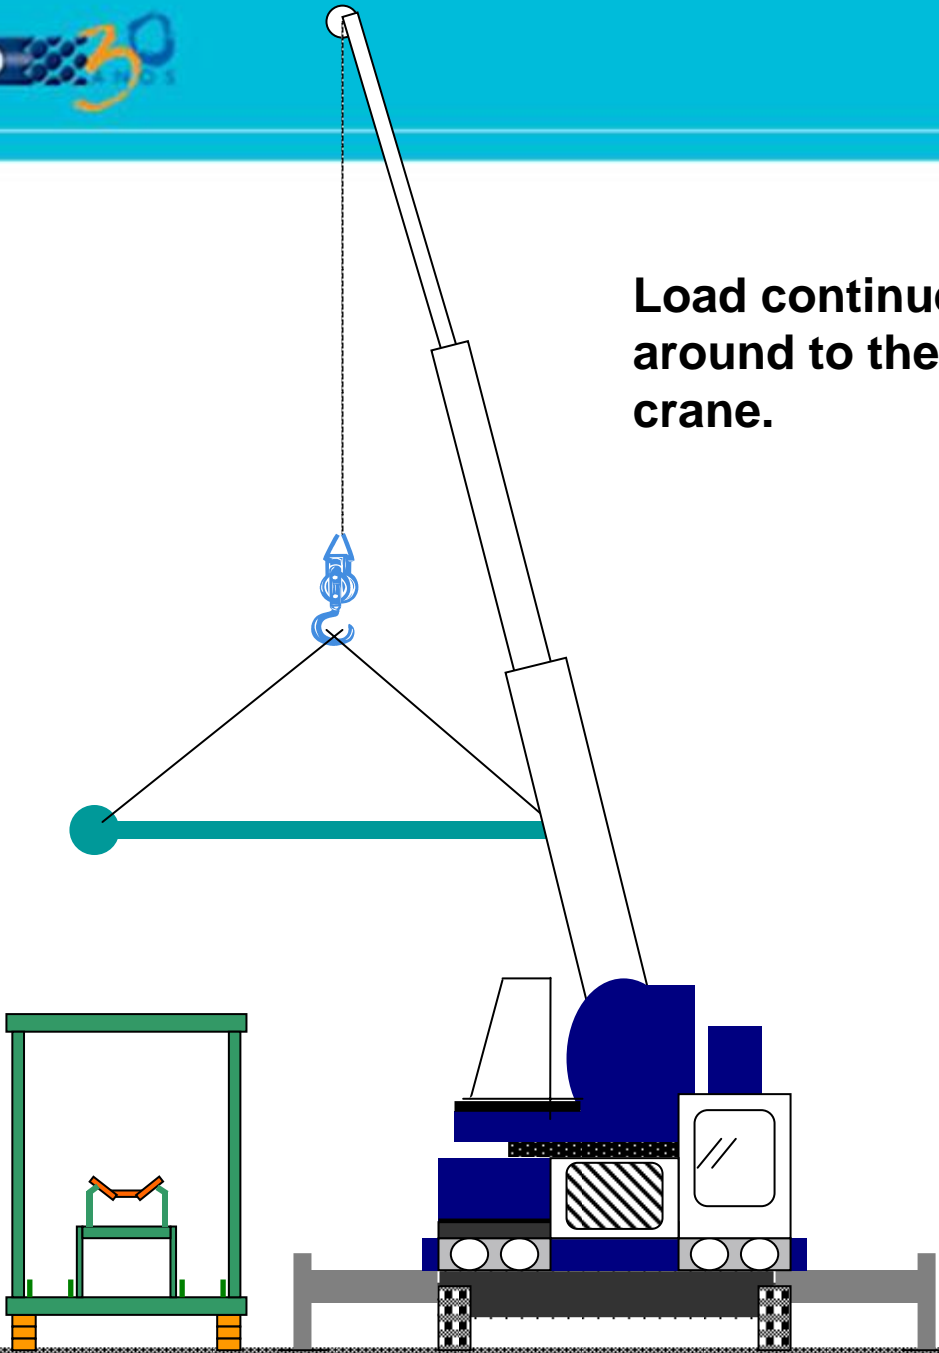
**Load continues to be slewed around to the other side of the crane.**

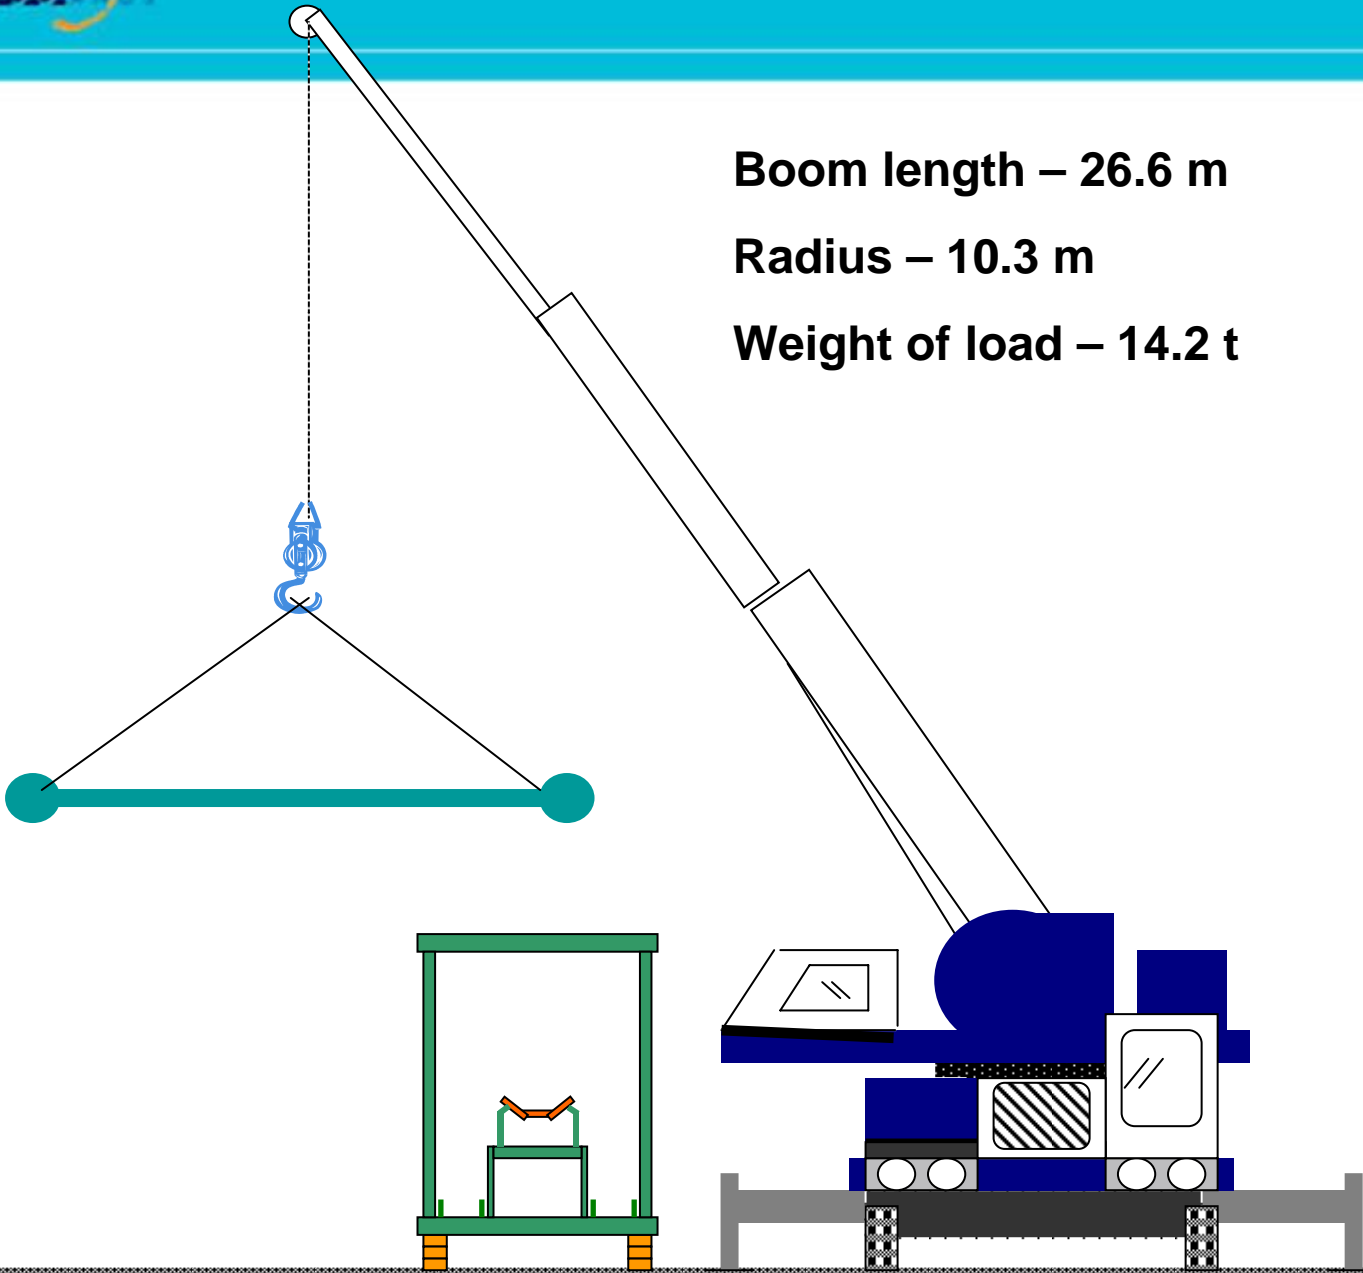
**Boom length – 26.6 m**

**Radius – 10.3 m**

**Weight of load – 14.2 t**

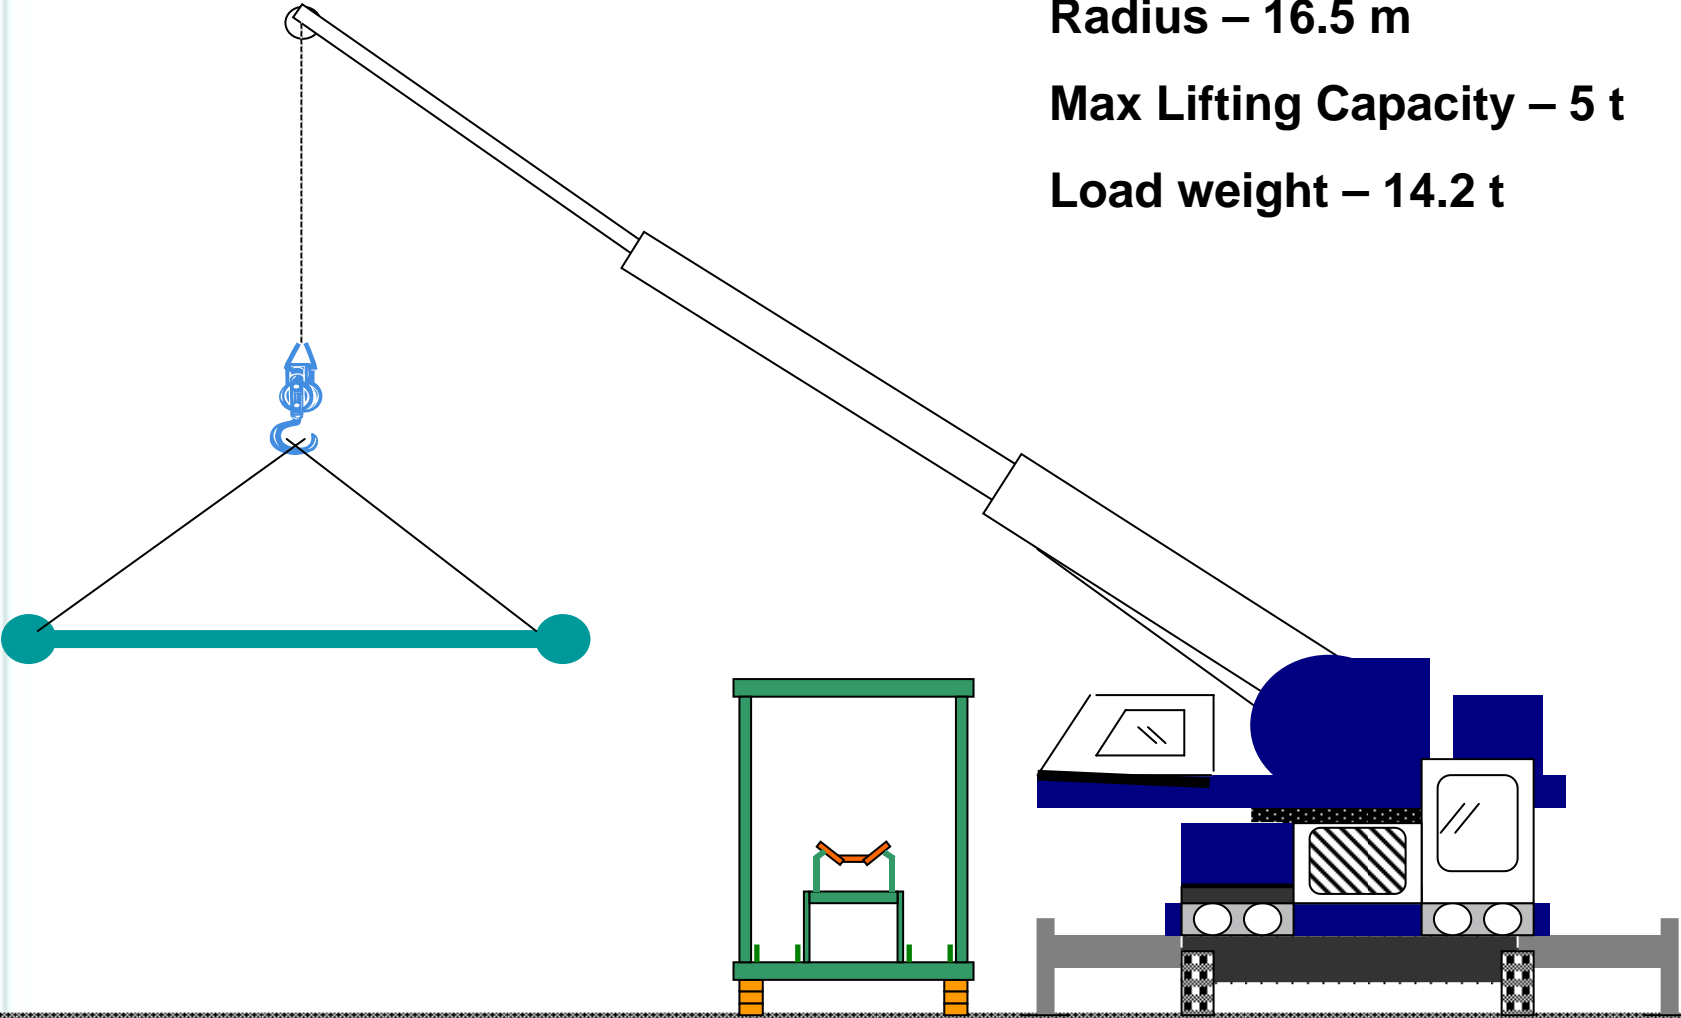
**Boom length – 26.6 m**

**Radius – 16.5 m**

**Max Lifting Capacity – 5 t**

**Load weight – 14.2 t**

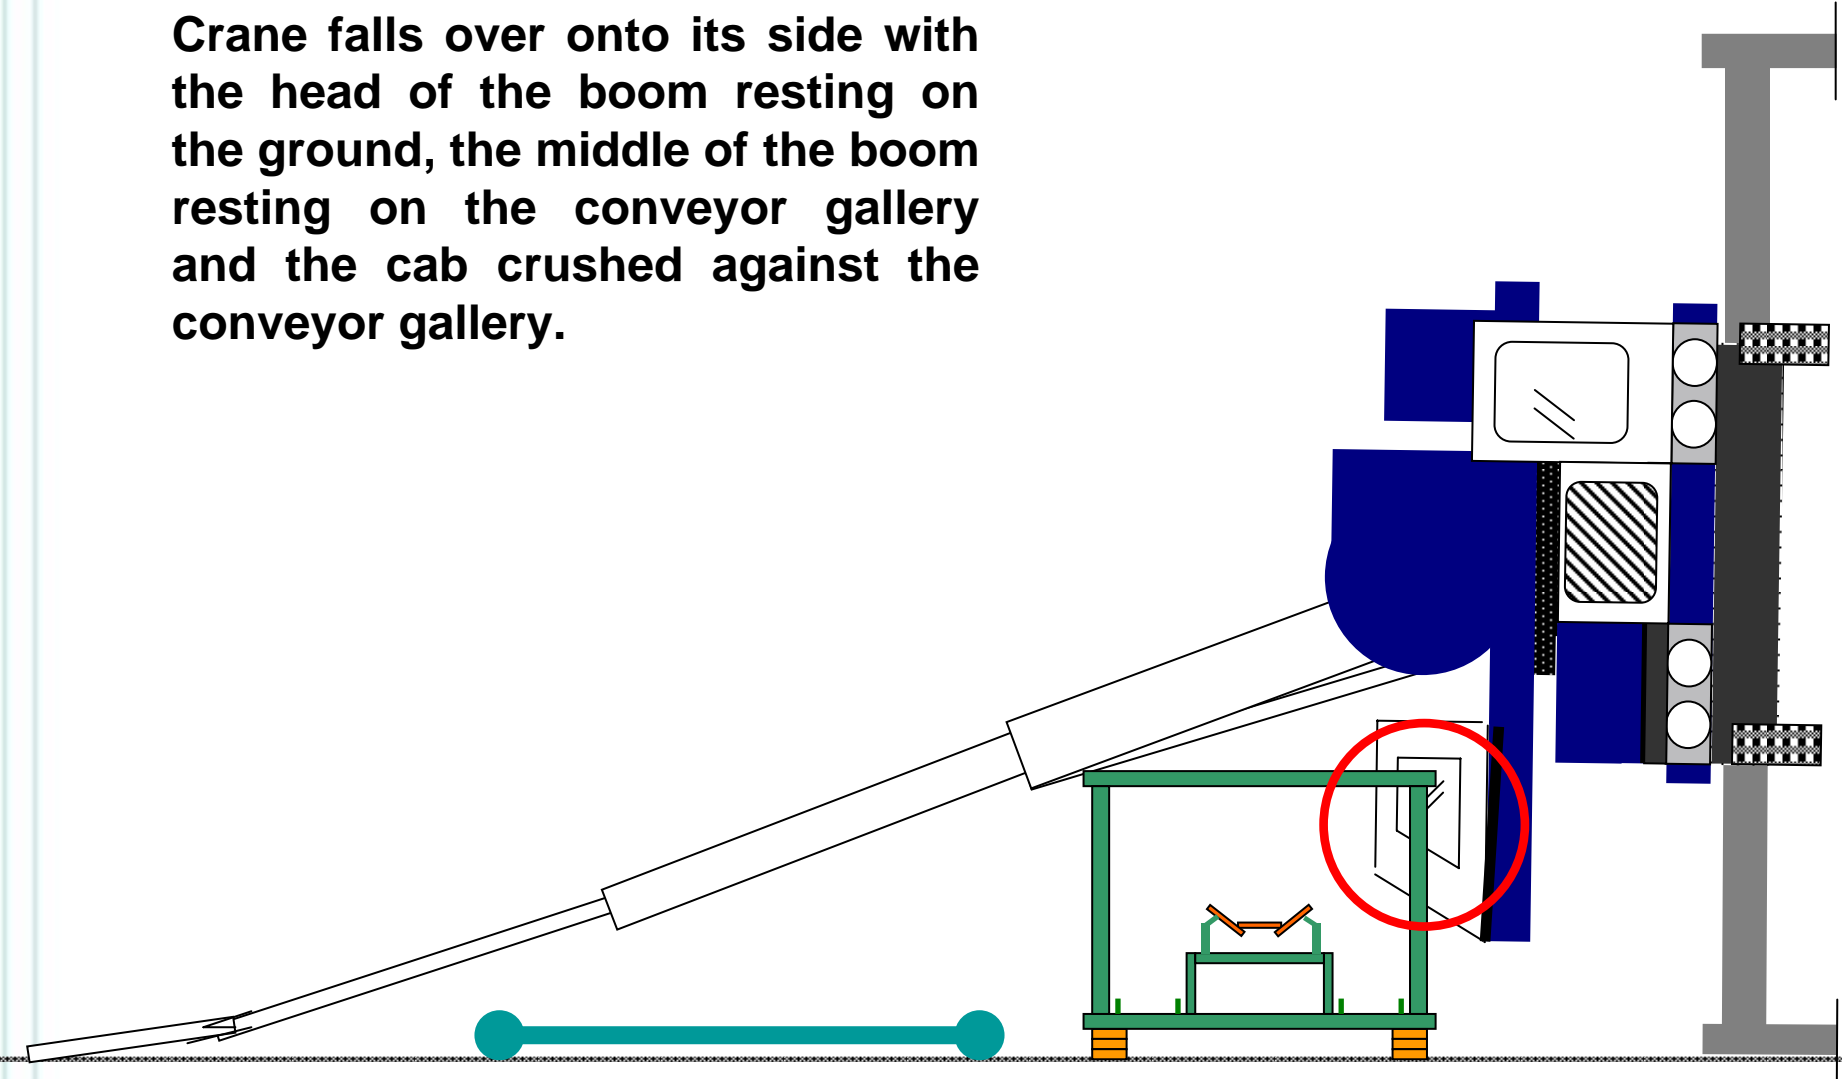
**Crane falls over onto its side with the head of the boom resting on the ground, the middle of the boom resting on the conveyor gallery and the cab crushed against the conveyor gallery.**

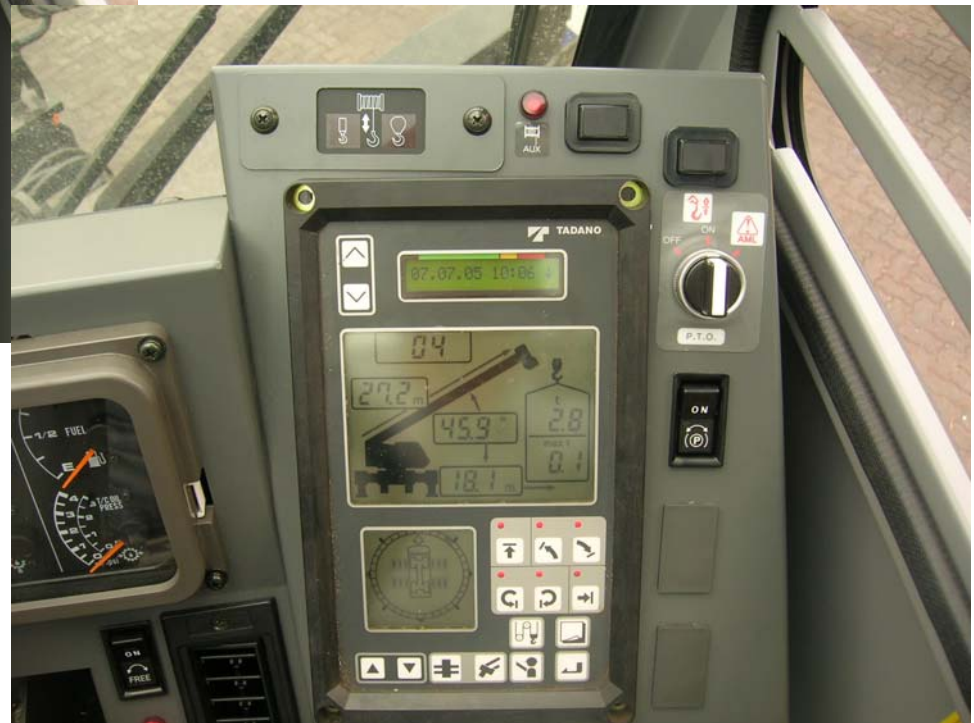
The crane operator had a history of overriding the crane limits and overloading the crane. Shown by computer records from the crane over 40 overloading incidents during October 2007

1. The computers in all site cranes (where fitted) have their data downloaded to investigate if the overloading of cranes is a general violation or restricted to this crane operator.
2. Emergency bypass controls are to be locked in the off position at all times.
3. Crane operators are to ensure that the all emergency bypass controls are locked in the off position at the Start of each shift.
4. Supervision is to inspect all emergency bypass controls during each shift to ensure they are locked in the off position.
5. Crane operational data from the onboard computer is to be downloaded each month to review the safe use and operation of the crane for the month.
