REPORT OF INVESTIGATION

Fatal Underground Coal Burst Accidents  
August 6 and 16, 2007

Crandall Canyon Mine  
Genwal Resources Inc  
Huntington, Emery County, Utah  
ID No. 42-01715

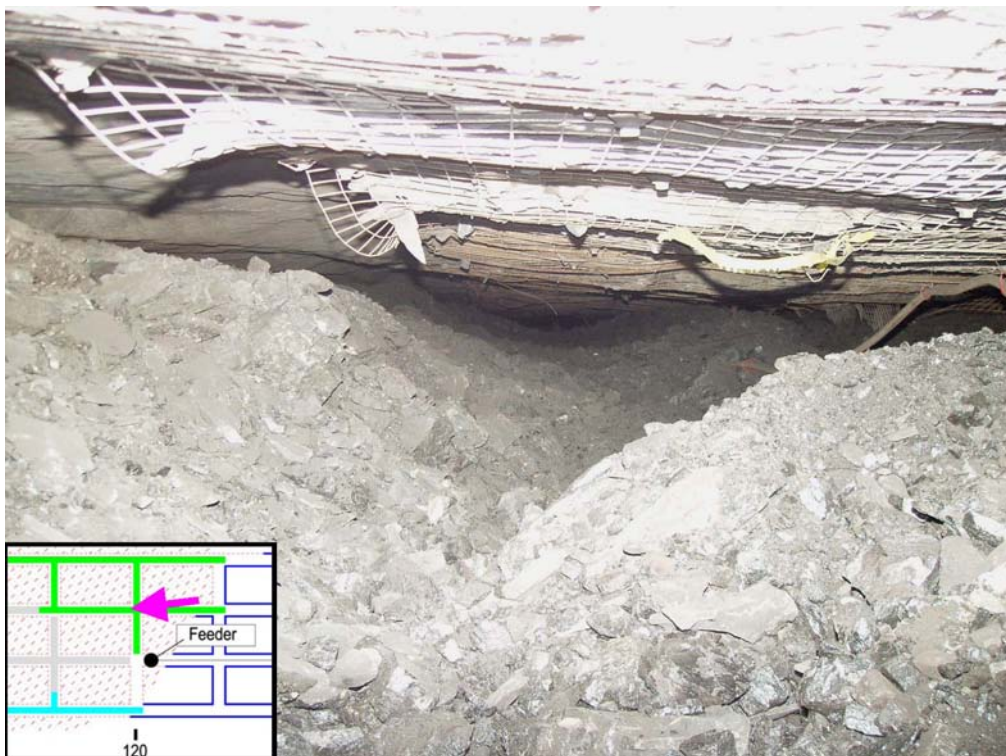
On August 7, 2007, a burst occurred in the clean-up area. UUSS registered a magnitude 2.8 seismic event at 1:13 a.m., which coincided with the approximate time of the burst. Ron Paletta (MSHA coal mine inspector) was standing near the feeder breaker with Benny Allred and Gale Anderson. The burst knocked Paletta to the ground and again damaged or destroyed ventilation controls to crosscut 93. The burst put a large amount of dust into suspension throughout the area and limited visibility to only a few feet. There were no injuries associated with this event. However, the burst partially refilled approximately 300 feet of entry that had been cleared (see Figure 4). Neither LHD was in the area refilled by burst material. One LHD was loading loose coal near the feeder between the Nos. 2 and 3 entries and the other LHD was outby the feeder in the No. 3 entry. All miners were withdrawn to crosscut 109 and accounted for.

**Figure 4 - View of No. 3 Entry after August 7 Burst**  
Entry cleaned by diesel loaders refilled with rubble (view indicated by arrow in index map insert).

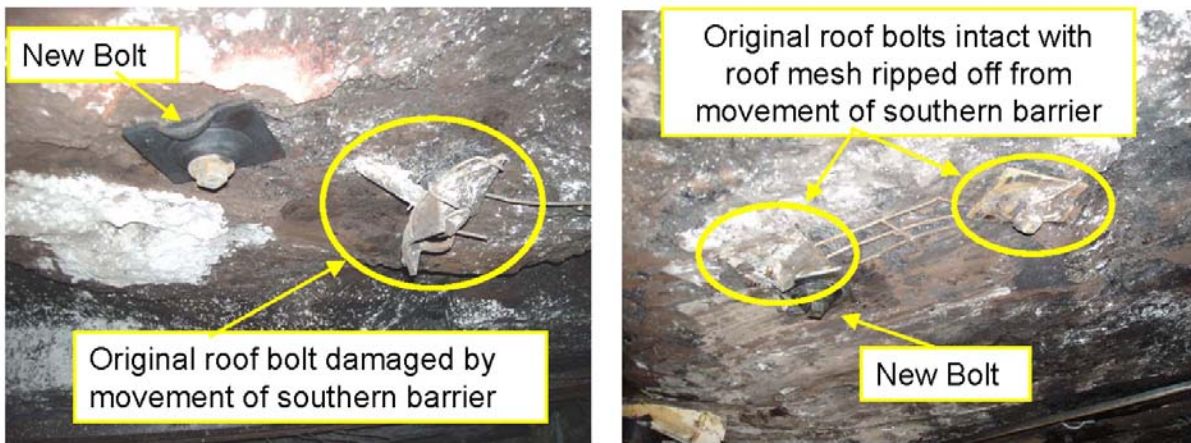
As loading advanced inby crosscut 123, rescuers observed that part of the barrier south of the No. 1 entry had moved northward as a result of the initial August 6 ground failure. The barrier rib had shifted northward as a unit, as much as 10 feet. In some areas the displaced barrier slid along the immediate roof and tore loose the original roof mesh (see Figure 7). In other areas, the immediate roof was carried northward and damaged the original installed roof bolts (Figure 8).

**Figure 7- Damaged Roof Bolts and Torn Mesh after August 6 Accident Resulting from Northward Movement of Southern Barrier**

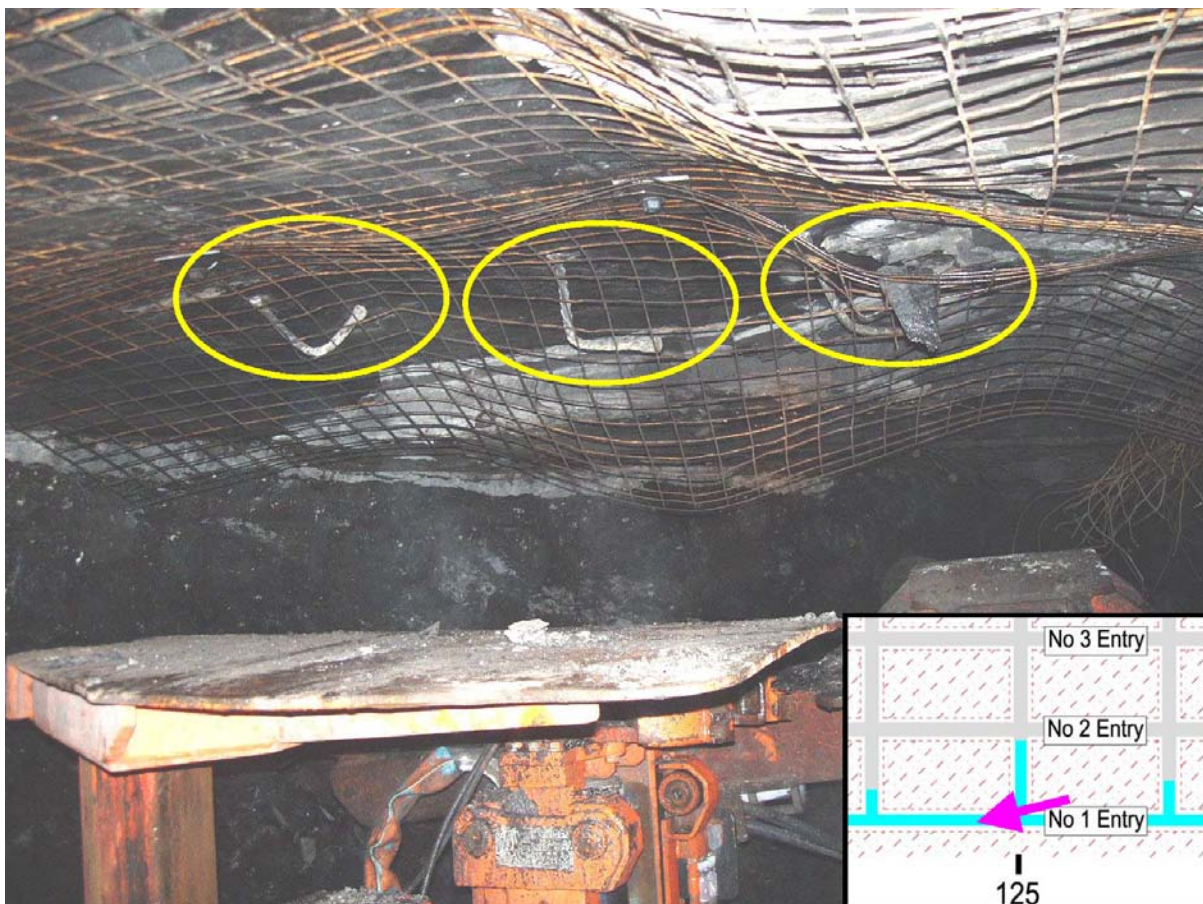
**Figure 8 - Damaged Roof Bolts in No. 1 Entry after August 6 Accident Resulting from Northward Movement of Southern Barrier. Mesh shown was installed during rescue operations, over damaged original roof bolts. Camera view is indicated by arrow in index map insert.**

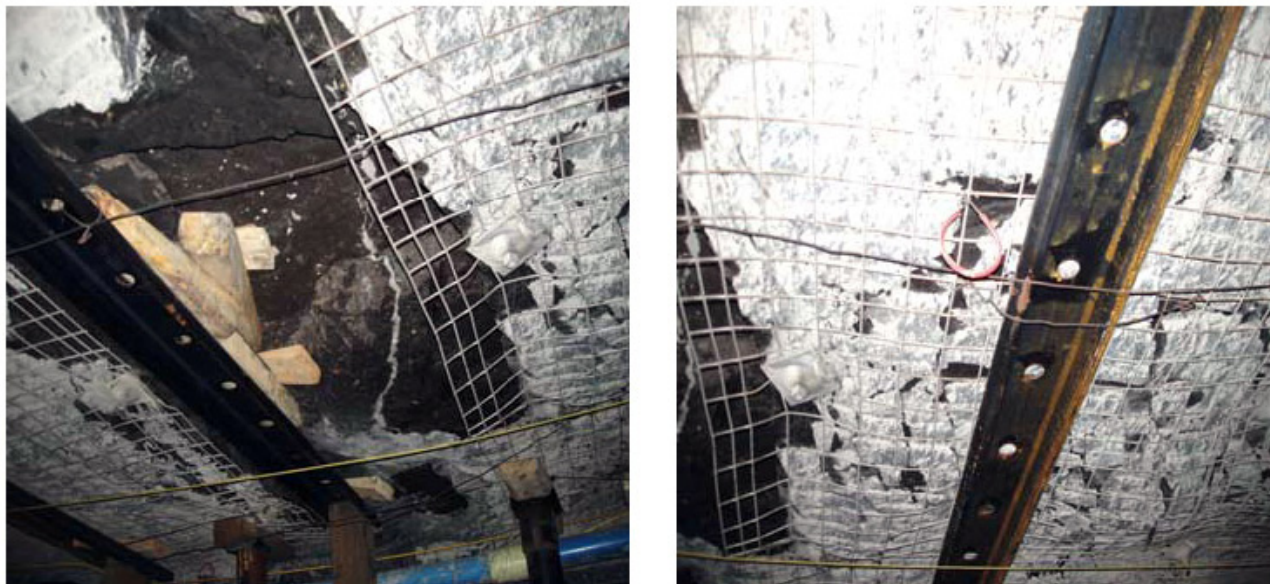
On August 12, roof deterioration was observed near crosscut 115 in the No. 1 entry. Steel channels were installed for additional support in this area (see Figure 9). The channels were supported on both ends with hardwood posts. At the time, clean-up in the No. 1 entry had advanced just inby crosscut 124. The No. 1 entry was packed with rubble the full width and height of the original mined opening. The continuous mining machine was loading from a rubble pile that resembled an unmined coal face (see Figure 10 and Figure 11). Observations of RocProps tilted from vertical prompted MSHA to install a measurement point to monitor horizontal movement between crosscuts 123 and 124.

**Figure 9 - Steel Channels Installed in No. 1 Entry to Support Deteriorated Roof**

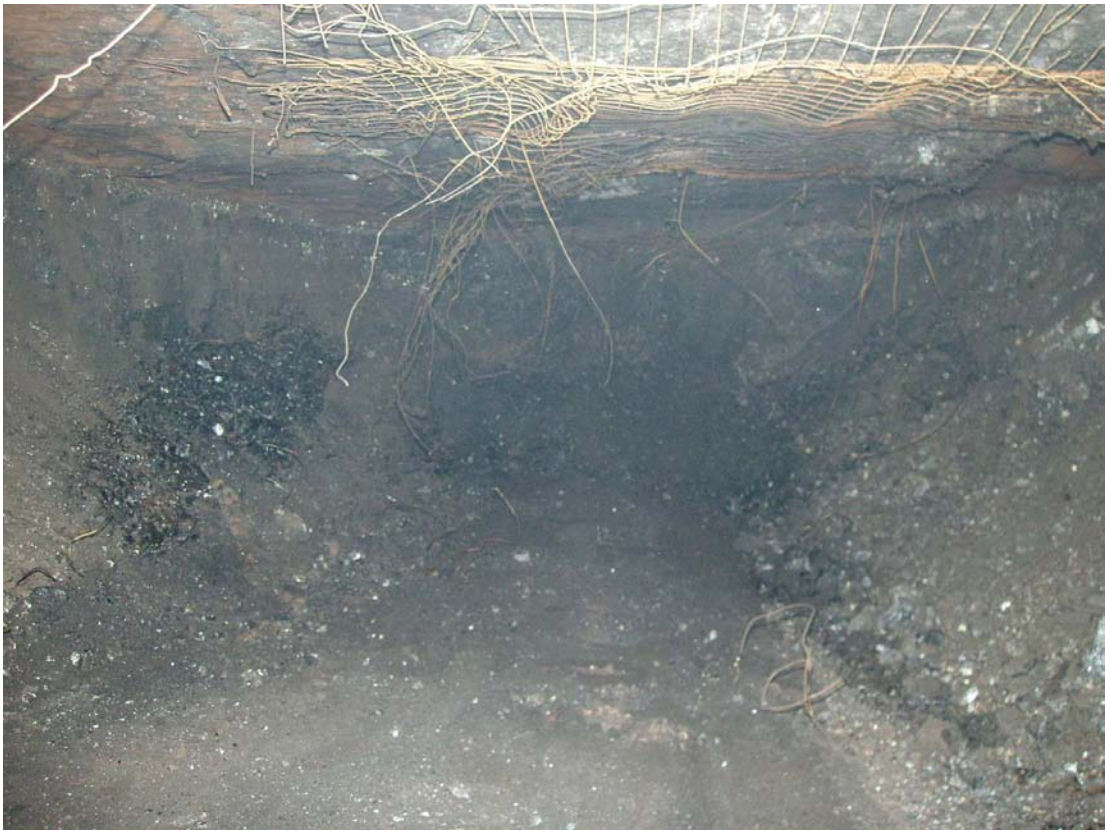
**Figure 10 - No. 1 Entry Packed with Coal Rubble Inby Crosscut 124**

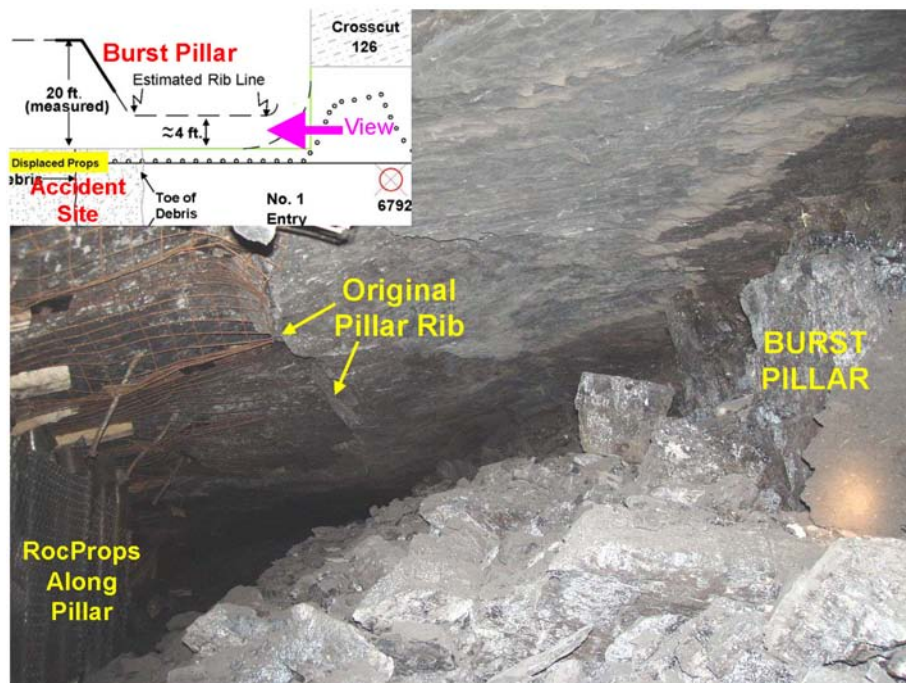
At 6:38 p.m., as the crew completed installing ground support in the clean-up area, the coal pillar between the No. 1 and No. 2 entries burst. Coal was thrown violently across the No. 1 entry during the magnitude 1.9 seismic event. The burst created a void up to 20 feet deep into the pillar at the roof line (see Figure 12 and Figure 13, view indicated by arrow). The dislodged coal threw eight RocProps, steel cables, chain-link fence, and a steel channel toward the left side of the entry, striking the rescue workers and filling the entry with approximately four feet of debris (see Figure 14). Heavy dust filled the clean-up area, reduced visibility, and impaired breathing. Oxygen deficient air from the inby area migrated over the miners. The dust and oxygen deficiency were slow to clear due to damaged ventilation controls.

Figure 12 – Damage to Outby Portion of Pillar on Right Side of No. 1 Entry (Outby August 16 Accident Site)

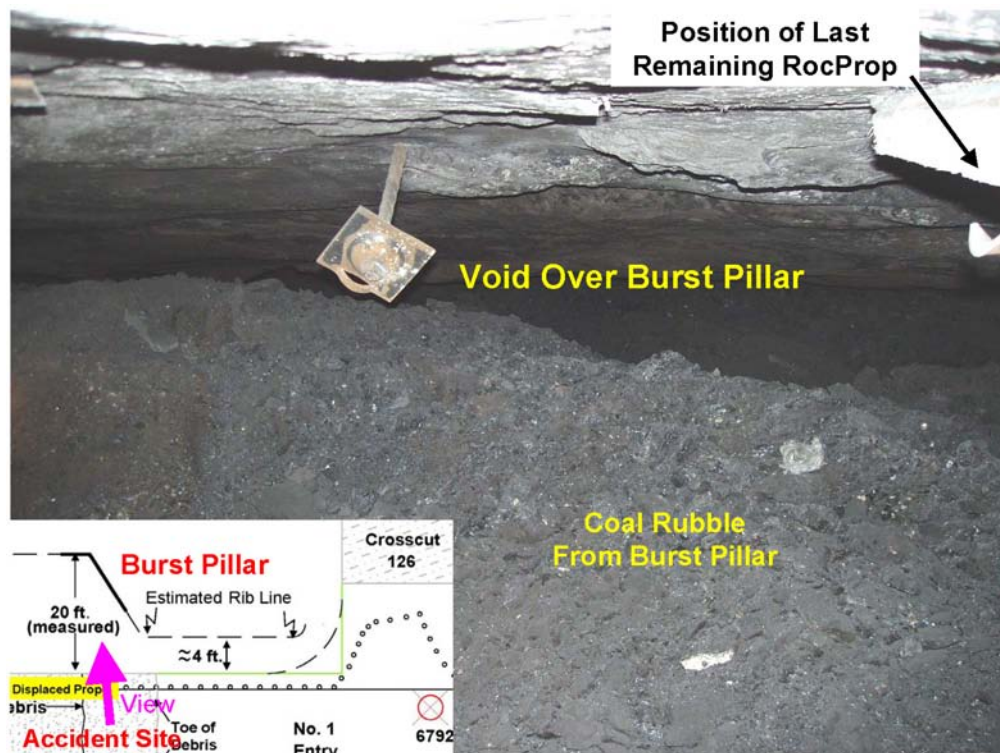
Figure 13 - 20-foot Deep Void over Pillar on Right Side of No. 1 Entry following August 16 Accident

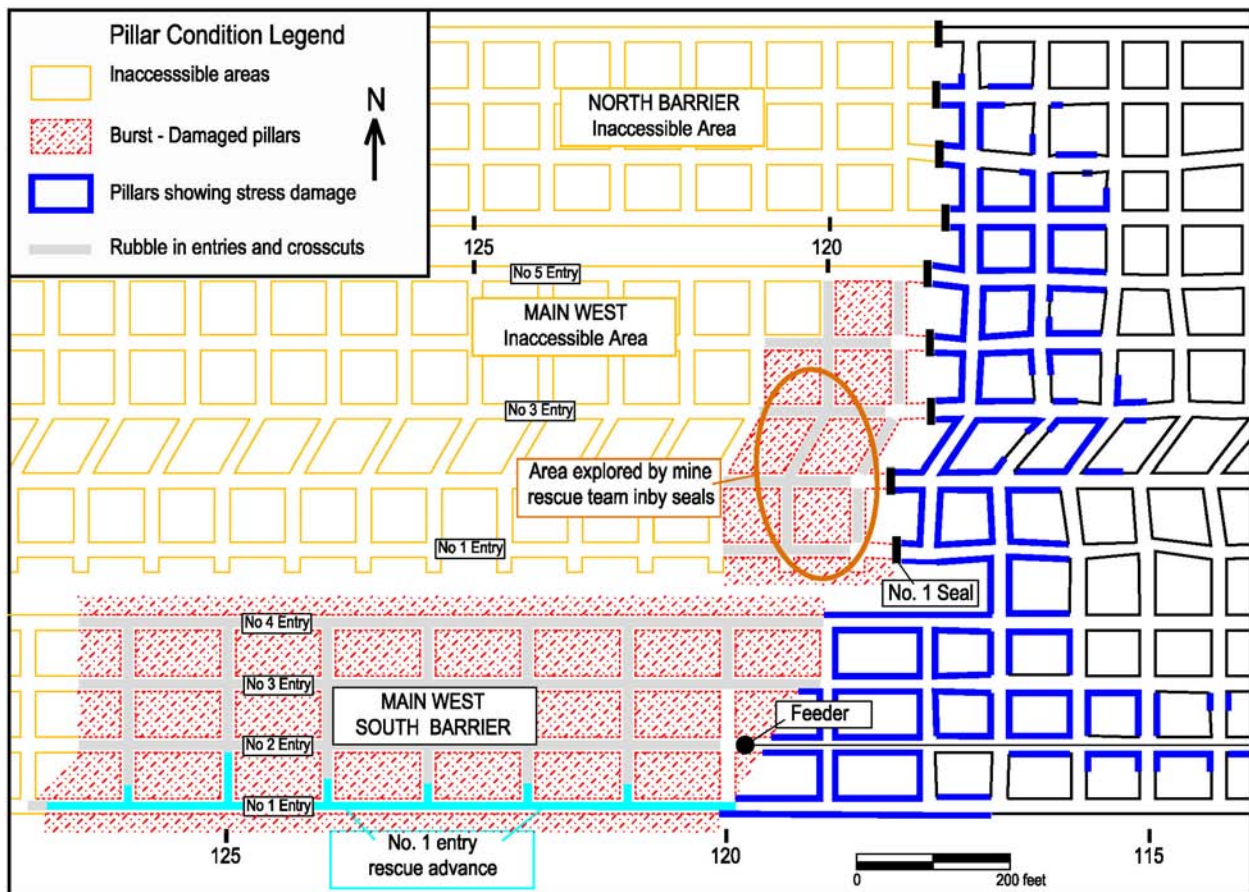
Within minutes of the accident, mine workers attempted to reach the South Barrier section to assist their coworkers. These initial efforts and additional attempts in the following days demonstrated that bursting had damaged pillars as far outby as crosscut 119, approximately ½ mile outby the entrapped miners. Debris from the outburst blocked access to all South Barrier entries inby crosscut 126 (see Figure 26). Attempts to reach the miners by breaching a seal and entering the Main West entries revealed poor ground conditions there as well. Inby the seals at Main West crosscut 118, the ground was working and bounces were occurring. Pillar deterioration (rib sloughage) had narrowed walkways to no more than 2 to 3 feet. Roof bolts were showing signs of excessive loading.

Figure 26 - Extent of Pillar Rib Damage Outby Crosscut 119

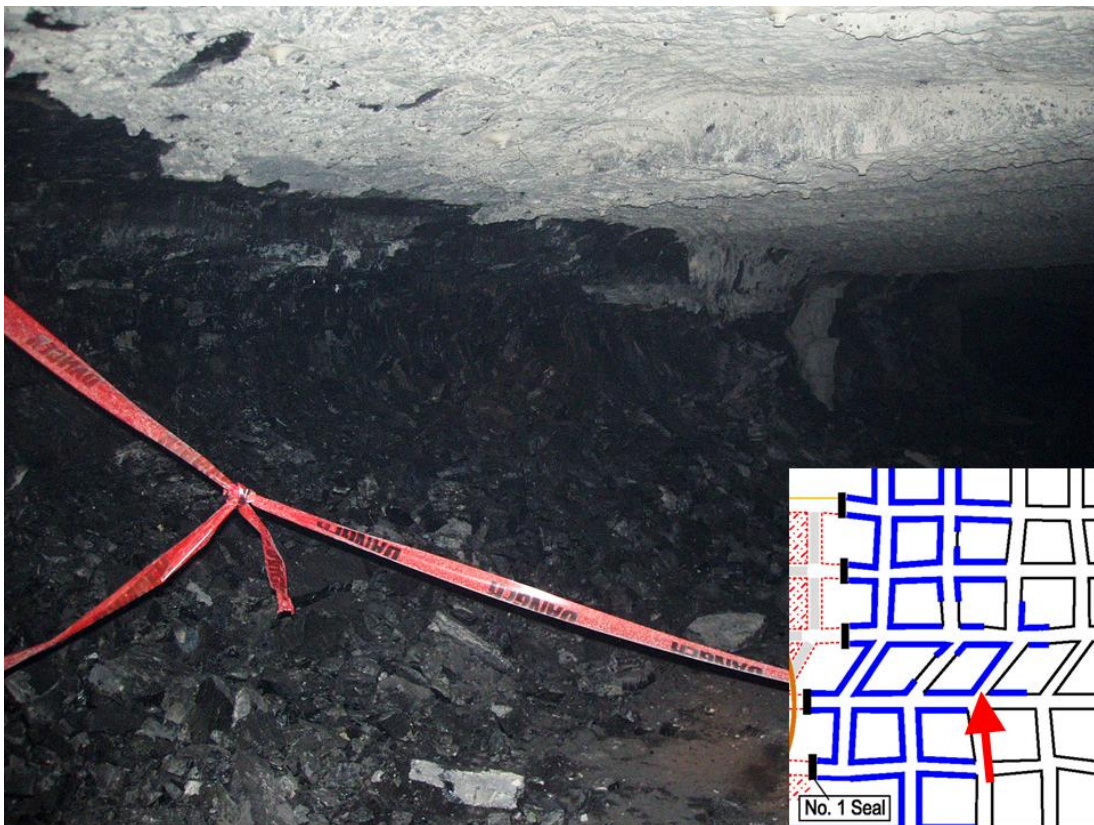
On August 11, 2007, ground conditions were mapped in the Main West entries and the North and South Barrier workings outby crosscut 119. Pillar damage was noted up to three crosscuts outby the seals (see Figure 26). The damaged ribs did not appear to be the result of bursting. Rather, the damage appeared to be associated with abutment stress transferred from inby the seals. Figure 27 and Figure 28 illustrate the difference between damaged and undamaged pillar rib conditions. Figure 27 shows normal Main West pillar rib conditions and Figure 28 shows recent pillar rib sloughage from abutment stress.

Figure 28 - Main West Pillar Rib Condition showing Recent Sloughage from Abutment Stress

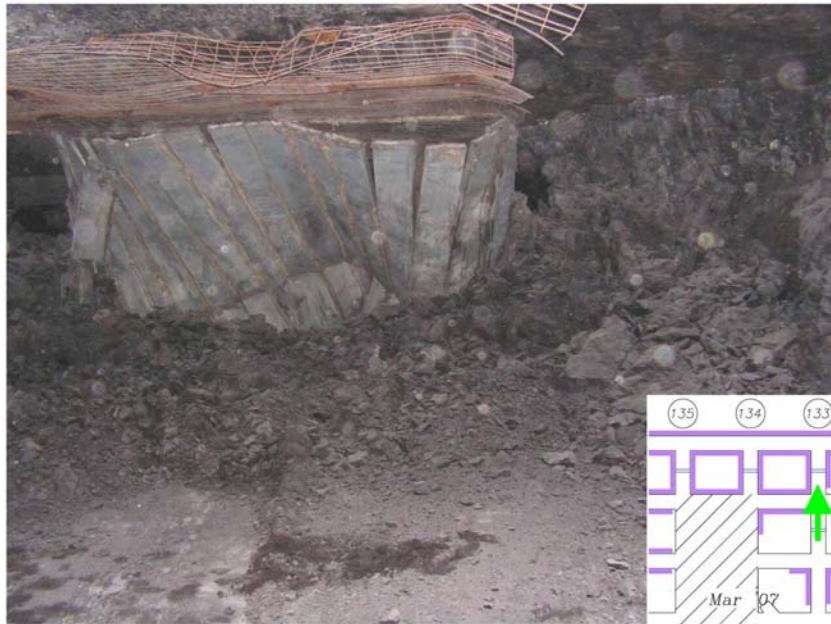
At the request of Adair, AAI personnel observed conditions in the section on March 16, 2007. The site visit was documented by photographs and a map showing pillar, entry, and crosscut conditions from crosscut 131 to 145. Figure 38 and Figure 39 illustrate a damaged stopping and conditions in the No. 4 entry from a collection of photos taken on March 16, 2007 (see Appendix O to view additional pictures). AAI's notes and photographs confirmed Falk's representation of conditions on the section in his report. The North Barrier section was sealed on March 27, 2007.

**Figure 38 – Stopping Damaged during March 2007 Coal Outburst Accident on North Barrier Section**

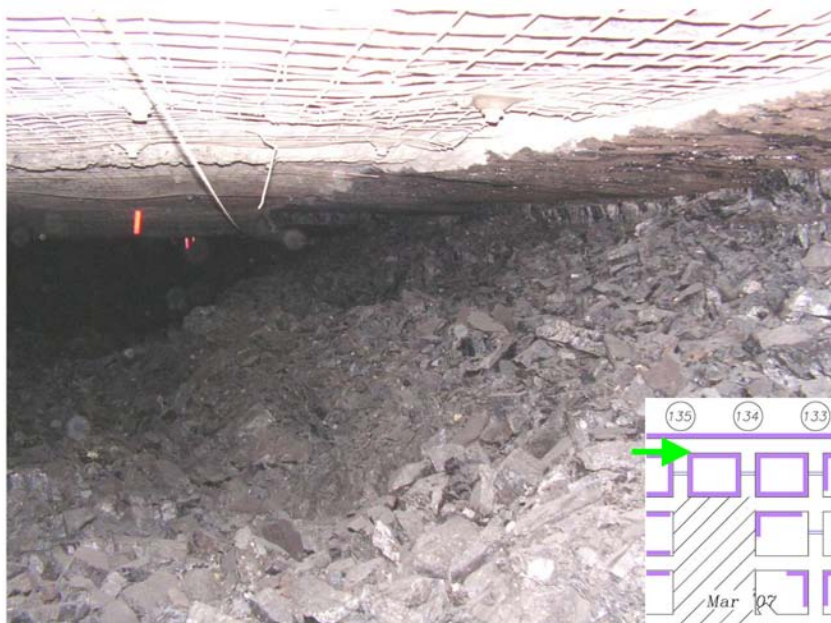
**Figure 39 –Damage in No. 4 Entry after the March 2007 Coal Outburst Accident on North Barrier Section**
