Alert Notification

Number: 7-3-US-GL-GL-00008

QHSE ALERT

SALA Fall Protection Harnesses

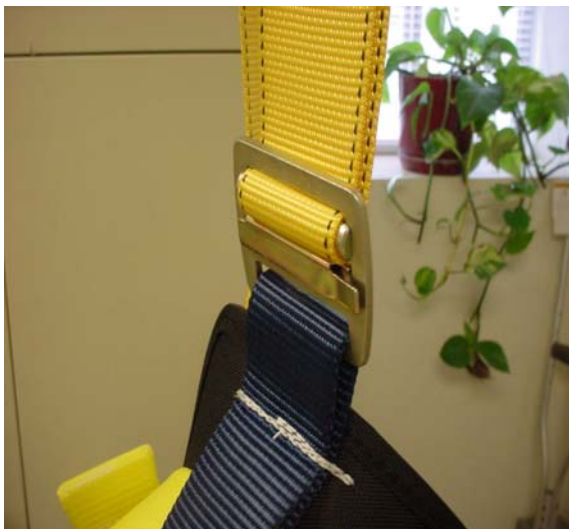
Correct

Recently, two separate incidents involving SALA "bosun's chair" style fall protection harnesses were reported. In the first incident, a new SALA Model 1106103 Delta II Oil Derrick Harness was noted to have been improperly assembled by the manufacturer. Specifically, the webbing was improperly threaded through a turnbuckle. This was a new harness that had just been removed from the packaging. A picture of the improper assembly is below, along with a photo of a correct assembly.

All SALA fall protection harnesses are to be quarantined and closely inspected for defects and/or improper assembly. Any harnesses found to have actual or suspected problems should be removed from service. Information on harnesses found to be unfit for service (including model, lot number and manufacture date) should be sent to Tracy Watson, Mid-Continent HSSE Area Manager.

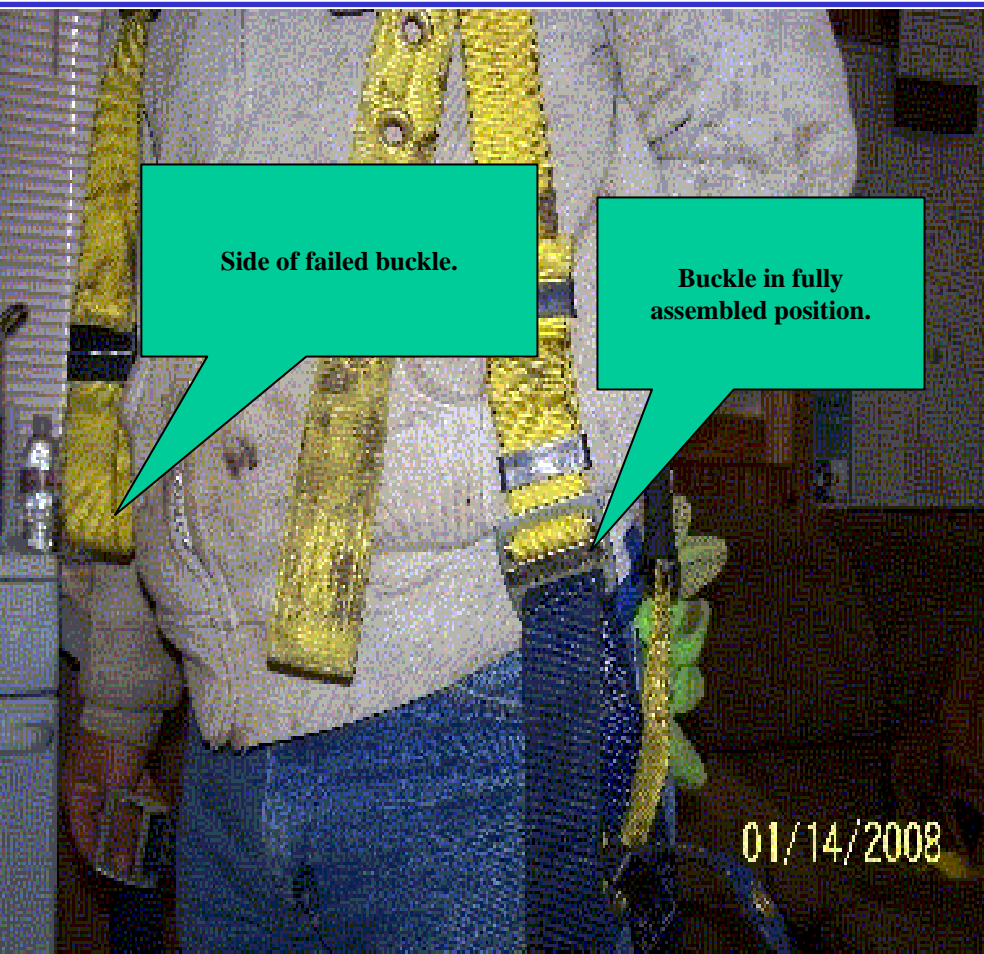
What happened: . : NM-SAFETY HARNESS ADJUSTING LATCH FAILURE. EE had just climbed down out of derrick after tripping out of hole. Upon releasing from climbing assist EE heard something drop to rig floor. Upon inspection found roller cam to right side torso adjusting strap. Investigation in progress.

- Sala brand harness, Model #1104804, Lot# 12832203, Date of manufacture 06-06.
- PPE in question was a personal issue item and had been issued to EE new Dec. 07.
- All components of the harness showed no sign of wear or rough service.
- Spring loaded safety slide came out of buckle allowing the roller tensioner to fall free from buckle.
- Had this happened under load it would have been a catastrophic failure of safety harness.
- All harnesses of this type should be closely inspected giving special attention to the adjusting buckle and the spring loaded tensioner.
- Currently contacting Sala regarding this incident.

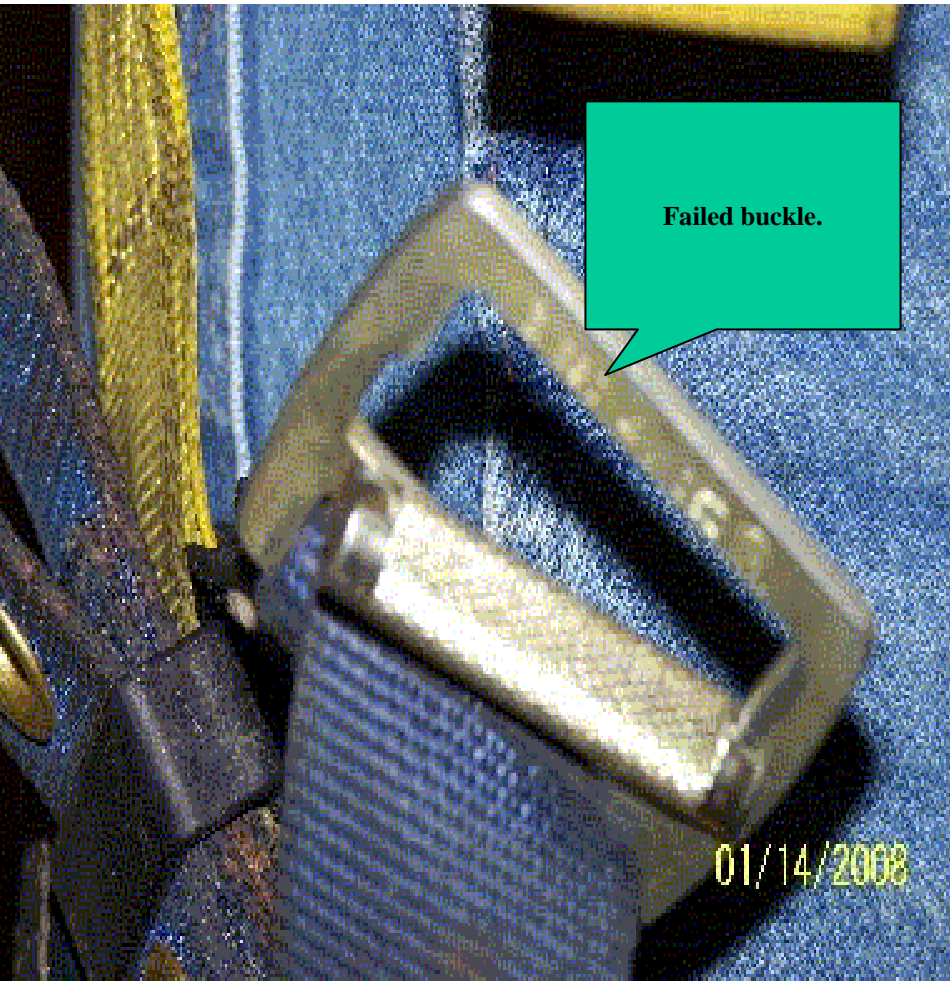
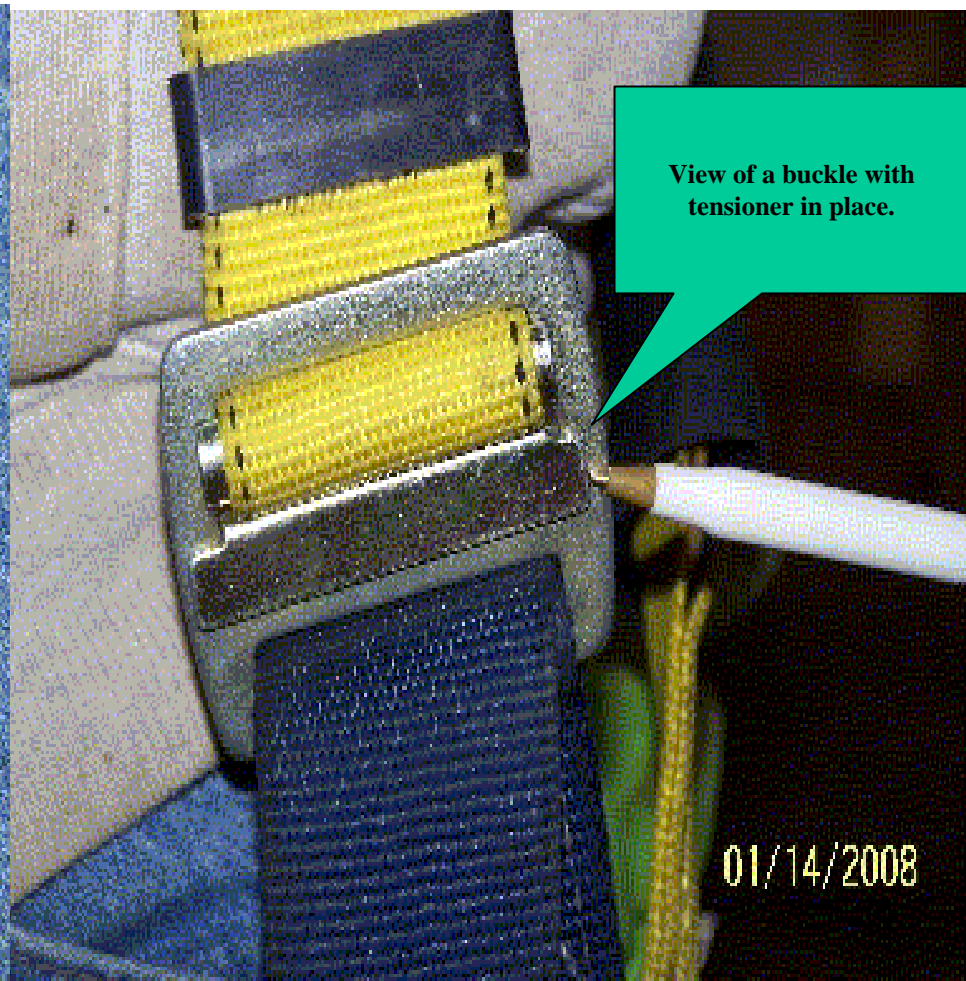
What happened: . : NM-SAFETY HARNESS ADJUSTING LATCH FAILURE. EE had just climbed down out of derrick after tripping out of hole. Upon releasing from climbing assist EE heard something drop to rig floor. Upon inspection found roller cam to right side torso adjusting strap. investigation in progress.
