Workplace Health and Safety Fatality Report

**PICKUP TRUCK AND DRIVER CRUSHED BY
HEAVY HAULER**
Date of Incident: April 26, 2008
Type of Incident: Fatality

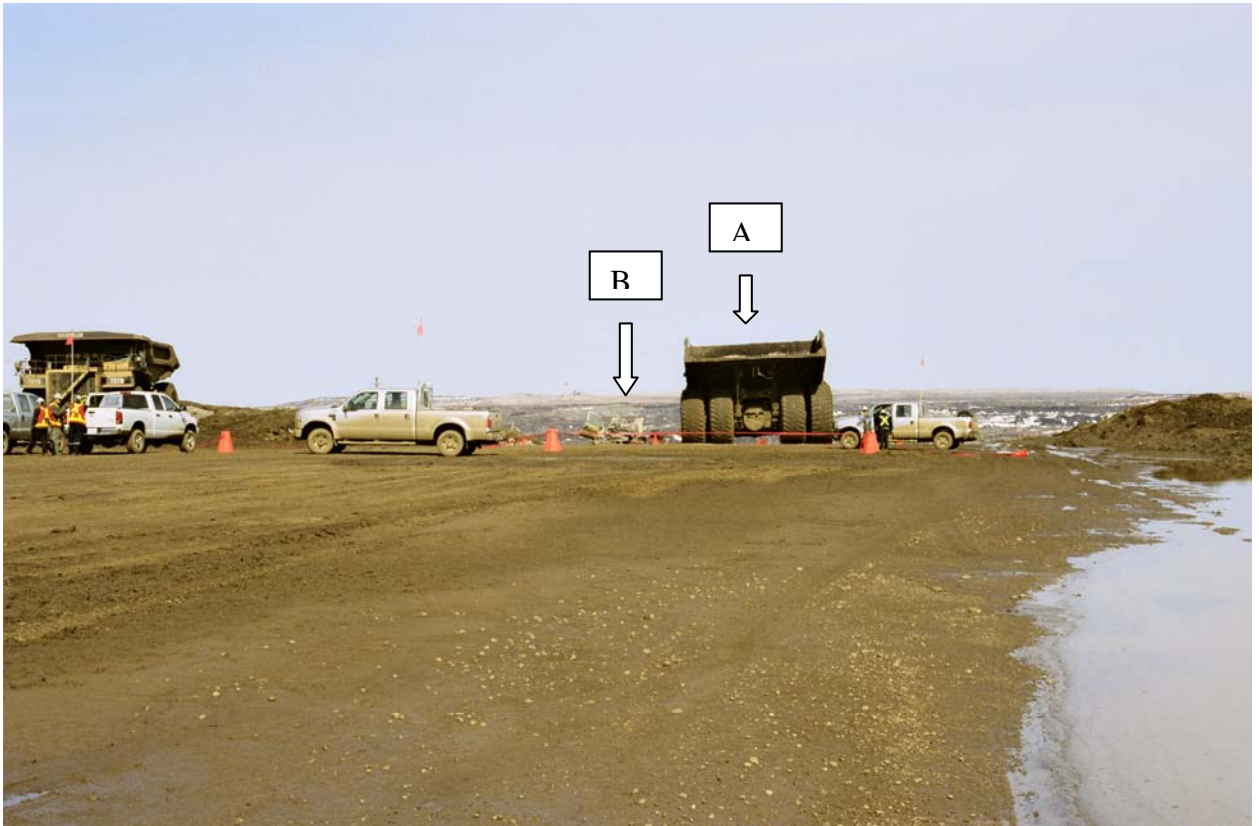
- 4.1 Albian Sands Energy Inc. Muskeg River Mine is located approximately 75 km north of Fort McMurray, Alberta. The incident occurred at the top of a ramp leading from the mine to the Crusher Pad, at the intersection where the ramp enters the Crusher Pad. (Attachment "A", Map). (Attachment "B", Diagram) (Attachment "C", Photograph #1)

Photograph #1 Looking northeast across the Crusher Pad to the incident scene.
Arrow "A" shows the heavy haul truck. Arrow "B" shows the pickup truck.

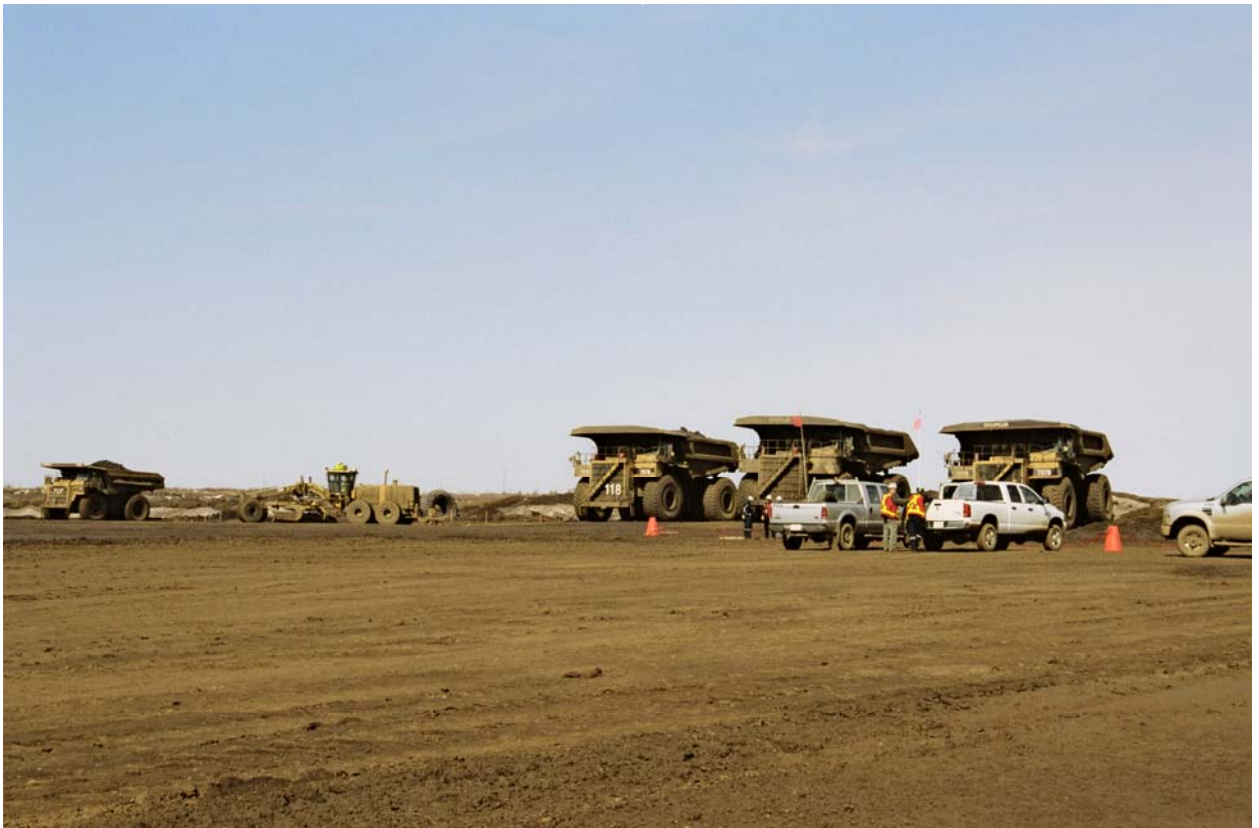
5.1.2.1 The Crusher Pad is a large flat roughly rectangular area approximately 180 m by 200 m. At the south-east side of the pad two haul roads enter the pad. The ramp rising from the mine enters at the northeast corner of the pad, and a road leading to the processing and administration areas enters from the south-east corner of the pad. Crusher inlet chutes leading into two crushers are located on the north-west side of the pad. Each crusher inlet chute has two dump blocks where heavy haulers can dump their loads. Heavy haulers are parked on the pad during shift changes and also when they are awaiting instruction to travel to a shovel to be loaded. (Attachment "B", Sketch) (Attachment "C", Photograph #2)

Photograph #2	Shows heavy haul trucks and other equipment parked on the northeast side of the Crusher Pad.
---------------	--

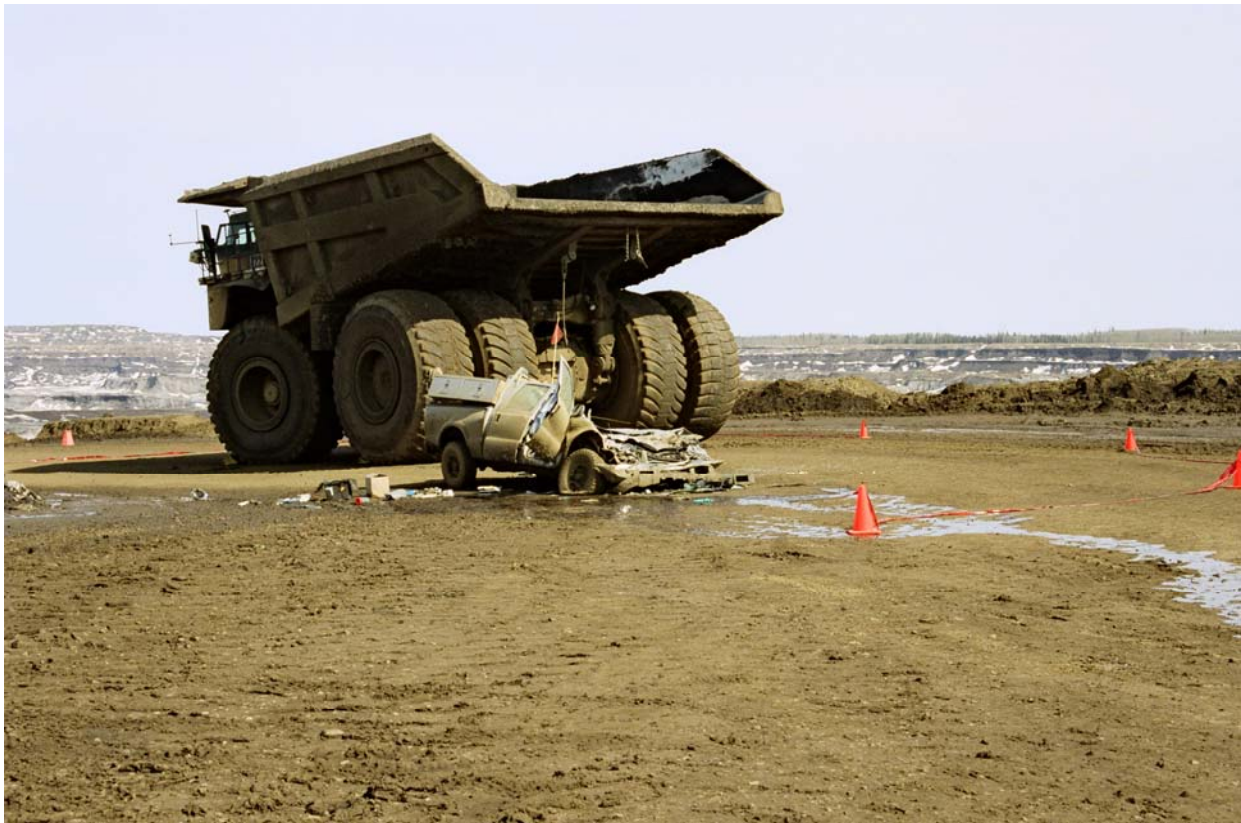
Photograph #3

- 6.7 The Other Operator in Truck #102, observed Truck #122 turn left onto the ramp from the Crusher Pad. As Truck #122 made the turn, the left front wheel of Truck #122 struck the pickup being driven by the Electrician that was stopped at the top of the ramp entering the Crusher Pad. The left dual rear wheels of Truck #122 then ran over the pickup truck at an angle of approximately 45 degrees from the right front wheel of the pickup truck, crushing the hood and then the cab and the truck bed on the left side of the pickup truck. The Other Operator stopped Truck #102, used the radio system to tell Truck #122 to stop and called in an emergency situation. (Attachment “C”, Photographs #3, #4, #5, #6, #7)

Looking east. Shows the pickup truck and heavy haul truck where it stopped after the incident.

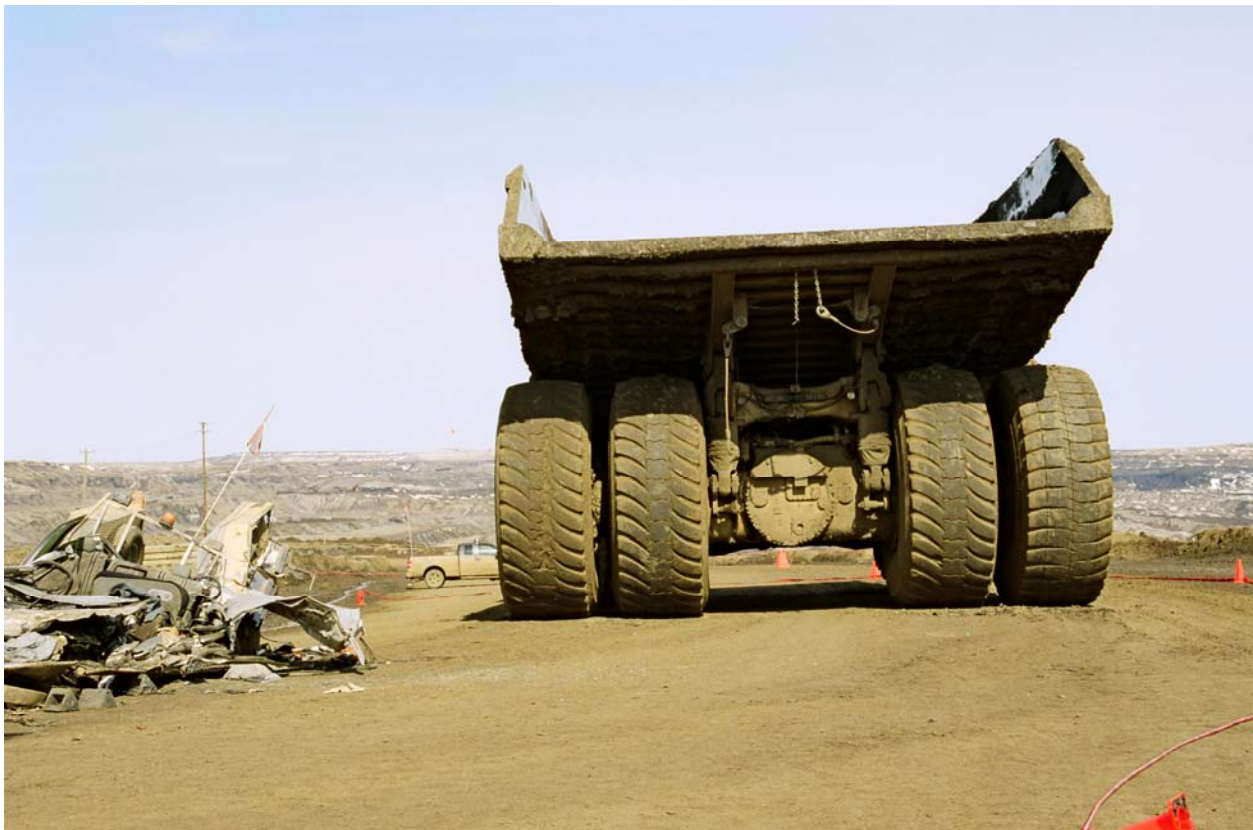
Photograph #4

Looking northeast. Shows the heavy haul truck and the pickup truck. The roof of the pickup truck was cut and lifted by emergency services to remove the Electrician from the pickup truck.

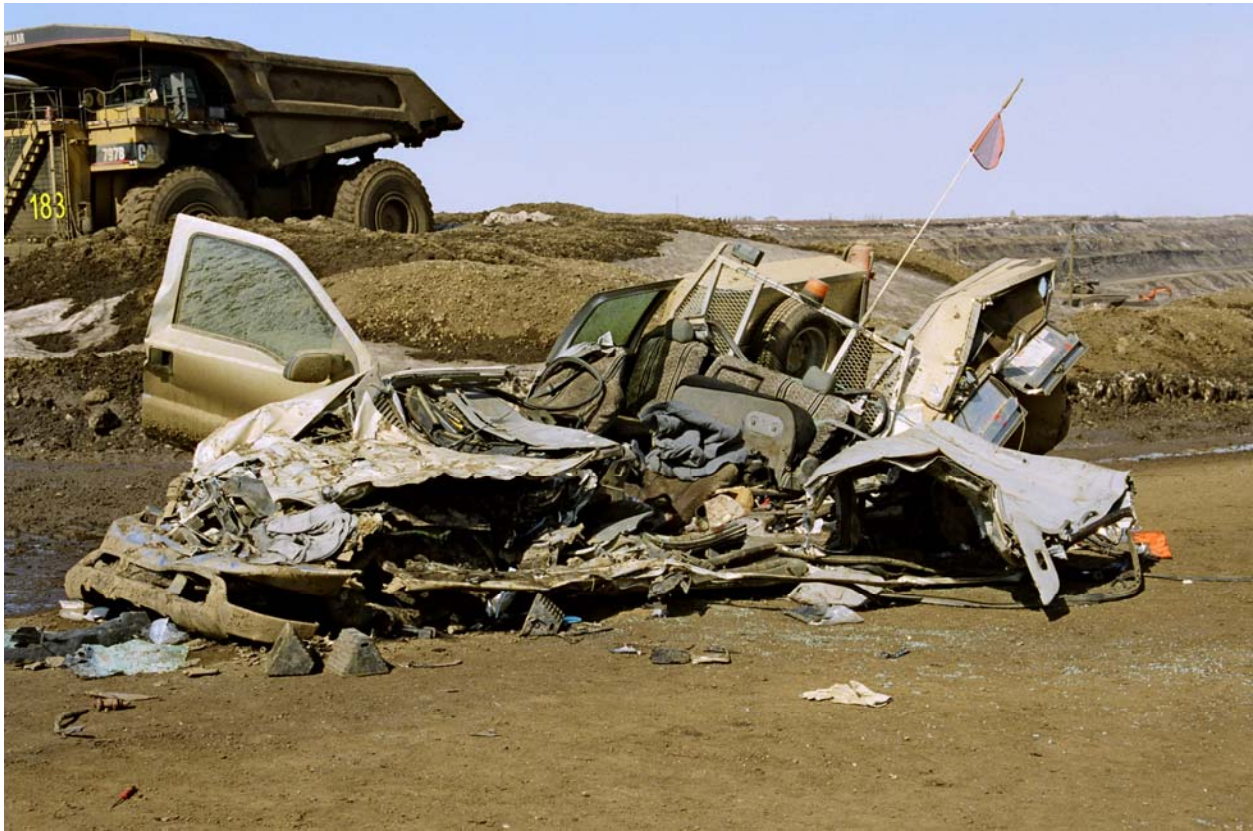
Photograph #5

Looking north. Shows the driver's side of the pickup truck.

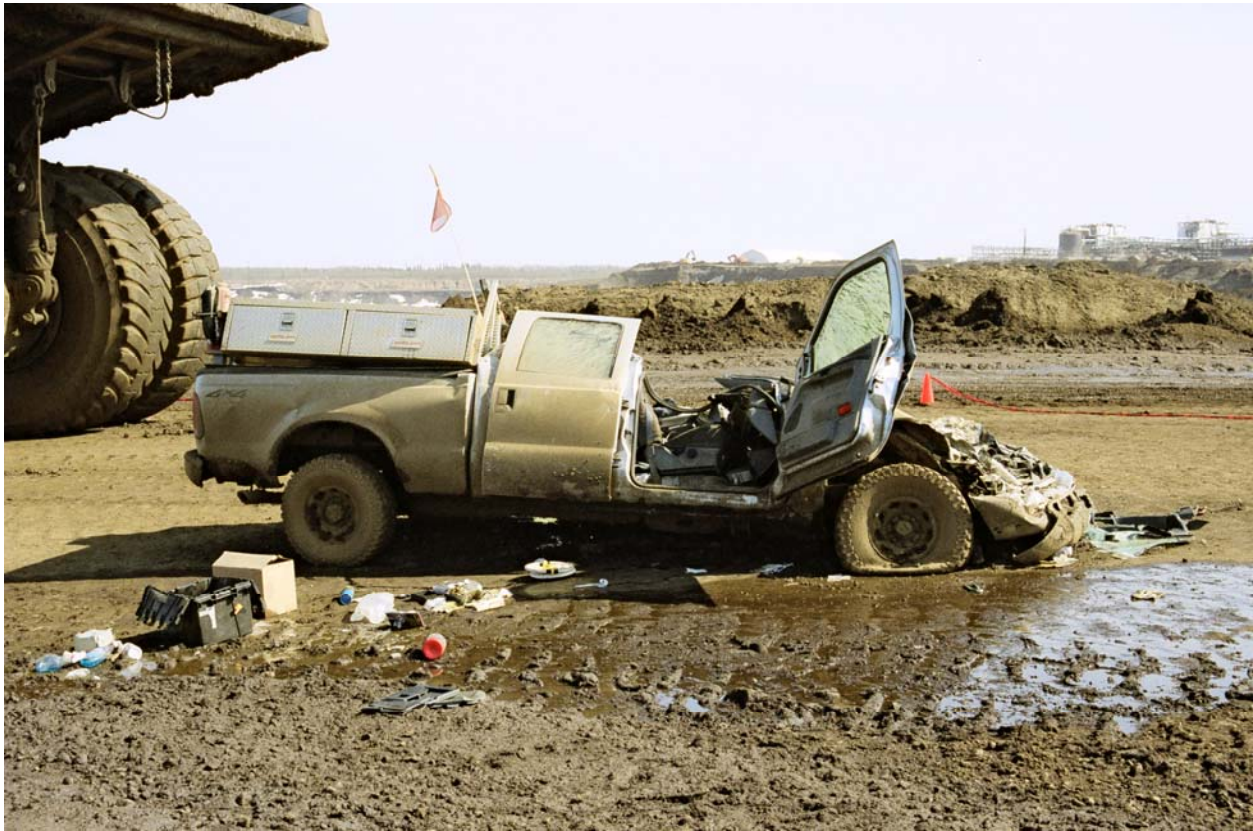
Photograph #6 Looking southeast. Shows the passenger side of the pickup truck.

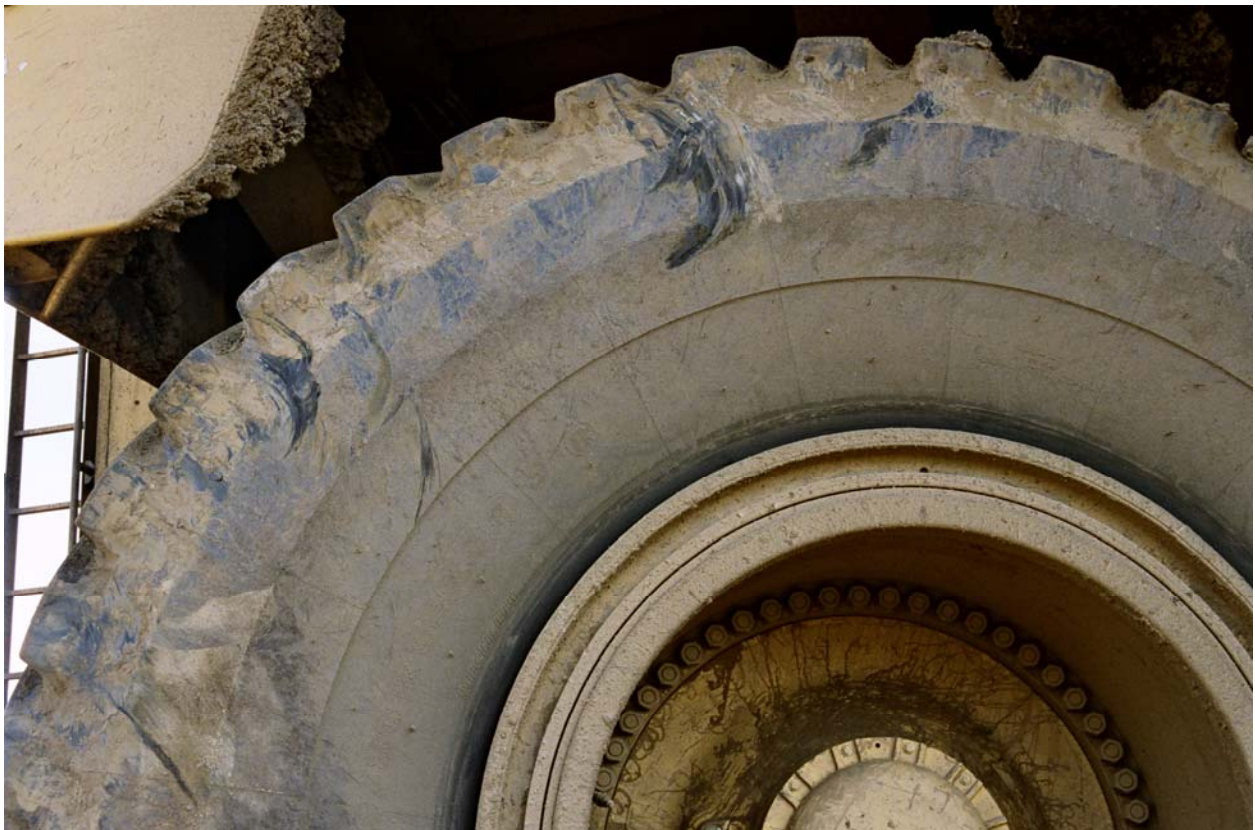
Photograph # 7 Shows marks on the front driver's side tire of the heavy haul truck.

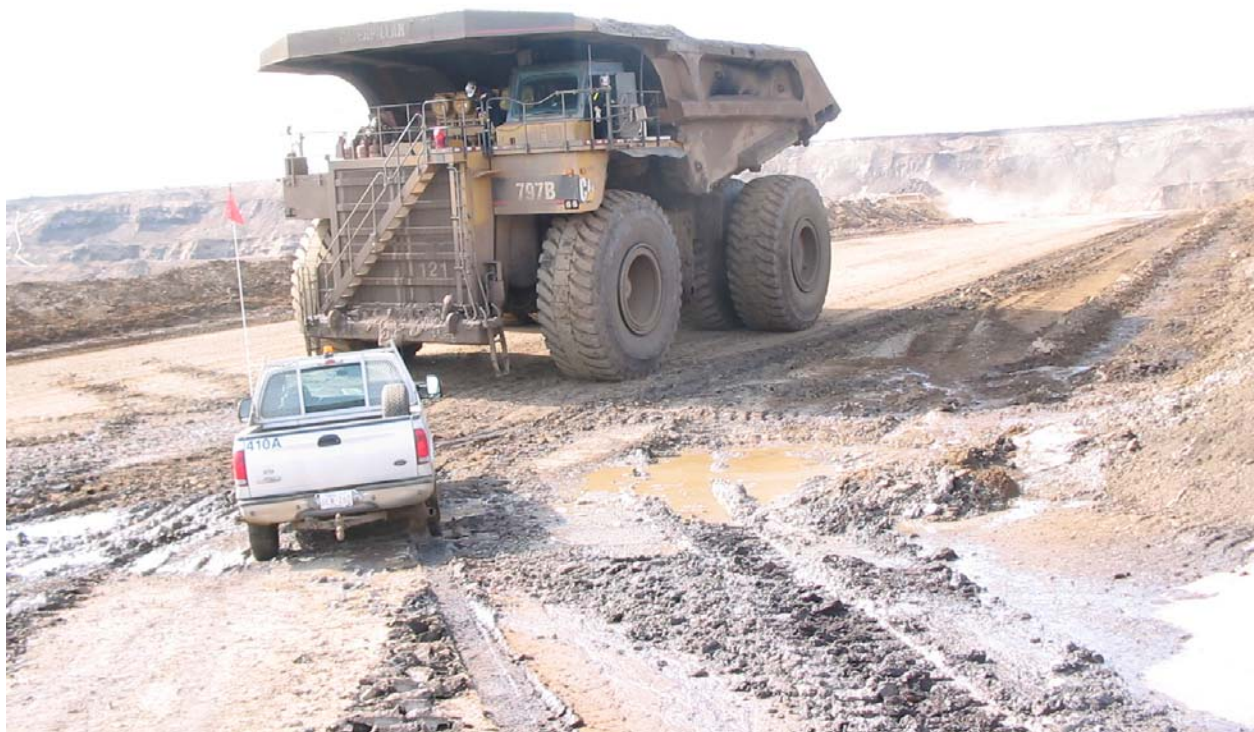
- 7.2.1 The Operator of the heavy haul truck #122 stated that she never saw the pickup until after the incident had occurred and an emergency had been called. Heavy haul truck operators have limited visibility close to the truck on the left-hand or driver's, side, because of the height of the driver's seat above ground, and blind spots caused by the frame of the cab and the large rear - view mirrors fitted to the vehicle on the left side. Tests carried out by Workplace Health and Safety Compliance and Albian Sands Energy Inc. showed that a Caterpillar 797B operator starts to lose sight of a pickup truck when the pickup truck is 7.5 m from the hauler on the left side front, and completely loses sight of the pickup truck when the pickup truck is 3.6 m from the hauler. These measurements were taken with the pickup truck outside the blind spots created by the cab frame and mirror. A pickup truck remaining in the blind spots would not be visible to the operator at any time. (Attachment "C", Photographs #8, #9,)

Photograph #8 Shows a reconstruction carried out to assess the sight lines from an identical heavy haul truck. At this point the pickup truck starts to disappear from the view of the heavy haul truck operator.

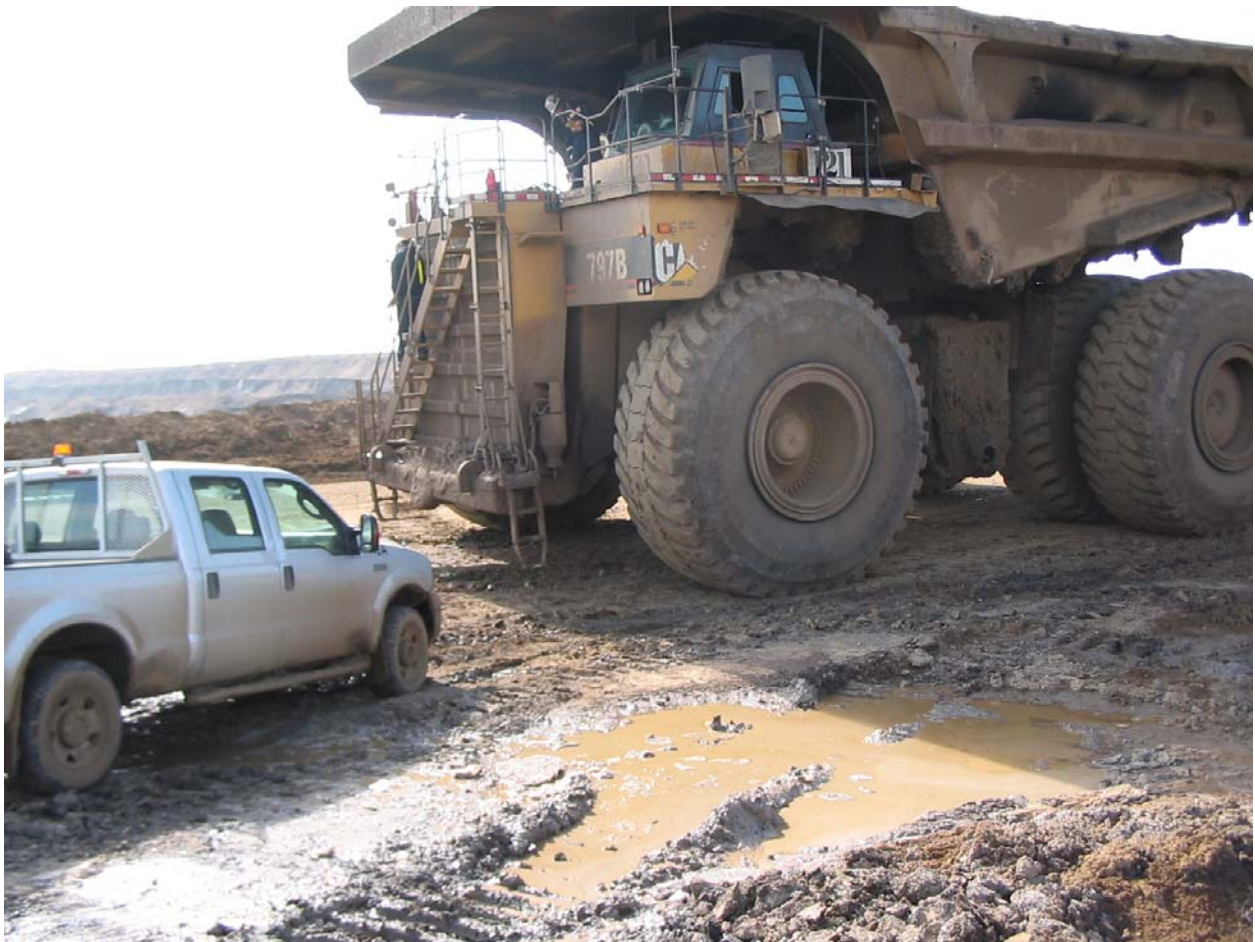
Photograph #9 Shows the reconstruction. At this point the pickup truck is not visible to the heavy haul truck operator.

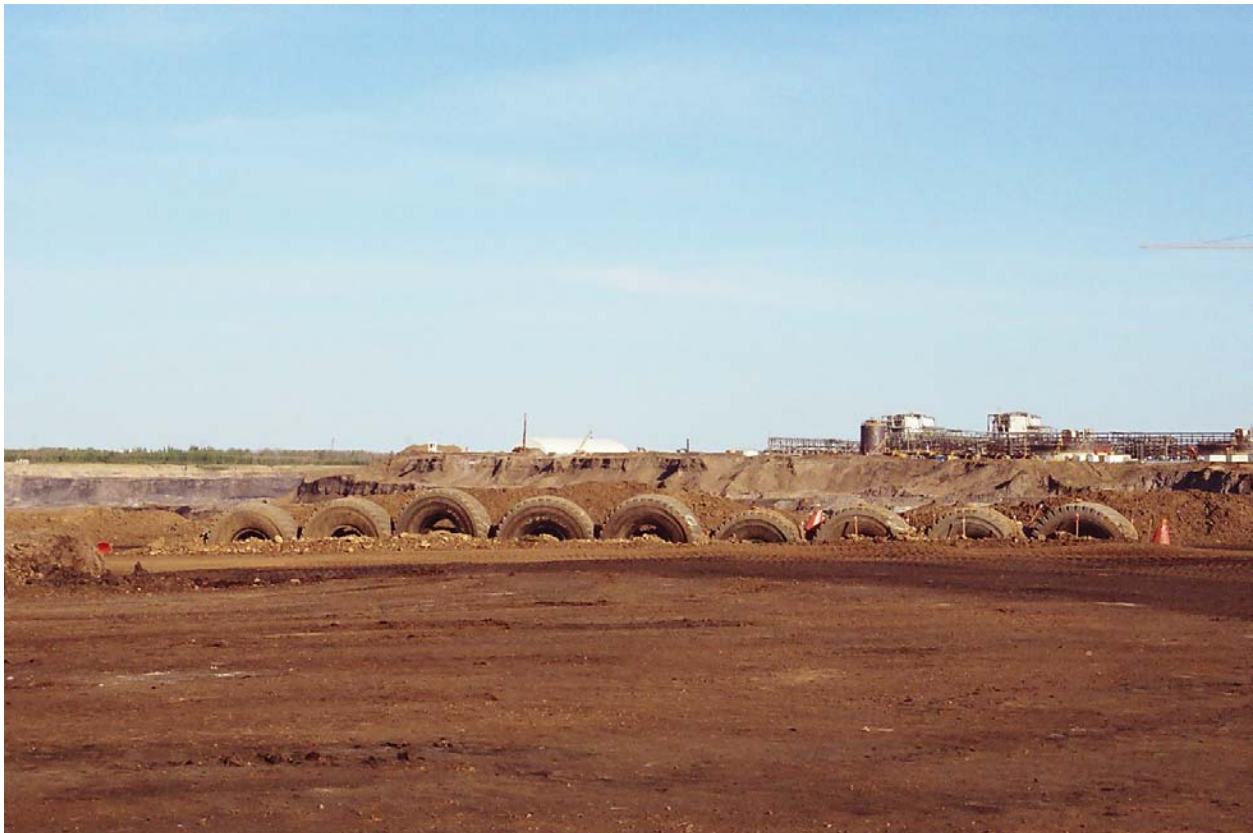
Photograph #10 Shows the traffic island, constructed from heavy haul truck tires, installed on the crusher pad after the incident.

- 8.2.1 Albian Sands Energy Inc. constructed traffic islands at the southeast side of the crusher pad. Heavy haulers leaving the pad were given an instruction to pass around the traffic islands when leaving the pad. This prevented heavy haul trucks from cutting the corner at the intersection with the ramp. At the same time, Albian Sands Energy Inc. implemented a system requiring drivers of light vehicles to use an alternate route to and from the mine, avoiding the crusher pad. Albian Sands Energy Inc. surveyed the entire mine site and installed similar traffic islands at other intersections in the mine. (Attachment "C", Photographs #10, #11)

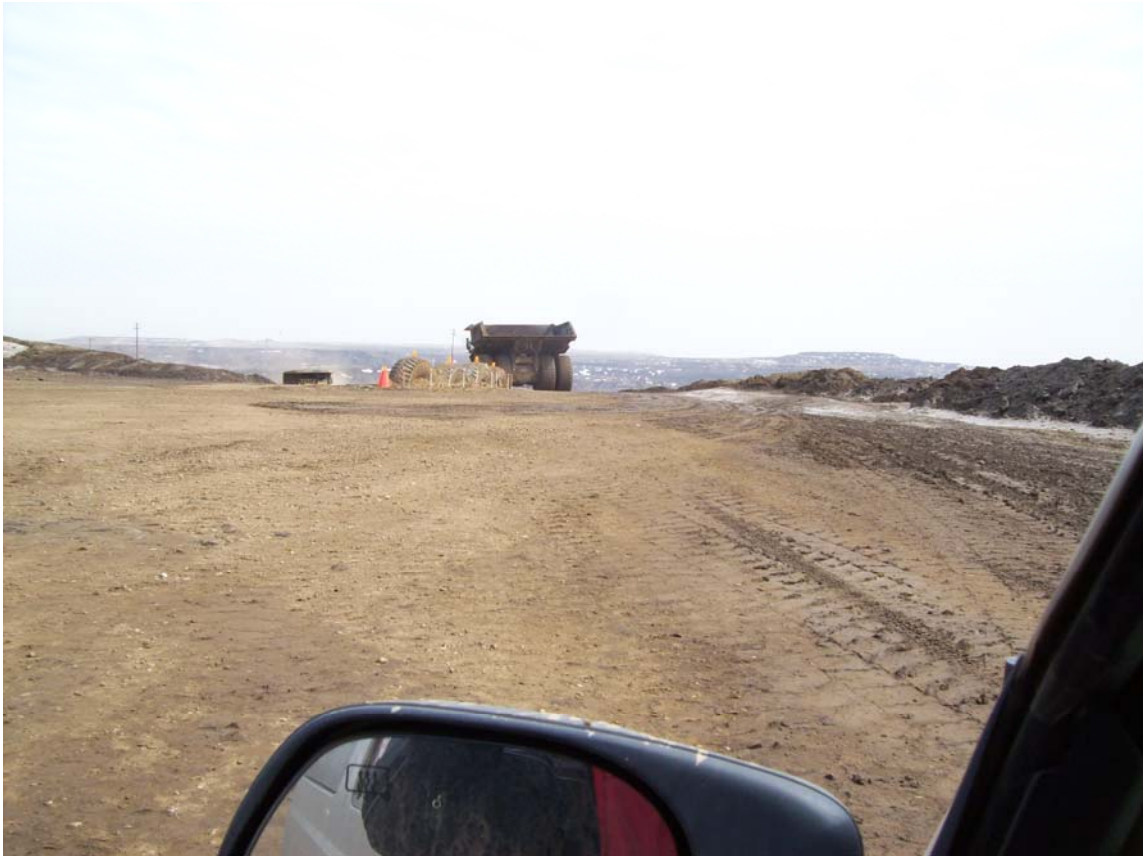
Photograph #11 Shows a heavy haul truck descending the ramp from the Crusher Pad after passing around the traffic island.

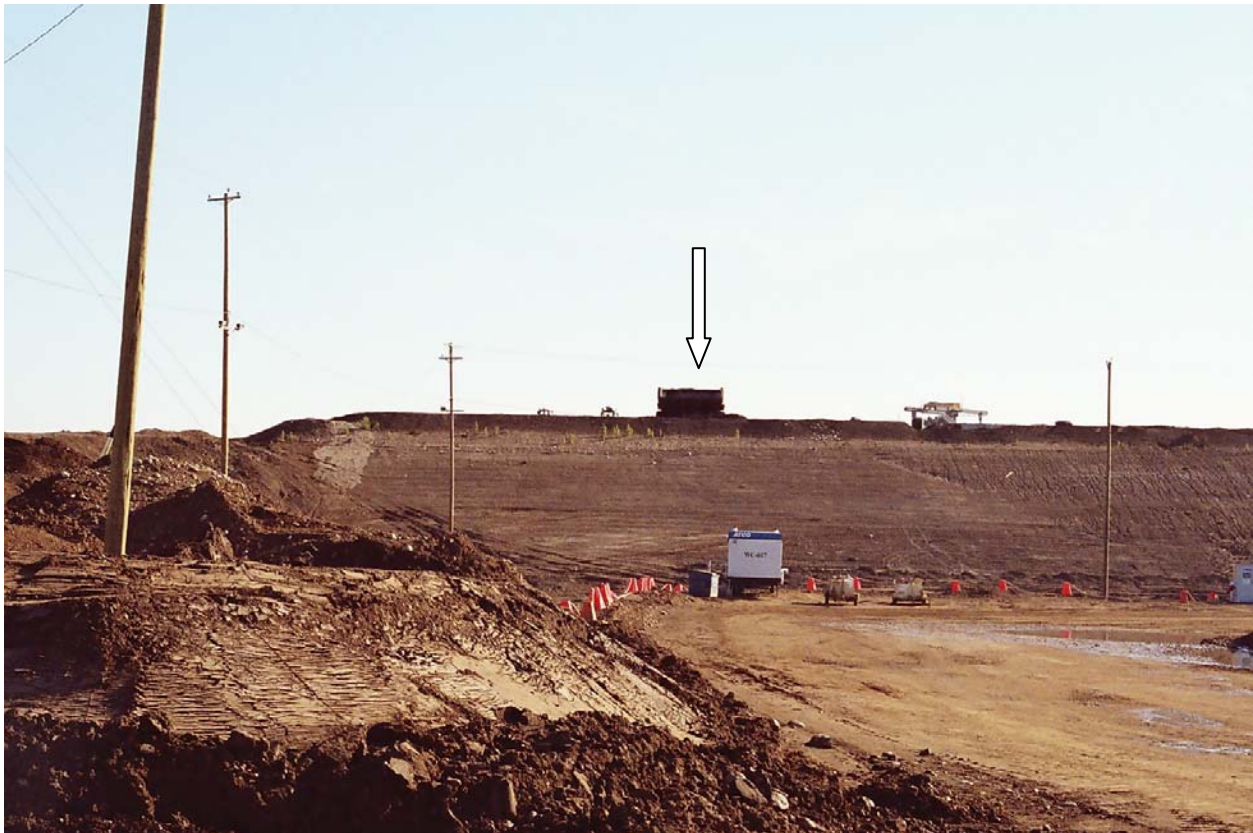
Photograph #12

- 7.2.6 Workplace Health and Safety Compliance and Albian Sands Energy Inc. carried out checks to determine if heavy haul trucks operating or parked on the Crusher Pad were visible to drivers of light vehicles approaching the Crusher Pad on the ramp. It was found that heavy haulers on the pad were clearly visible from the base of the ramp and during most of the ascent. When approaching within 50 m of the intersection with the Crusher Pad the berm at the northeast corner of the Pad obscured the view of the heavy haulers. (Attachment "C", Photographs #12, #13, #14)
- 7.2.7 The Operator of the heavy haul truck #122 at the time of the incident was a qualified and experienced operator.

Reconstruction shows the view that a pickup truck driver has at the bottom of the ramp. A heavy haul truck parked on the Crusher Pad can be seen before the pickup truck starts to ascend the ramp. Arrow shows that a heavy hauler parked on the northeast side of the crusher pad is clearly visible.

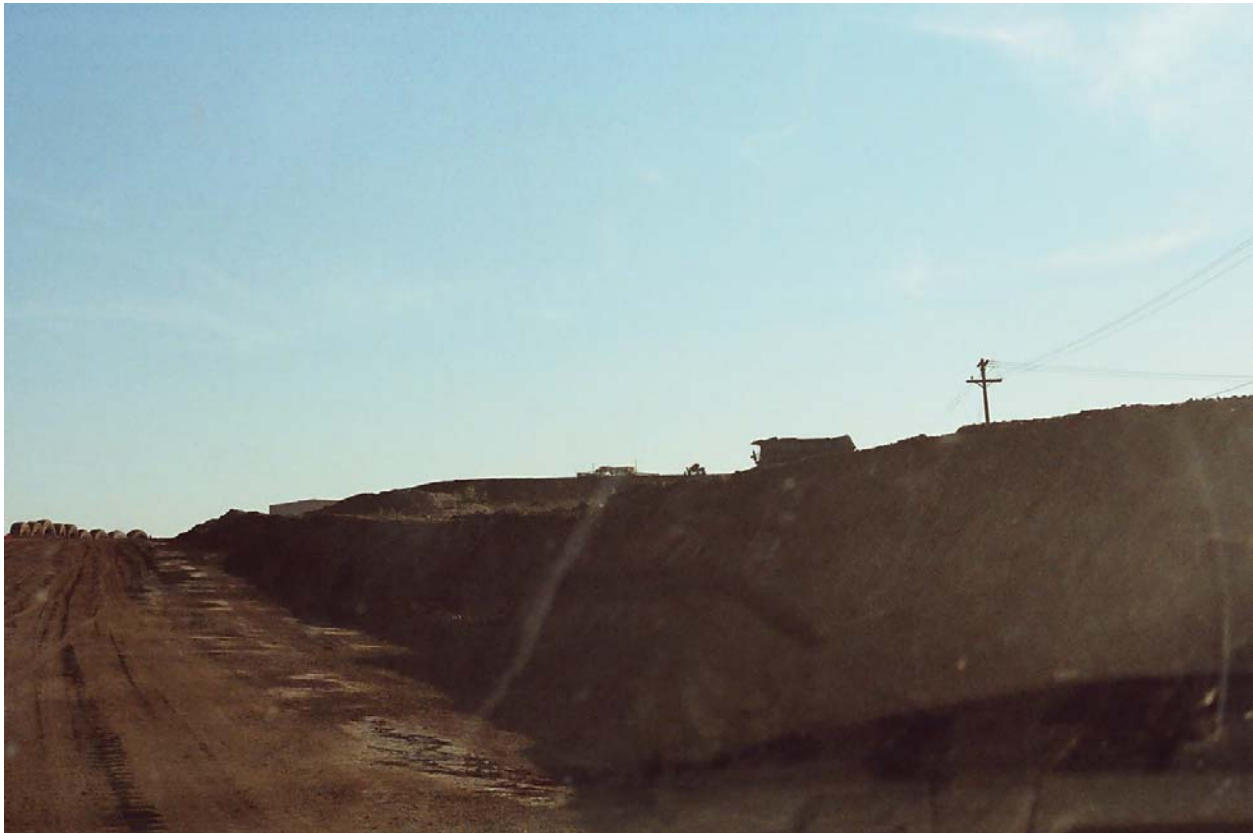
Photograph #13

Reconstruction shows the view of a pickup truck driver ascending the ramp. The heavy haul truck parked on the crusher pad can be seen by the pickup truck driver.

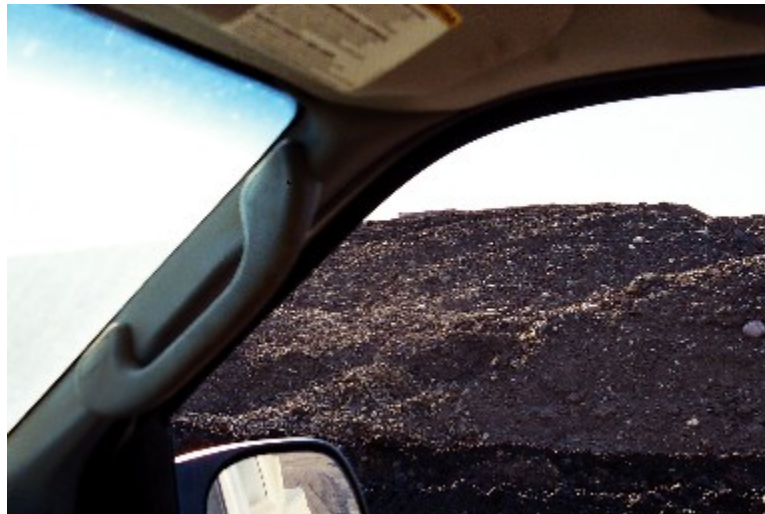
Photograph #14

- 7.2.5 Workers driving light vehicles on the Muskeg River Mine site are required to complete a Mine Driver training course and to operate the vehicle in accordance with Albian Sands Work Practices. The Electrician had completed the Mine Driver training course and was qualified to operate a light vehicle in the mine. Heavy haulers always have right-of-way over light vehicles. Drivers of light vehicles in the mine are instructed to approach heavy equipment from the front and cab side of the heavy equipment, and to stop and remain at least 50 m away from heavy equipment until visual or radio communication is made with the heavy equipment operator. Acknowledgement from the operator of the heavy equipment must be received before moving any closer. Albian Sands Work Practices instructions clearly describe the limited visibility from the cab of a heavy equipment operator, and contain the instruction “Never assume the operator of heavy equipment can see you”. The Electrician had positioned his pickup truck closer than 50 meters away from heavy haul trucks that were positioned on the Crusher Pad, and had not obtained authorization from the Operator of a moving heavy haul truck to approach. However, had he stopped further back from the pad his view of the pad would have been blocked by the berm on his right side.

Reconstruction shows the view of a pickup truck driver stopped at the berm at the entry to the crusher pad. The berm obscures the view of the Crusher Pad and the heavy hauler cannot be seen by the pickup truck driver.

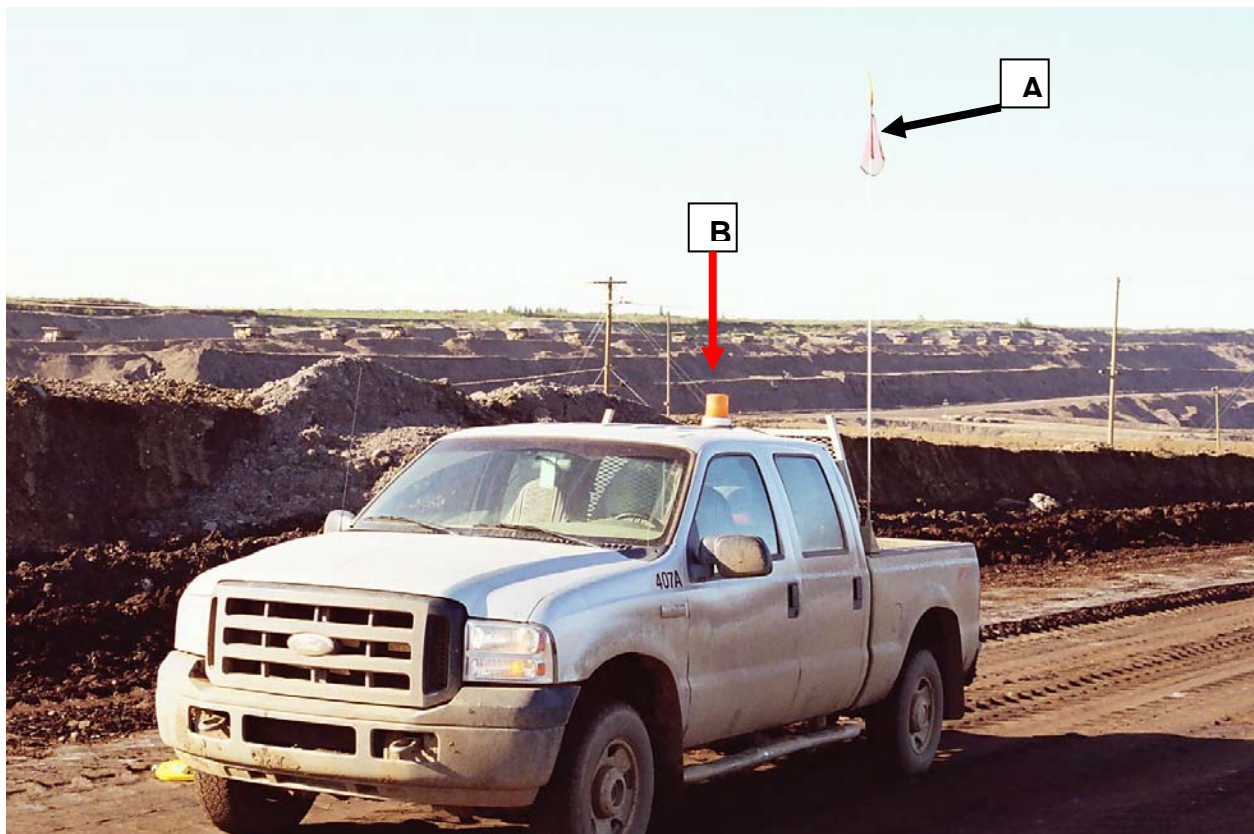
Photograph #15

5.1.4.1 The pickup truck that was involved in the incident was a 2004 Ford F250 Crew-cab. The vehicle was owned by Albian Sands Energy Inc. and identified as Unit #479. The vehicle was fitted with a buggy whip and flashing amber light. Light vehicles operating in the mine are also required to have their lights on at all times. (Attachment "C", Photographs #3, #5, #6, #15)

Shows a pickup truck similar to the one involved in the incident. Arrow "A" shows the buggy whip and flag. Arrow "B" shows the flashing amber light fitted to the cab roof.

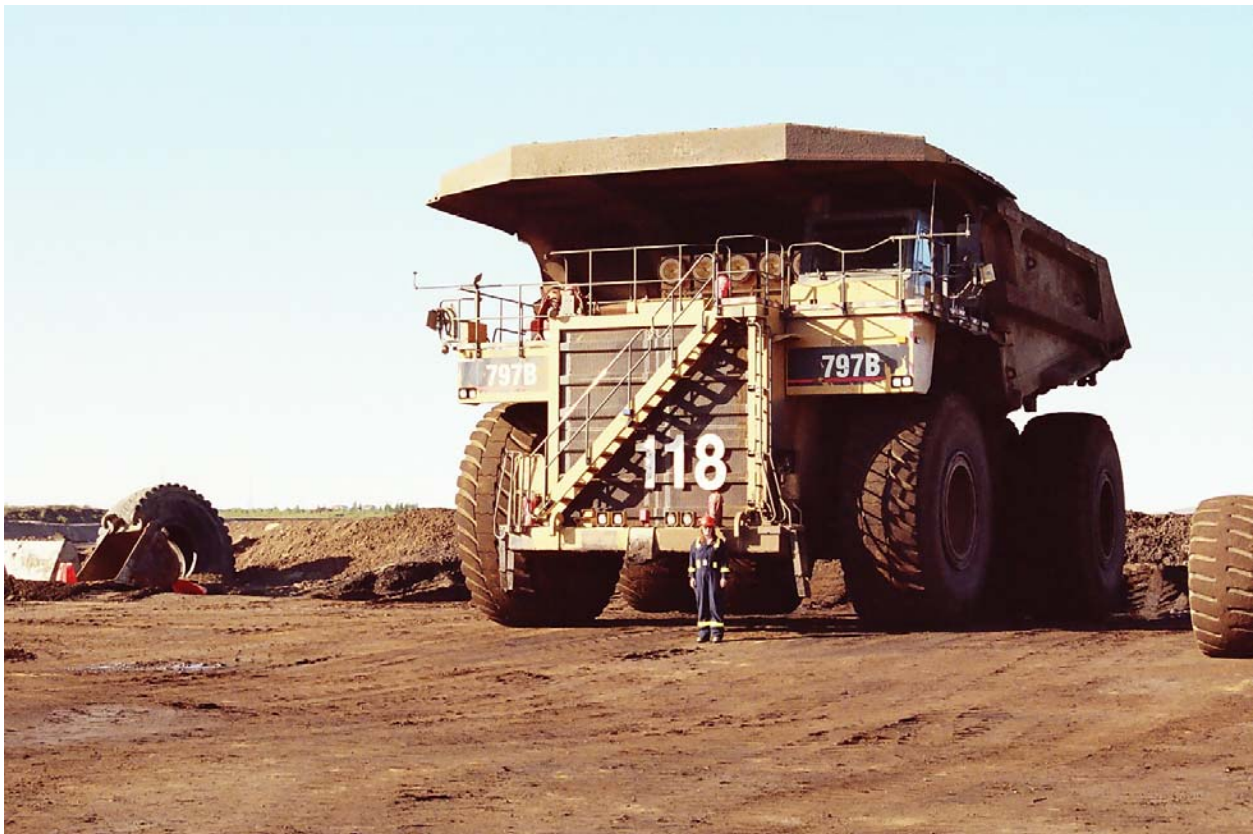
Photograph #16

5.1.3.1 The heavy haul truck that was involved in the incident is a Caterpillar 797B off-road mining truck. The vehicle is owned by Albian Sands Energy Inc. and identified as Haul Truck #122. The vehicle has a gross weight of 279,800 kg and a loaded operating weight of 623,500 kg. The vehicle was empty at the time of the incident. The vehicle has a wheelbase of 7.18 m, and an overall length of 14.53 m. The vehicle is 9.75 m wide and 7.6 m high. (Attachment "C", Photographs #1, #3, #4, #16)

Shows a heavy haul truck identical to the heavy haul truck involved in the incident. The officer standing at the front of the vehicle gives an indication of the size of the heavy haul truck.
