Aluminum Regulator Fire Injures One Fire Fighter-Nevada

SUMMARY

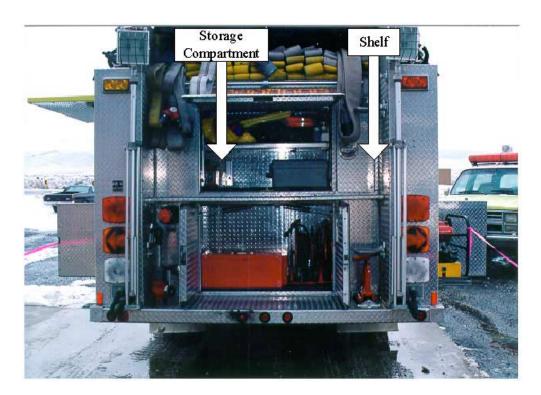
Photo 1: This photo depicts the storage compartment and shelf

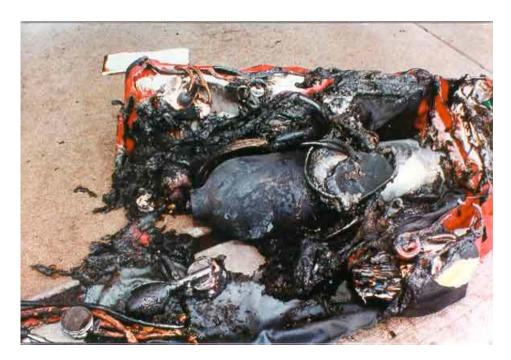
The regulator involved was an aluminum regulator designed for use with a portable or fixed oxygen cylinder ("D" and "E" size). The fire destroyed most of the regulator in this incident (see Photo 2). The cylinder was a "D" size cylinder. Records confirmed that the cylinder was in good condition before this incident. The cylinder was only slightly damaged during the incident. The post valve, which attaches the regulator to the cylinder, was severely damaged. It had severed near the base of its connection with the cylinder and was found completely detached from the cylinder. The cylinder was nearly full at the time of the incident (approximately 2200 psi). The regulator and cylinder were used the night before this incident with no reported problems. The regulator and cylinder were sent to an independent forensic testing laboratory for further evaluation.

Photo 2: This photo depicts the damaged oxygen system

Recommendation #1: Fire departments should consider the use of oxygen regulators constructed of materials having an oxygen compatibility equivalent to brass.^{2-7, 15}
