SAFETY ALERT

Lightning strikes stationary truck

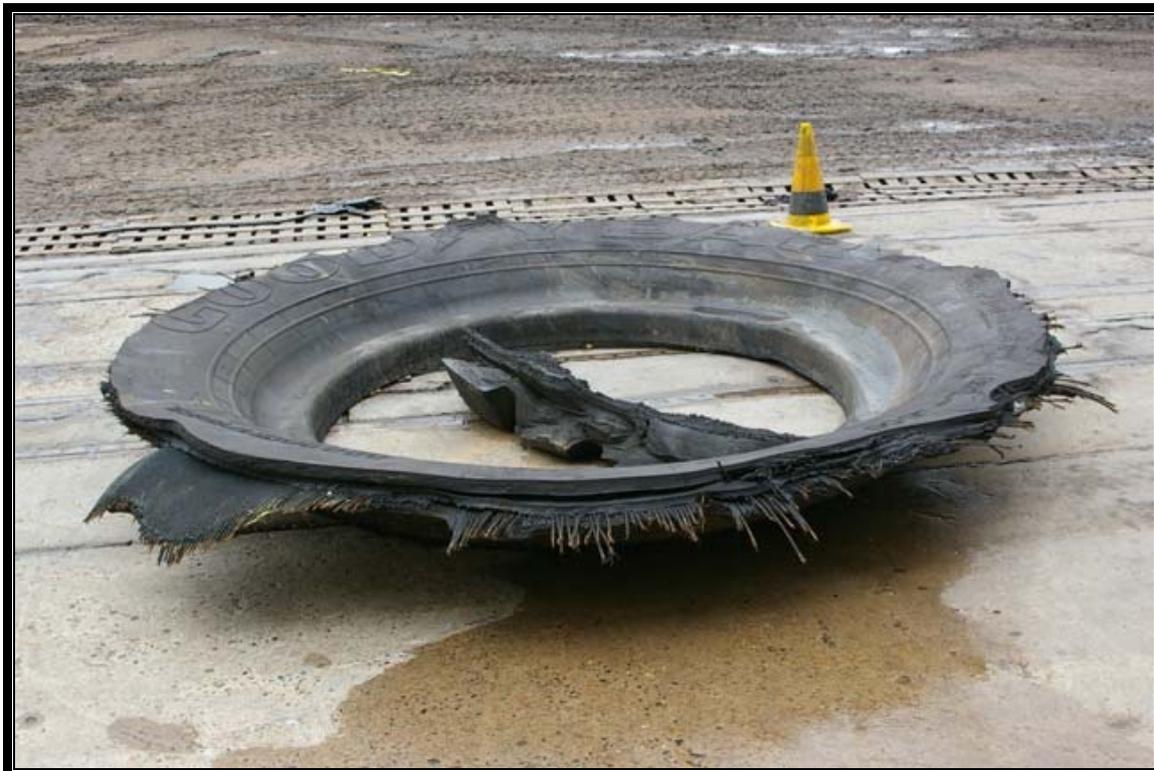
3. Position 1 tyre (new tyre) had one complete side wall blown out.
4. Position 3 tyre had the side wall blown out for three-quarters of the circumference.

Position 1 tyre (driver's side front) showed evidence of earthing through this tyre, and it's believed the lightning earthed through No 1 and No 3 position tyres.

Figure 3: Tyre side wall from position number 1
