SAFETY ALERT

Grinder Injury

January 06, 2004

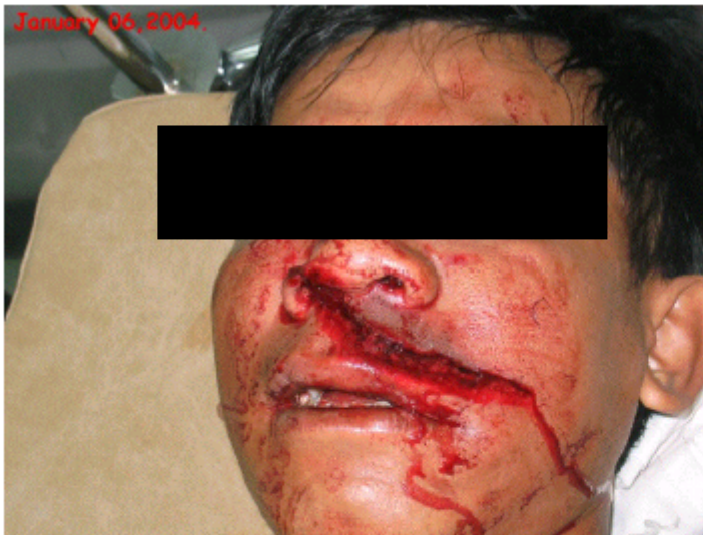
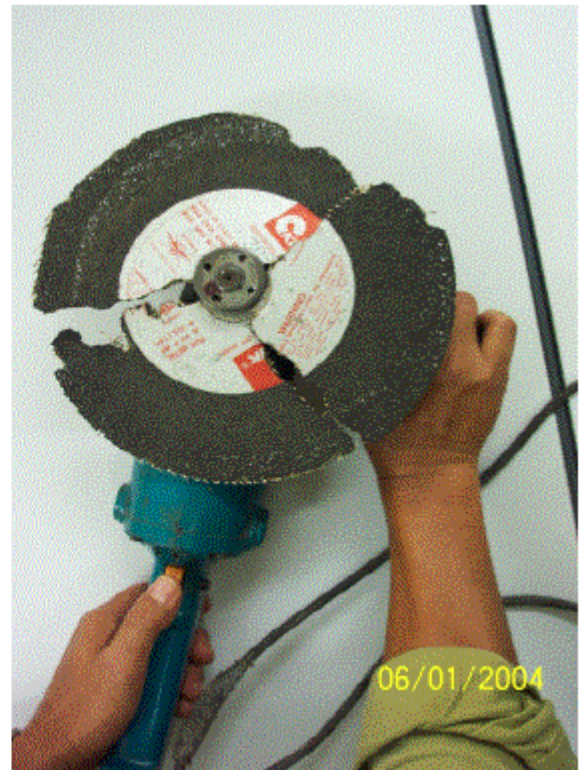
Based on manufacturer specification, Makita grinder model 9006B should use 6" grinding wheel, speed load 10,000 RPM.

9.5" grinding wheel was used instead of using 6" grinding wheel. This wheel was over sized and allowed only to be run at 3400 RPM.

Grinding wheel was running at 10,000 RPM (over rated speed) causing the wheel fly apart and hit the mechanic's face.

- Utilised improper tool.
- No grinder safety guard.
- Not using face shield for PPE.
- Mechanic has been warned but he ignored it.
