INFORMATION BULLETIN

Hunter Valley shotfirers light vehicle explosion

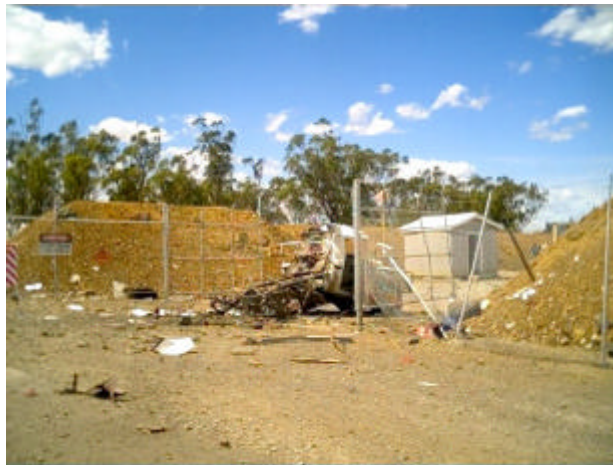
On February 6 in the Hunter Valley an unexplained explosion occurred on a shotfirers light vehicle that was carrying boosters and detonators. This resulted in the injury of a mine employee and substantial damage to the vehicle.

- Detonators and boosters had been transported in close proximity on the rear tray of the light vehicle and not separately in the designated magazines fitted to the light vehicle.
- Initiation is most likely to have occurred as a result of a burning cigarette butt starting a fire in the box of detonators, causing at least one detonator to explode, initiating a booster which in turn shock initiated the neighbouring boosters.

GUARD AGAINST COMPLACENCY AROUND EXPLOSIVES, INCIDENTS OF THIS TYPE CAN BE AVOIDED IF CORRECT PROCEDURES ARE IN PLACE AND FOLLOWED.
