CRANE INCIDENT ONBOARD TANKER

October 2005

Introduction

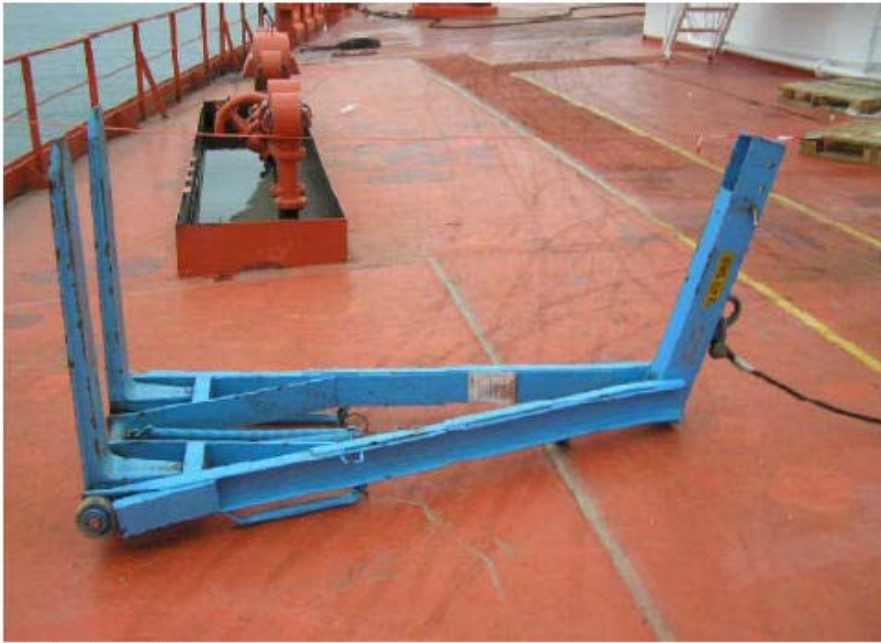
- ▶ 16:15 a very distinct bang was heard by several people on the vessel and the tug. The crane wire broke and the fork pallet including the hook block fell down.
- ▶ It is believed that the pallet fork struck the C/E in to the back of the head (right side), and thereafter hit one of the waste oil drums placed close to the ship's rail.
- ▶ The C/E fell down and hits his head (left side) against the frame of a save-all coaming around a fuel oil tank vent pipe.
- ▶ Both injuries were later classified to be mortal by attending doctor.

5) Fork pallet

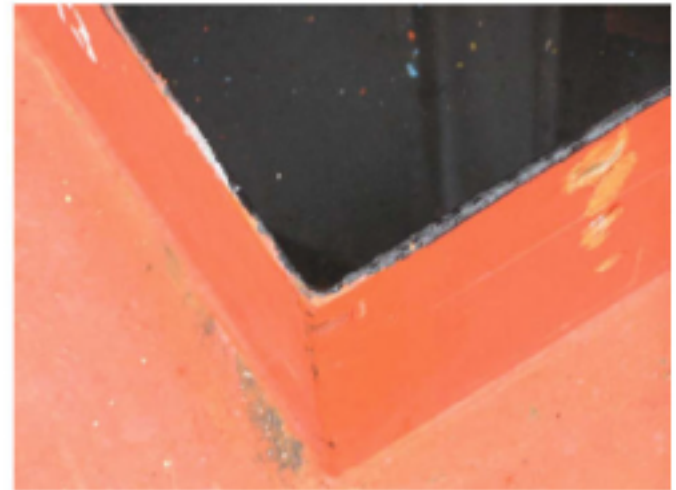
6) Close-up picture of the FOT save-all coaming.

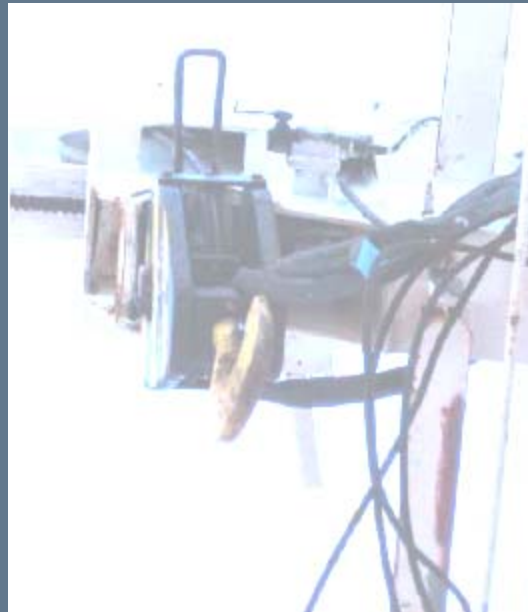
- ▶ **Immediate causes identified:**
 - ▶ Crane hook block hoisted all the way into “block’s” garage causing wire to break.

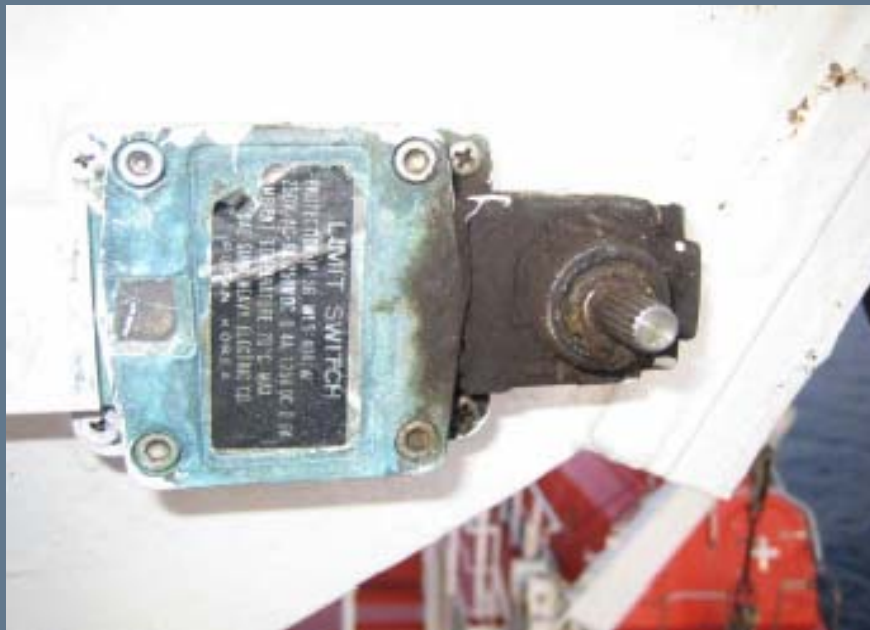
- ▶ Immediate causes identified:
 - ▶ Crane hoist limit switches not working / missing

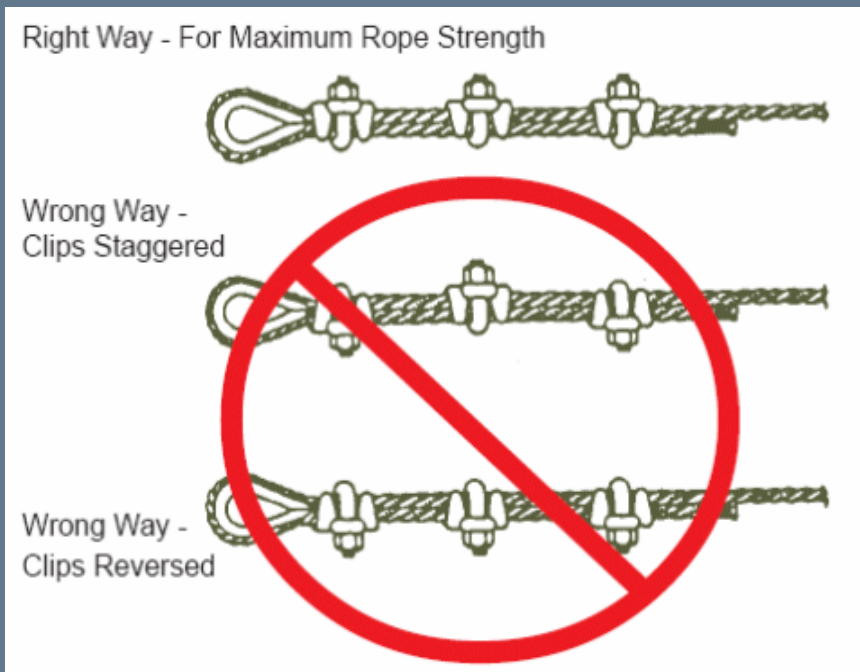
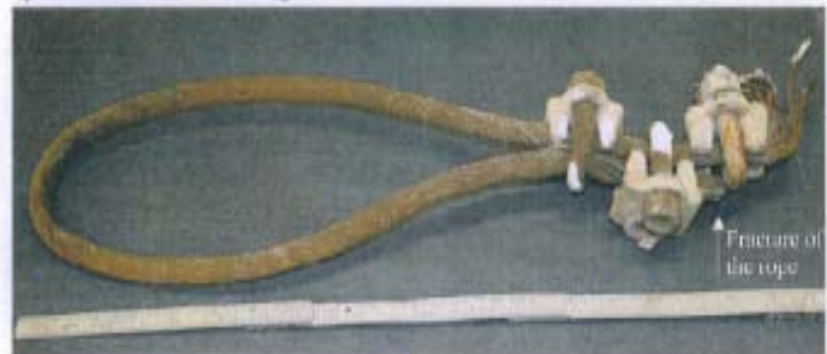
- ▶ Immediate causes identified:
 - ▶ Hoisting wire wrongly mounted

Figure 4 Rope end (closed around the thimble) with U-bolt clips attached based on the observed contact marks on the rope.

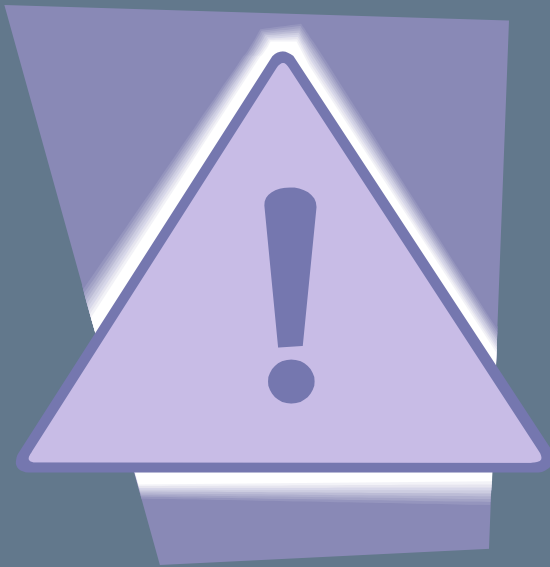
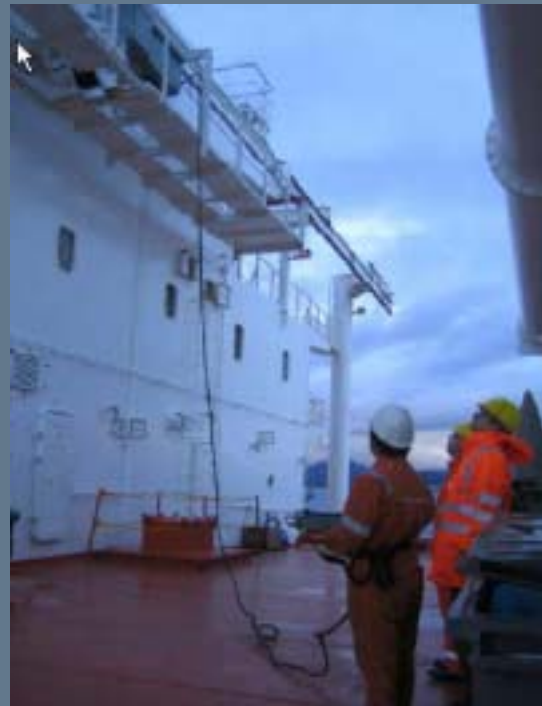
- ▶ **Immediate causes identified:**
 - ▶ Chief engineer walking under hanging load
