SAFETY ALERT

Crane A-frame mast falls on rigger

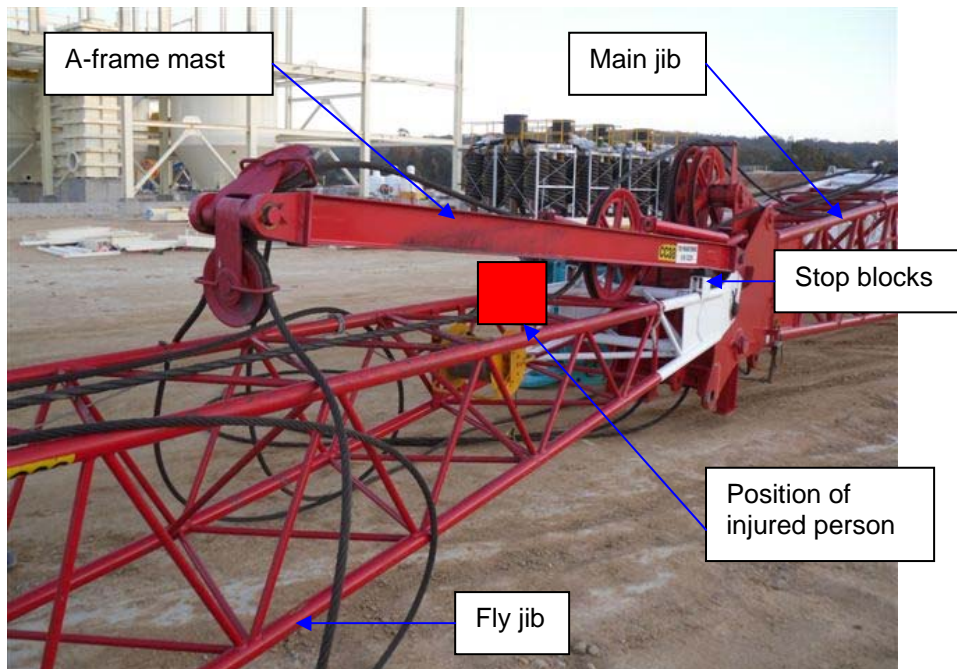
Crane operators were making changes to the crane fly jib configuration in preparation for the next series of lifts. The crew had shortened the fly jib and were preparing to shorten the pendent wires from jib to fly. This required the pendent wires to be disconnected, which left the A-frame mast in an unsecured vertical position. As the rigger lent over the fly jib to couple up the overwind electrical sensor, the A-frame mast fell forward, landing on his upper torso and causing injuries, including rib fractures.

A photograph showing the location of the A-frame mast after the fall.

If the rigger was in a position closer to the head of the main jib the incident outcome may have been more severe, including a fatality.

- failure to follow the original equipment manufacturer's documented procedures
- failure to isolate gravitation energy
- the workgroup made an incorrect assumption that the tube on the A-frame mast was a double-acting retainer, which they believed secured the A-frame mast in position. This allowed them to disconnect the pendent ropes
- people being placed in pinch point areas.

- when hiring or dry hiring plant, ensure documentation that details safe operation of the plant is provided by the plant owner or hirer
- when supplying operators to operate hired plant, ensure the operators are competent to operate the plant safely
- ensure all lift studies are documented and communicated to those involved in the lifting process
- ensure lift studies which require configuration changes to the crane jib, fly jib or other parts make reference to safe work procedures for the task
- review documented procedures for the safe operation of plant prior to the commencement of unfamiliar tasks
- identify site-specific hazards which must be assessed and controlled.
