Fatality Investigation Report

OR 2003-40-1 UNIVERSITY

Effort to clear rock jam in operating rock crusher fatal

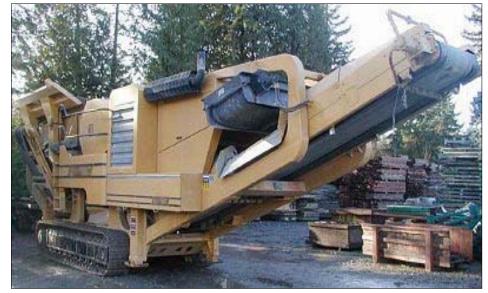
Portable rock crushing system.

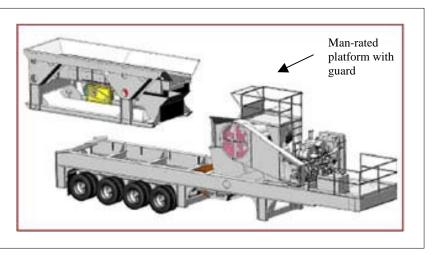
This drawing shows a typical truck-mounted horizontal impactor, with a man-rated viewing platform directly over the intake chute of the impactor unit The platform is equipped with a guard to protect an observer from flying rock and debris. The guard also discourages any intervention with a tool to break a rock jam.

Recommendation #3: Manufacturers should consider designing and installing viewing decks where worker's can safely access the equipment to observe operation.

Installing a man-rated viewing platform is a more certain way to eliminate the incentive for workers to position themselves directly over the intake to observe crushing operations. A

designated platform discourages an operator from attempting to access the machine from any other location. A protective guard of plexiglas or wire screen is typically mounted on front of the platform to protect an observer from rocks or debris ejected from the chute.
