REPORT ON THE UPPER BIG BRANCH MINE DISASTER

# HOMICIDE

UNITED MINE WORKERS OF AMERICA

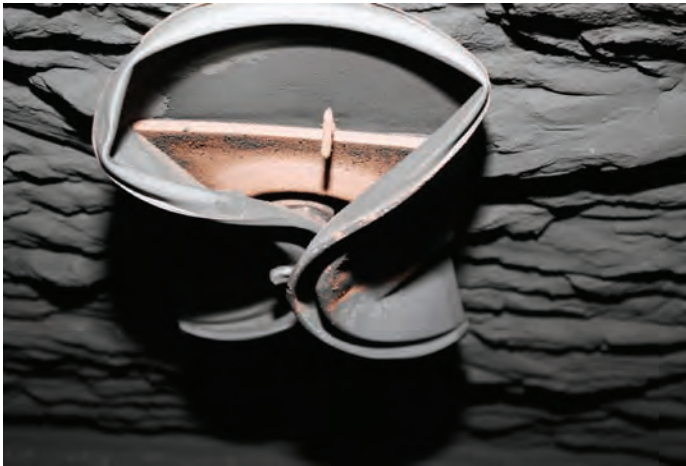
Roof bolt plate bent from initial path (left side) and secondary path (right side) of explosion.

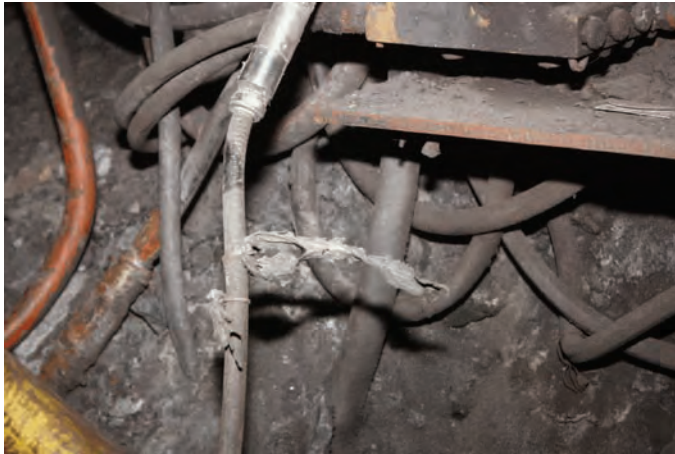
The investigation showed that poor ventilation must have been a common problem on the longwall. The investigation revealed a burnt remnant of a brattice cloth hanging from shield 173 towards the tailgate drive where a methane sensor was mounted. The curtain o-rings and tie wires indicate it was hung from the shield towards the face to a point just inby the tailgate methane sensor. This would direct all the airflow towards the sensor, diluting the methane at that point and eliminating its ability to detect the actual amount of methane on the face.

**Melted canvas and plastic ties on air hose where canvas was used to direct airflow onto methane sensor on the longwall.**

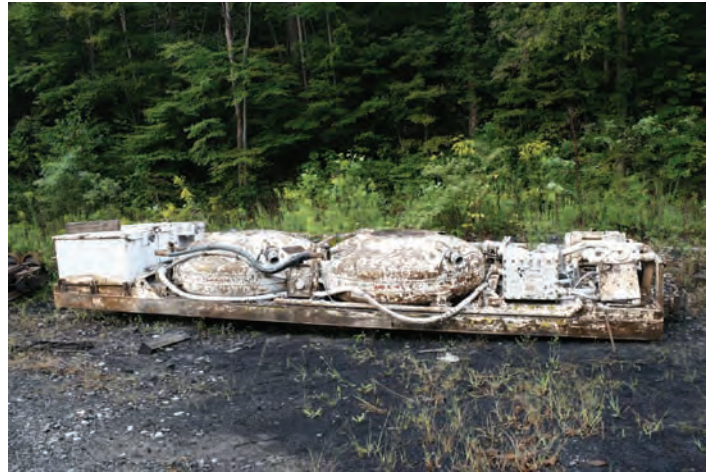
When MSHA put power on the machine to test it as part of the investigation, the motor burned up.

UBB rock-dusting machine where it was found outside the mine.

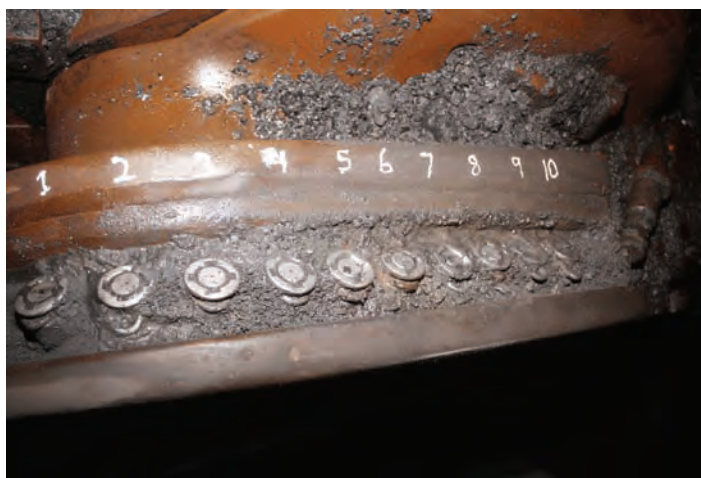
- Headgate drum - of the twenty-eight sprays visible, nineteen were operating and nine were plugged.
- Headgate ranging arm - of the ten sprays visible, five were plugged.
- Tailgate drum - of the forty-two sprays visible, twenty-seven were operating, eight were plugged and seven were missing.
- Tailgate ranging arm - of the ten sprays visible, five were plugged.

**Headgate ranging arm sprays on the UBB longwall. Five of the ten sprays were plugged and did not work.**

With almost forty percent of the visible water sprays plugged or missing, the spray system was unable to function as designed. The fact that thirty-four of the sprays were plugged is problematic and should be cited by the Agencies. However, in this particular case, the Union believes none of the sprays on the shearer drums were working properly, because the missing sprays reduced the water pressure significantly, thus rendering the system useless for purposes of safety.

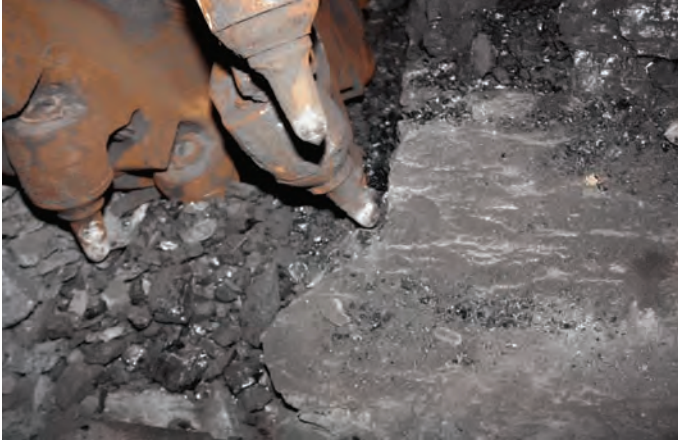
**Photo 1.** The longwall taildrum bits in a cut-out at the tail. The UMWA believes sparking from this area caused an initial methane ignition, which then grew into a coal dust explosion.

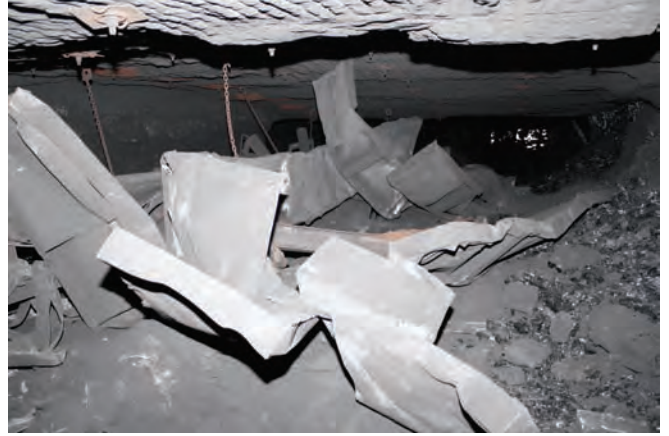
**Photo 2.** Steel overcast cover panels twisted and crumpled at #1 Crosscut in the Tailgate 22 Section.

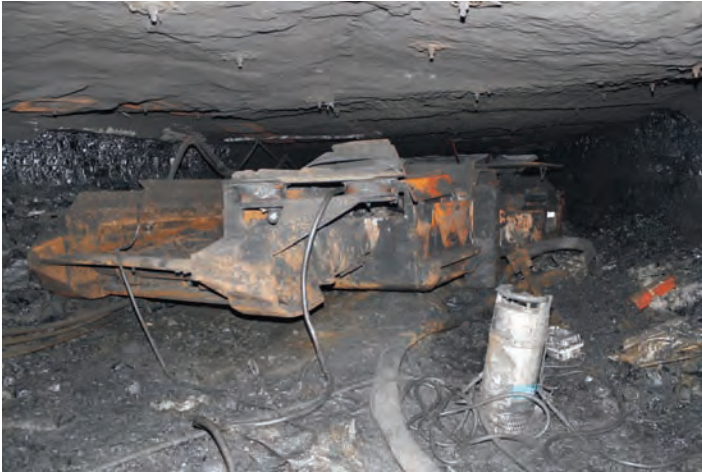
**Photo 3.** A shuttle car inby the belt dump point in the Tailgate 22 Section shows evidence of the flames and forces of the explosion.

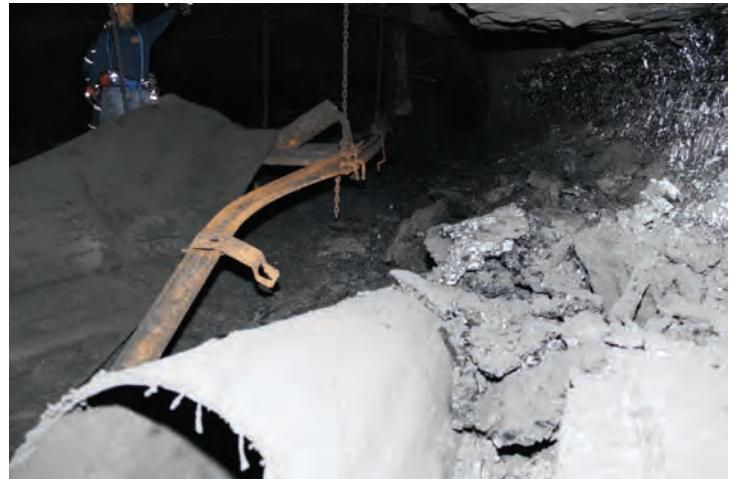
**Photo 4.** Bent and twisted steel belt structure at #4 crosscut of Tailgate 22 Section shows evidence from the forces of the explosion.

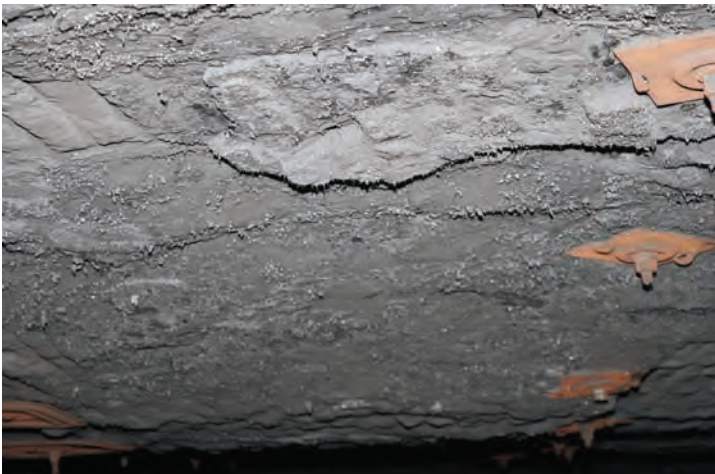
**Photo 5.** Evidence of coking on mine roof inby the first open crosscut in the #1 Entry. This type of coking is a residue of a coal dust explosion.

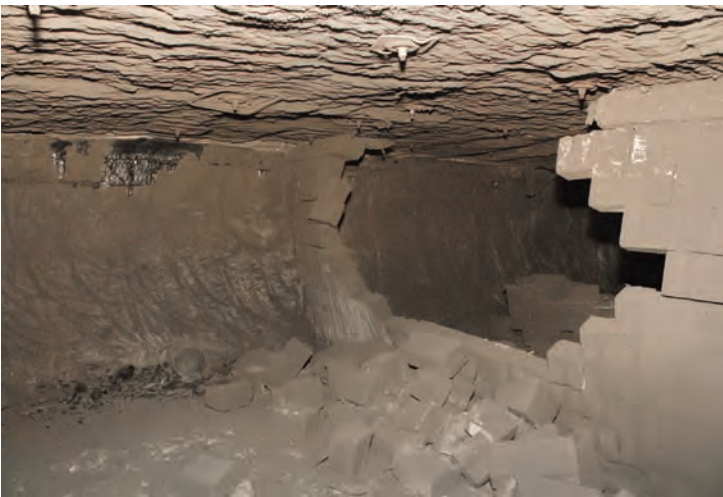
**Photo 9. Stopping blown out toward the north as a result of the initial path of forces, at 73 crosscut, northeast of 78 switch.**

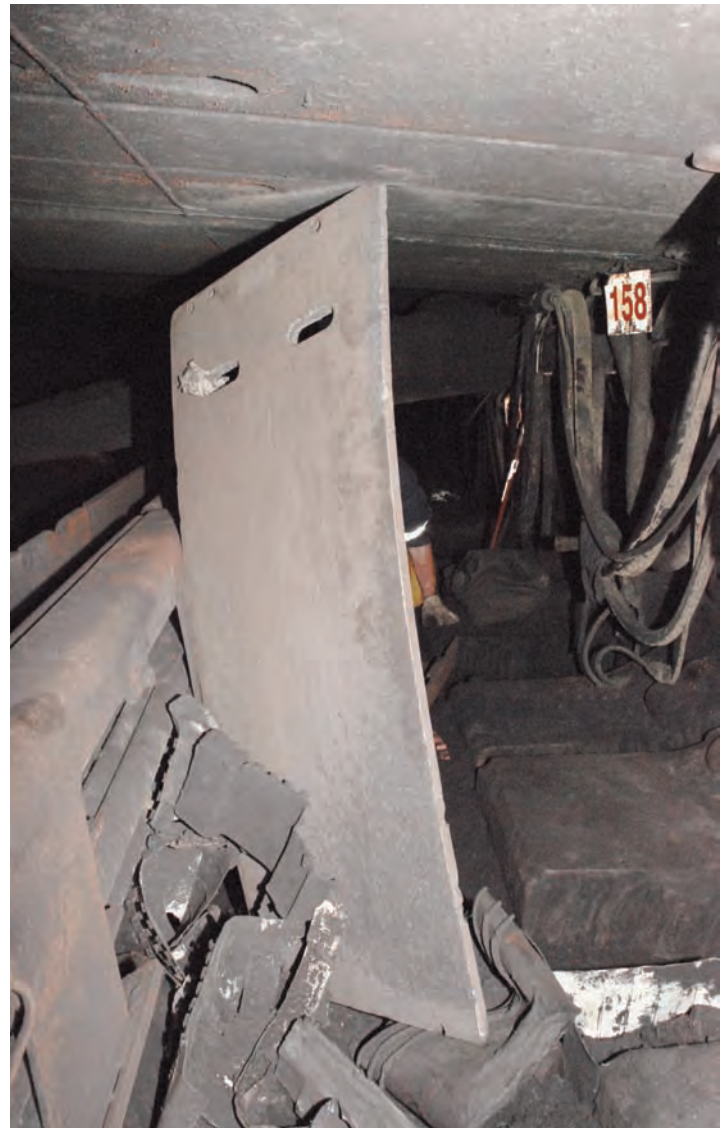
**Photo 10. Tail drive assembly lid wedged between top of longwall shield and toes of shield at Shield #158.**

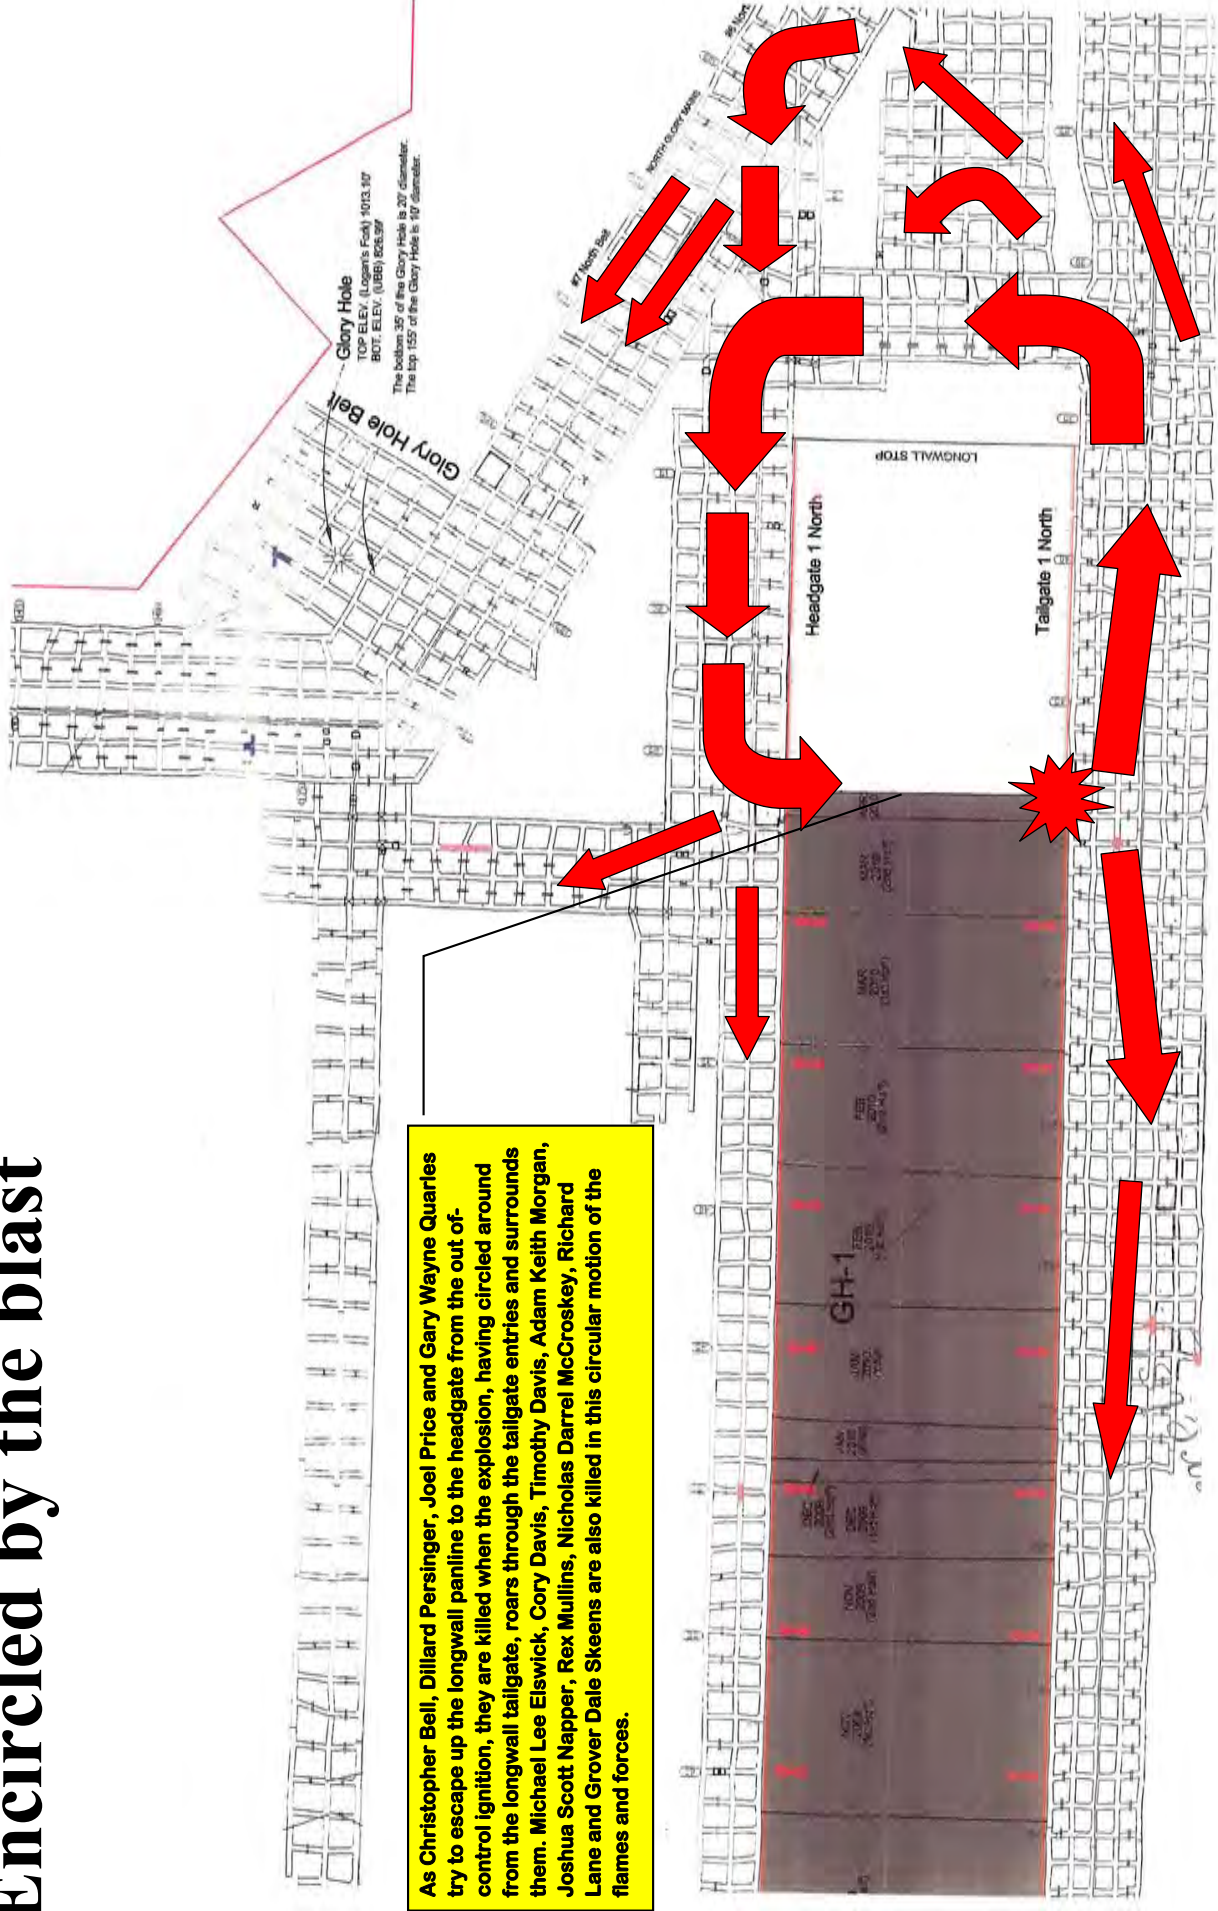
# Encircled by the blast

As Christopher Bell, Dillard Persinger, Joel Price and Gary Wayne Quarles try to escape up the longwall panline to the headgate from the out of-control ignition, they are killed when the explosion, having circled around from the longwall tailgate, roars through the tailgate entries and surrounds them. Michael Lee Elswick, Cory Davis, Timothy Davis, Adam Keith Morgan, Joshua Scott Napper, Rex Mullins, Nicholas Darrel McCroskey, Richard Lane and Grover Dale Skeens are also killed in this circular motion of the flames and forces.
