**TO :** OUR VALUED DISTRIBUTORS  
**FROM:** Alex Tsen –Fall Protection Project Manager  
**DATE:** September 3, 2008  
**SUBJECT:** FP541 Rope Grab Clinch Nut Product Advisory

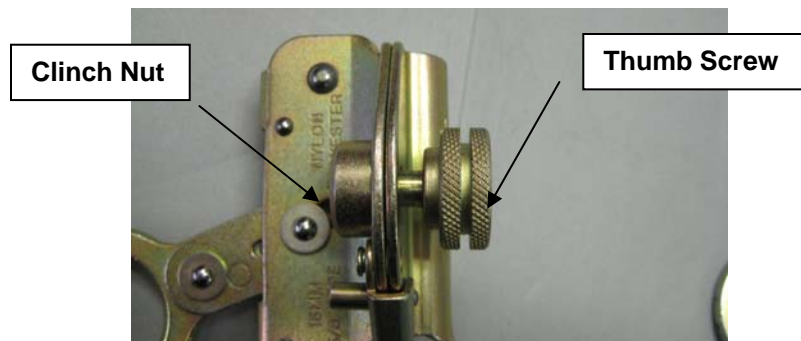
Figure 1

Initially, repetitive impact on the unit can cause the locking thumb screw to back away from the clinch nut (Figure 1). Once this occurs, additional repetitive impact on the end of the screw can cause the clinch nut to dislodge from the housing of the rope grab (Figure 2). If there is further continuous impact on the unit after the clinch nut is dislodged, the clinch nut may eventually become completely dislodged from the locking thumb screw (Figure 3). Without the positive connection between the clinch nut and thumb screw, the rope grab will not perform properly in the event of a fall which can lead to serious injury or death.

To ensure that this does not happen in your workplace please identify areas where this unit may be exposed to repetitive impact and notify your personnel of this possibility. Please ensure that the thumb screw is always tightly secured to the cinch nut and that it is periodically checked to ensure that the tight positive connection still exists. More frequent inspections may be required for applications where the unit is exposed to high repetitive impact of the unit.

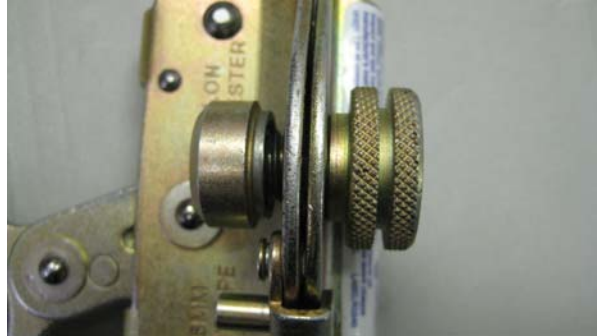
Figure 2

While a rope grab will continue to function as intended until the cinch nut is dislodged completely from the unit (Figure 3), we recommend that in an abundance of caution, you remove any rope grab from service that begins to demonstrate a separation between the thumb screw and cinch nut. (Figure 2).

If during your inspections you become aware of the progression of the separation of the cinch nut from the thumb screw as described above, please remove the impacted rope grabs from service immediately and contact North Safety.

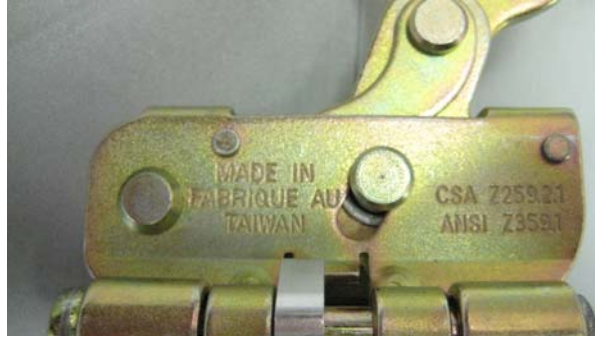
Figure 4

North safety has identified the problem only specific to FP541 series rope grabs that have a stamp on the housing that states "Made In Fabrique Au Taiwan" (Figure 4). North Safety is in the process of correcting the issue and we are confident that this will be rectified in a timely manner.
