U.S. Department of Labor
Mine Safety and Health Administration
Technical Support
Approval and Certification Center
Electrical Safety Division

Remote Control Fatal Accident Analysis Report

Victim's Physical Location With Respect to the Mining Machine

May 14, 2009

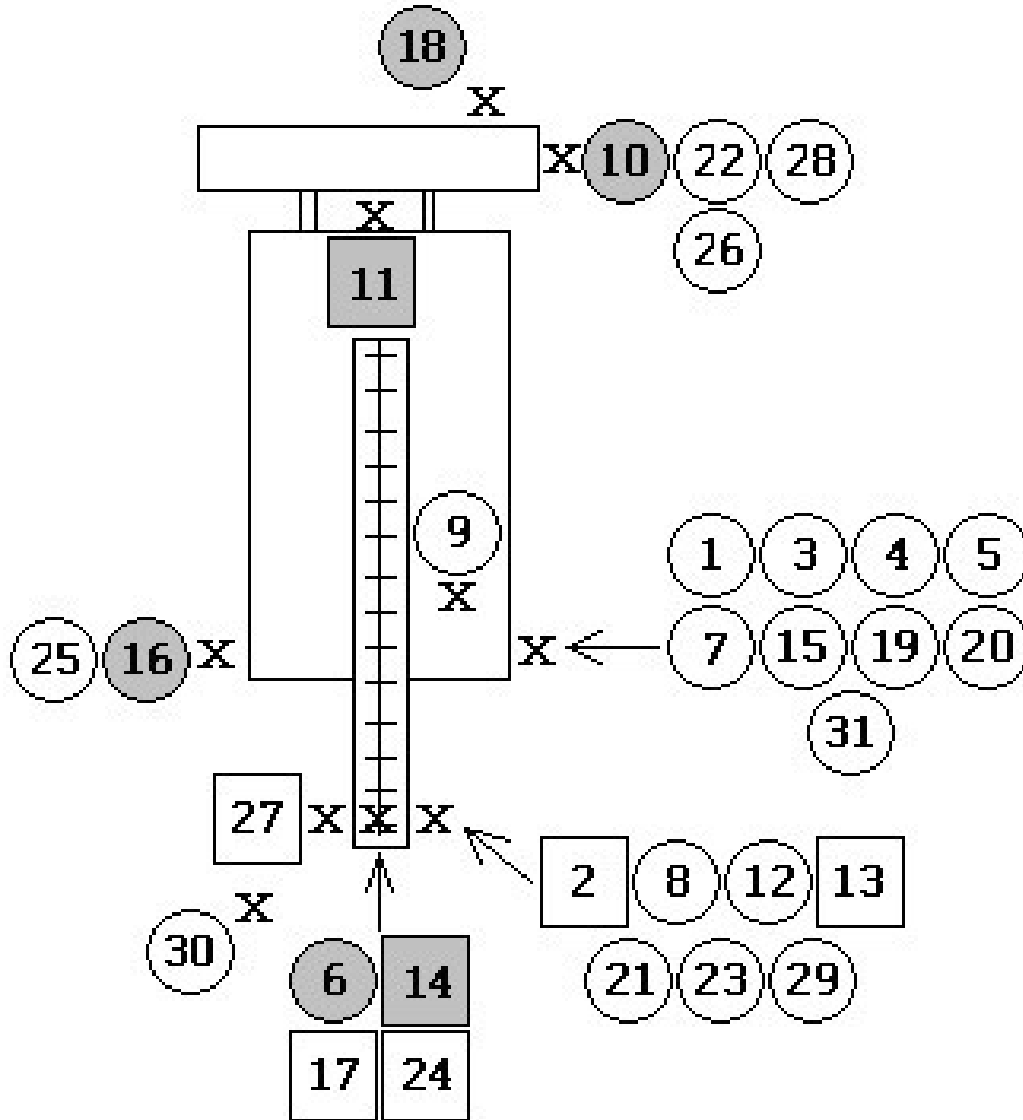
Figure 1

5. The machine operator was most at risk (23 out of 31 fatalities).
6. Most pinning and crushing accidents occurred on the right rear side of the machine (17 out of 31) with ten fatalities involving the right rear machine corner and seven involving the conveyor boom. The one operator fatality occurring at the left rear machine corner during non-maintenance work was with a machine designed for left side operation.

Location of Remote Control Victims With Respect to Machine

Note: Numbers refer to the number of the accident in the Accident Summary of this analysis. The "X" indicates general location of fatality. Accidents 2, 8, 12, 13, 17, 21, 23, 24, 27 and 29 were a result of trammng, not a result of moving the boom. Gray background indicates accidents that occurred while performing maintenance. All accidents with white background, except number 30, occurred while trammng the machine. The square around numbers indicates the victim was not operating the machine, and circled numbers indicate the victim was operating the machine (person in possession of remote control at time of the accident).
