# INVESTIGATION SUMMARY REPORT

## Marigold 2010-007

### ACCIDENT DESCRIPTION

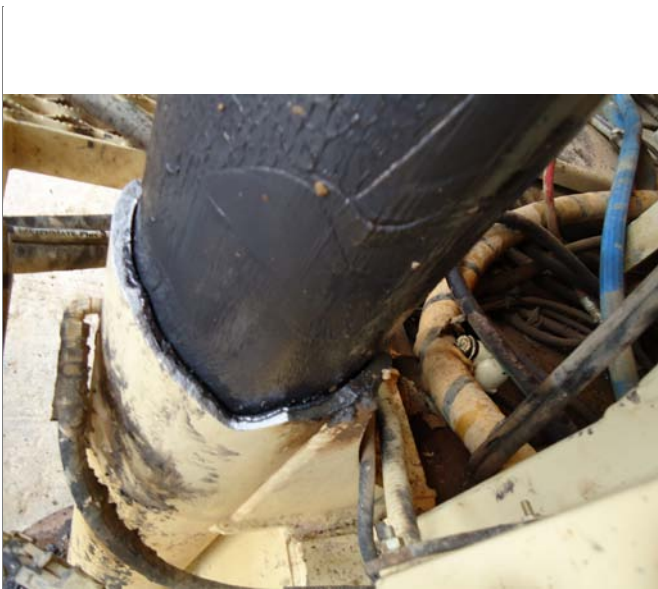
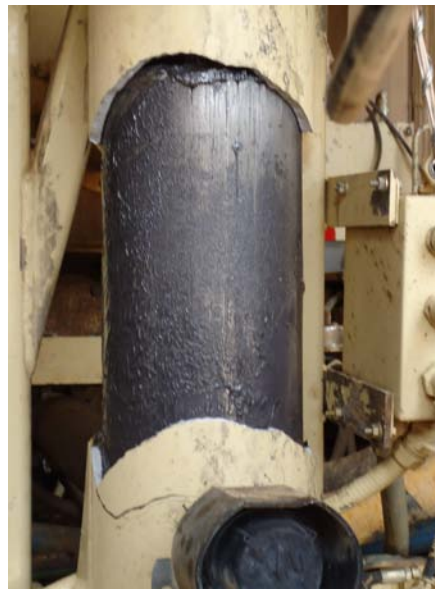
While Mine Maintenance was performing repairs on the 116 Ingersoll Rand DML Drill, the rear (non cab end) jack housing failed. The maintenance crew had removed the mast with the overhead crane and replaced the mast pivot bushings. The mast had just been reinstalled when the rear jack tube failed causing the rear of the drill to collapse to the floor. There were no personnel working in the vicinity of the jacks or under the drill at the time of the incident. The drill jacks were being used in the shop to provide additional stability during maintenance. There were no injuries associated with this incident.

Metal failure of the rear stabilizer jack structural mounting tube on the Ingersoll Rand DML Drill # 116

72.1 Inadequate Technical Design. The strength of the jack tube was not sufficient to sustain the wear and tear that the drills are exposed to resulting in premature catastrophic failure. Discussions with Cate Equipment (Dealer) indicated that the jack tubes were upgraded. Subsequent inspection of other DML drills on site also identified similar problem on those units.

- Inspect all DML Drills on site (Completed)
- Perform NDT on all drill jack tubes (Completed)
- Establish PM System to monitor these components on the drills to include daily visual inspections, scheduled PM inspections on annual NDT tests
- Complete update of Preshift Exam Sheet for Blast Drills
- Provide training update on this incident/issue with the drillers and maintenance personnel
- Revise Drill SOP to ensure that proper visual inspection of these jacks is completed before operation.
- Review Incident With all personnel on mine
- Review incident with other mines and organizations
- Review incident with Cate Equipment (Authorized Dealer). Completed.
- Identify a means of ensuring that Technical Service Bulletins are communicated/reviewed with Marigold Mine.
