COAL MINE

NEAR FATAL ACCIDENTS On July 10, 2009, an unintentional roof fall occurred in the #7 intake entry of the 9 Butt Rooms working section during the midnight maintenance shift. The face of the #7 entry began working around midnight and the miners were sent to gather posts and cribs to install in the area. The roof fell before additional supports could be installed. The roof fall started at the face and traveled outby for approximately 540 feet to the crosscut between number 6 and 7 of the Butt heading. The fall measured approximately 540 feet long, 18 to 20 feet wide and at least 10 feet high. The entire section was supported by 6 foot torque tension bolts on 4 foot by 4 foot centers. Additionally, four 10 foot cable bolts were installed in each intersection. On the midnight maintenance shift there were five men in the section. On a normal coal production shift there are nine men on the section.

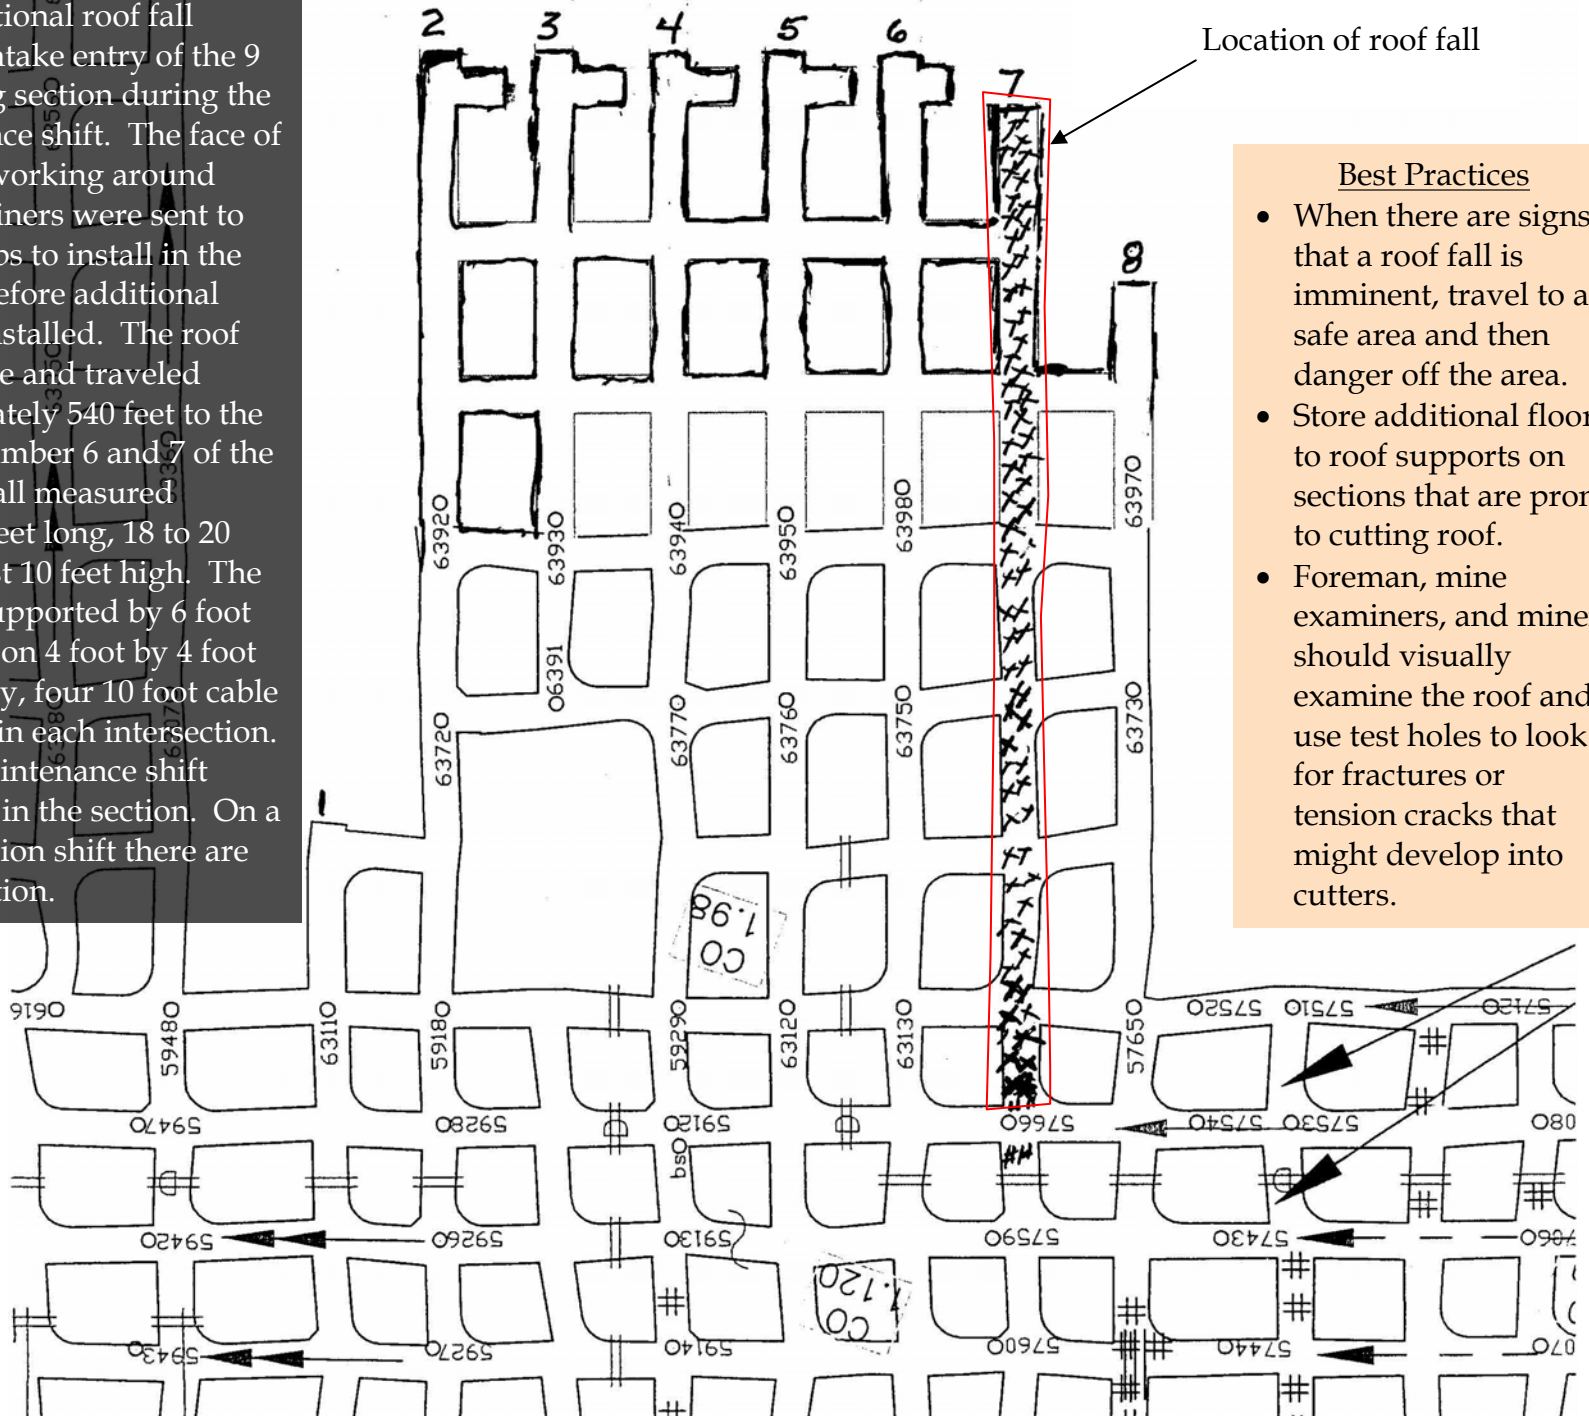
9 Butt Rooms

Location of roof fall

- When there are signs that a roof fall is imminent, travel to a safe area and then danger off the area.
- Store additional floor to roof supports on sections that are prone to cutting roof.
- Foreman, mine examiners, and miners should visually examine the roof and use test holes to look for fractures or tension cracks that might develop into cutters.
