Inspection Advisory

Dyna-Lock® Self-Retracting Lanyard – 20ft. Models

August 6, 2008

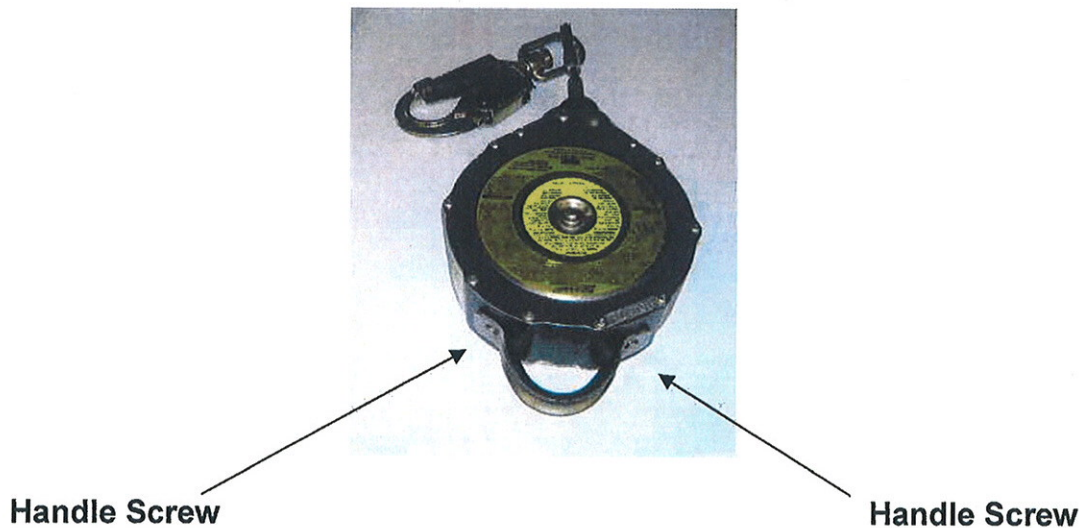
MSA recently received a report that the attachment handle on a 20 ft. Dyna-Lock Self-Retracting Lanyard (SRL) became loose and separated from the unit. Although the user was not injured, our inspection of the unit revealed that the ends of the two screws securing the handle were not swaged (flattened) as intended by our housing/handle supplier. The swaging process prevents the screws, which are installed from inside the housing, from unthreading. If a handle screw unthreads due to vibration or other means, the handle could detach from the housing and cause the SRL to separate from the anchorage resulting in loss of fall protection.

The photo below identifies by the arrows the location of the two handle screws to be inspected:

As a result of this finding, MSA requests that users receiving this Inspection Advisory immediately inspect the 20 ft. Dyna-Lock SRLs in their possession to determine if the screws securing the handle are swaged. Any units with unswaged screws (one or both) must be removed from service and returned to MSA for repair. The repair and the shipping are free of charge. Units not exhibiting this condition may remain in use.

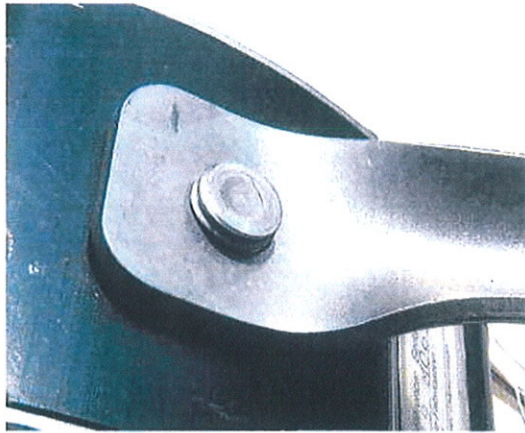
When inspecting 20ft. Dyna-Lock handle screws, compare them with the photos below. These photos illustrate the ends of a swaged (flattened) screw and an unswaged screw. Note that the swaged screw appears flattened; whereas, the unswaged screw has a cup shape appearance with a raised edge:

Good – Swaged (flattened) Screw

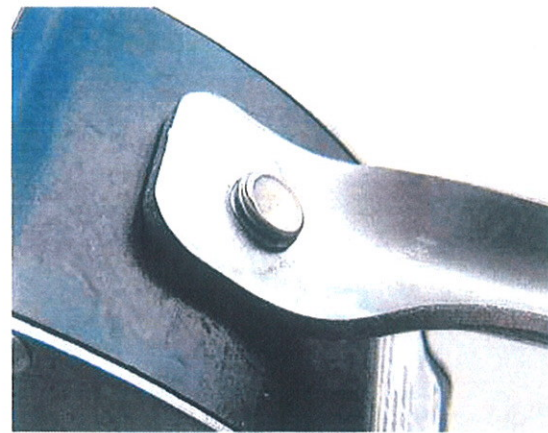
Bad – Unswaged (cup shaped) Screw

Upon inspection, if any units are found to have unswaged screws (one or both), immediately remove the unit from service. Complete the attached shipping form and return the unit and the shipping form to MSA at the address provided below:

When receiving a unit with the above described condition, MSA will replace the housing/handle assembly and also perform a general inspection and cleaning of the unit (minimum service) free of charge. Returned units will be repaired and express shipped back to the customer within approximately three business days of receipt.
