U.S. CHEMICAL SAFETY AND HAZARD INVESTIGATION BOARD

INVESTIGATION REPORT

LITTLE GENERAL STORE – PROPANE EXPLOSION

REPORT NO. 2007-04-I-WV

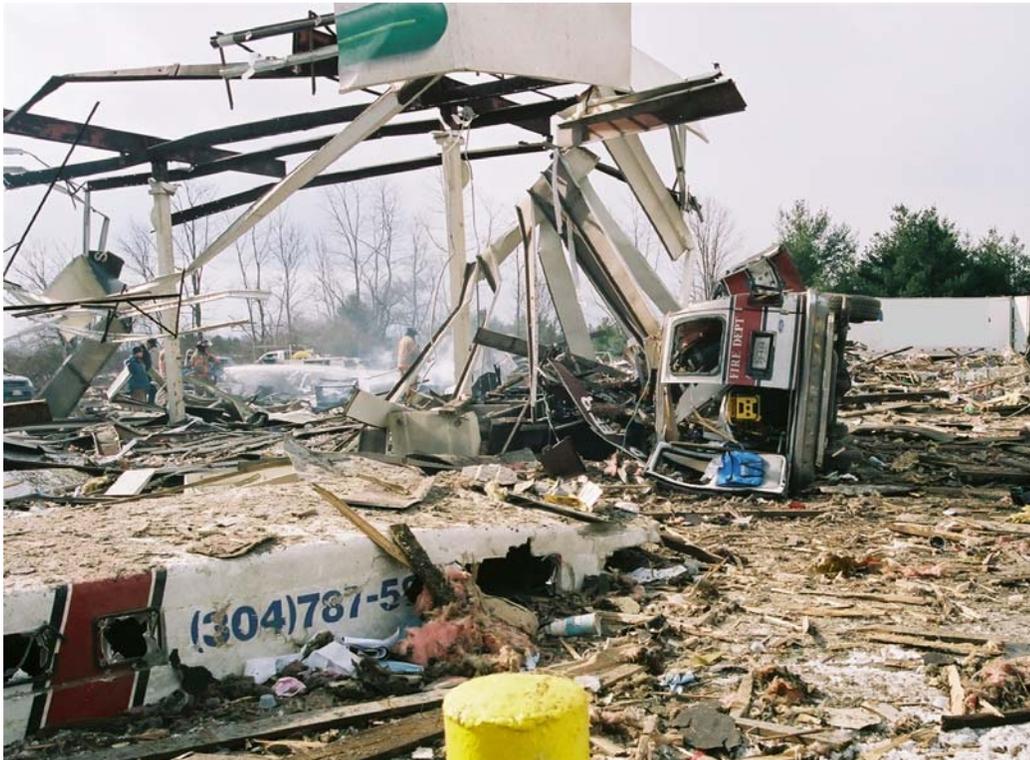
The explosion leveled the building, destroyed a Ghent Volunteer Fire Department ambulance (cover photograph), and damaged many parked vehicles. The force of the blast threw the Ferrellgas tank about 80 feet and the Thompson tank about 50 feet. Figure 5 is an event timeline of the initial emergency response.

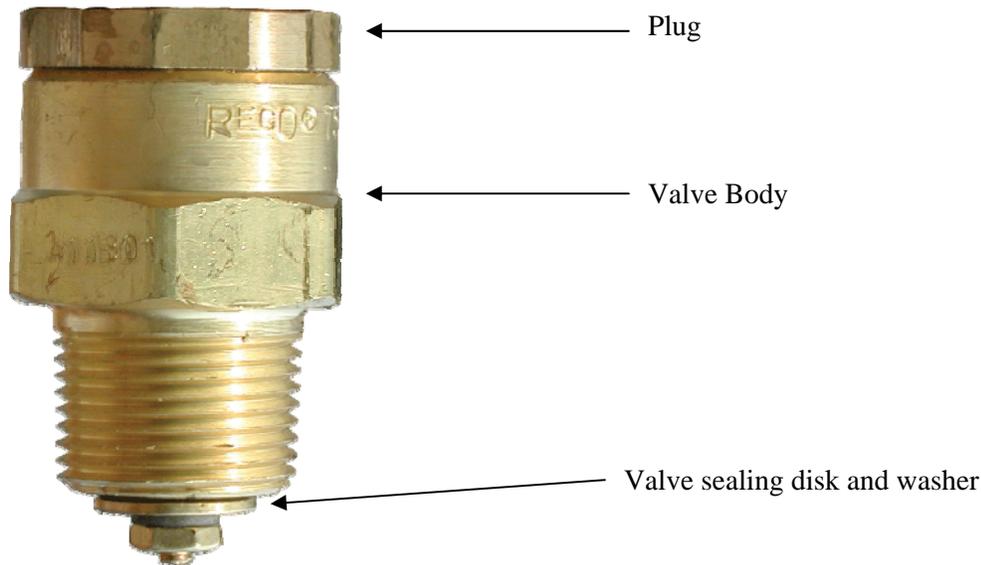
Figure 3. Liquid withdrawal valve.

Around 10:25 am, the junior technician removed a plug¹³ from the liquid withdrawal valve (Figure 3) on the Ferrellgas tank. When he removed the plug, liquid propane unexpectedly began spraying from the valve.

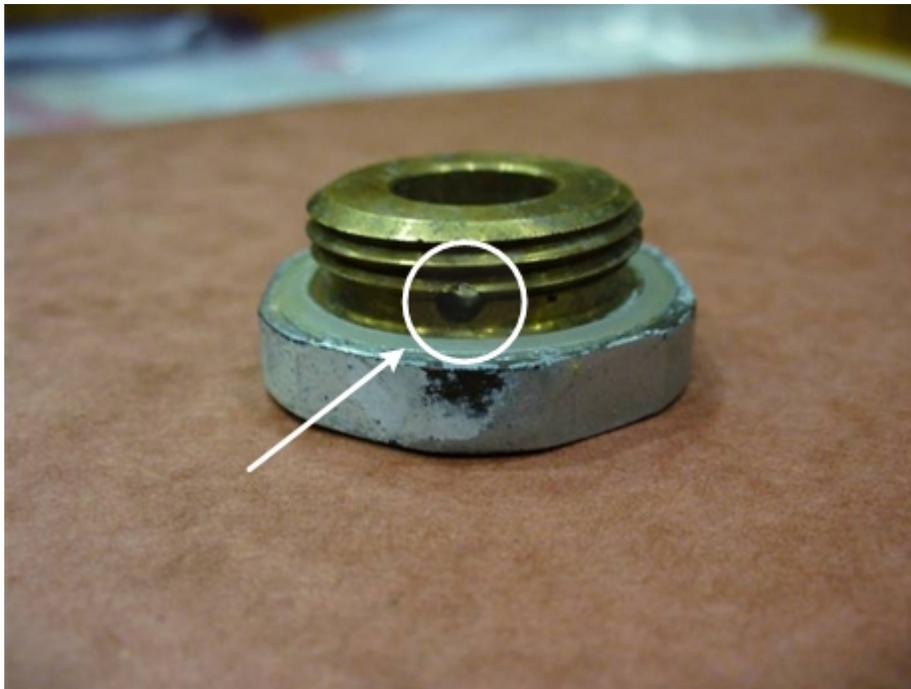
Figure 7. Incident valve plug (Telltale circled).

When the junior technician removed the plug from the liquid withdrawal valve, liquid propane released uncontrollably. The plug, though, has a telltale drilled through the threaded portion (Figure 7) which should have released a small stream of propane once the plug was partially backed out. This should have alerted the technician that the valve was leaking.

The CSB determined that the junior technician likely was unaware of the existence and function of the telltale due to inexperience and lack of training and removed the plug completely. Although the CSB determined that it is highly unlikely the telltale hole was obstructed at the time of the incident, CETP training could have made the junior technician aware of and prepared for the possibility of an obstruction of the telltale. The CETP section on liquid withdrawal valves states:

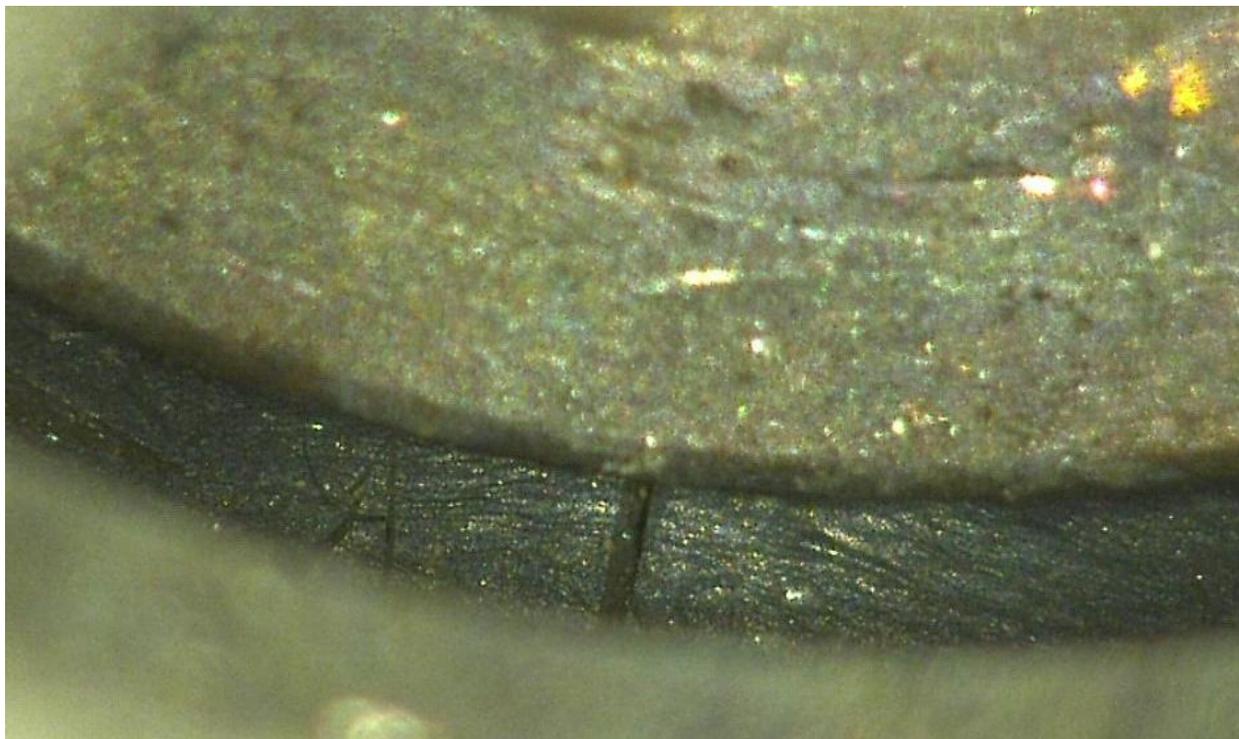
Figure 8. Crack in valve seal.

tests, and partially disassembled the valve. The CSB found the valve jammed, likely because of a manufacturing defect,²⁷ and the valve seal cracked (Figure 8). With the valve jammed in an open position, only the plug stopped the liquid propane from escaping. When the junior technician removed the plug, propane began uncontrollably releasing. Cracks in the seal material likely prevented the excess flow feature from limiting the release.

²⁷ A hole bored through the center of the lower guide through which the valve stem moves was determined to be too small for the valve stem to move freely.

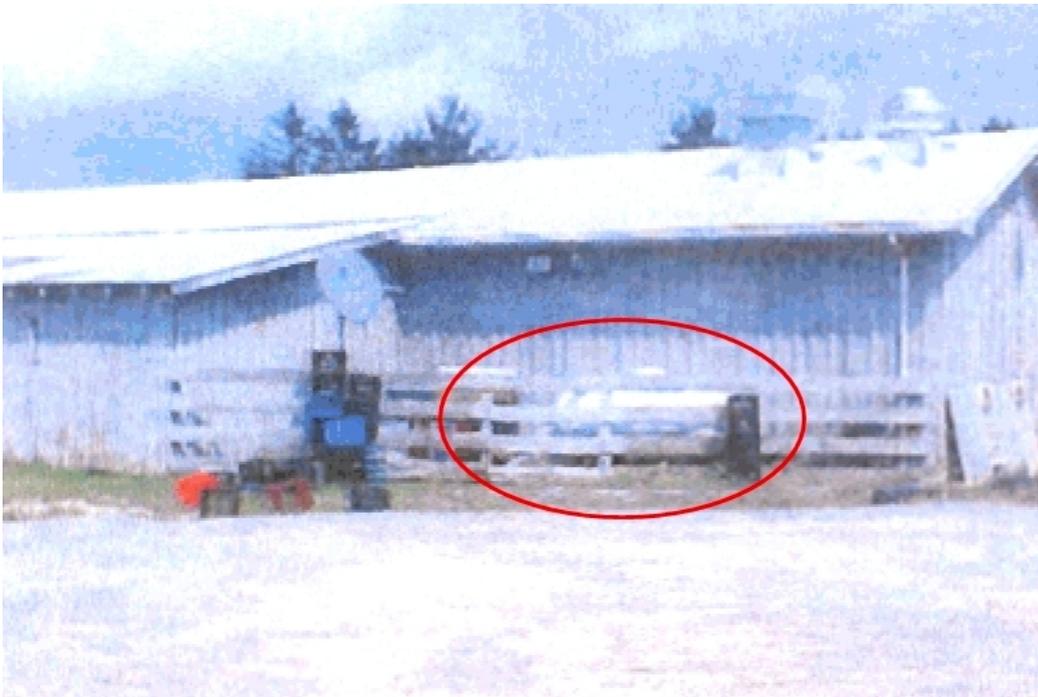
Figure 9. Pre-incident photograph of the Ferrellgas tank.

In 1994, Southern Sun installed the 500-gallon propane tank directly against the Little General store's exterior back wall. The tank remained in this position and in operation until the day of the incident. The position of the tank was contrary to both the West Virginia Fire Code and the OSHA LP gas standard.

Figure 9 shows a 2003 photograph of the building with the propane tank visible behind a wooden fence.

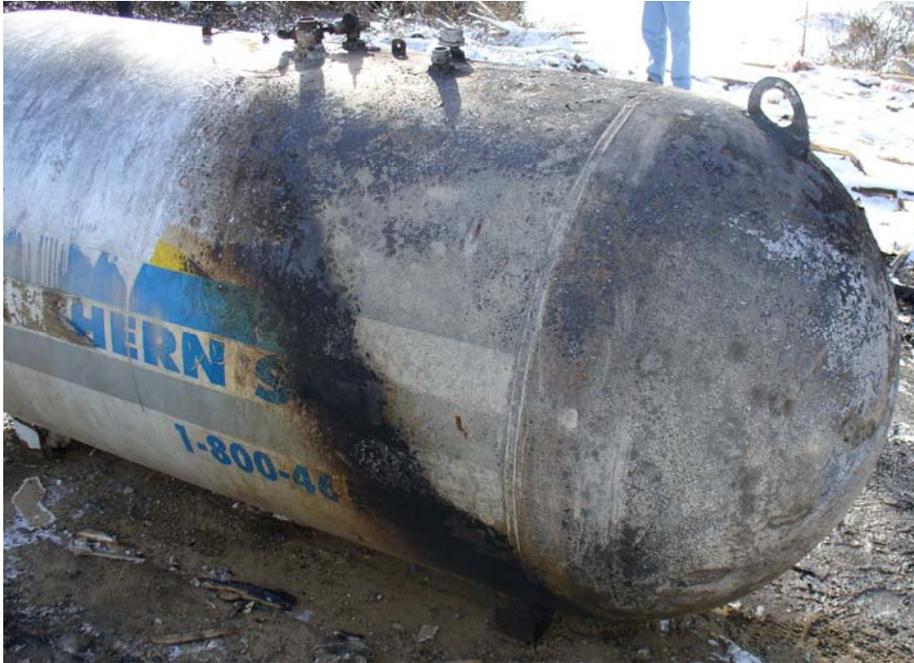
Figure 10. Incident tank side facing building.

Multiple witnesses told the CSB that Southern Sun placed the tank against the back wall. Paint patterns on the tank corroborate this: the outward facing side of the tank was painted with the Ferrellgas color and logo, while the side of the tank facing the building was painted with the Southern Sun name and logo (Figure 10). This suggests that Ferrellgas painted only the side of the tank that was accessible.
