# Diagram of events

Fatal Accident

29 October 2003

Mantos Blancos Division

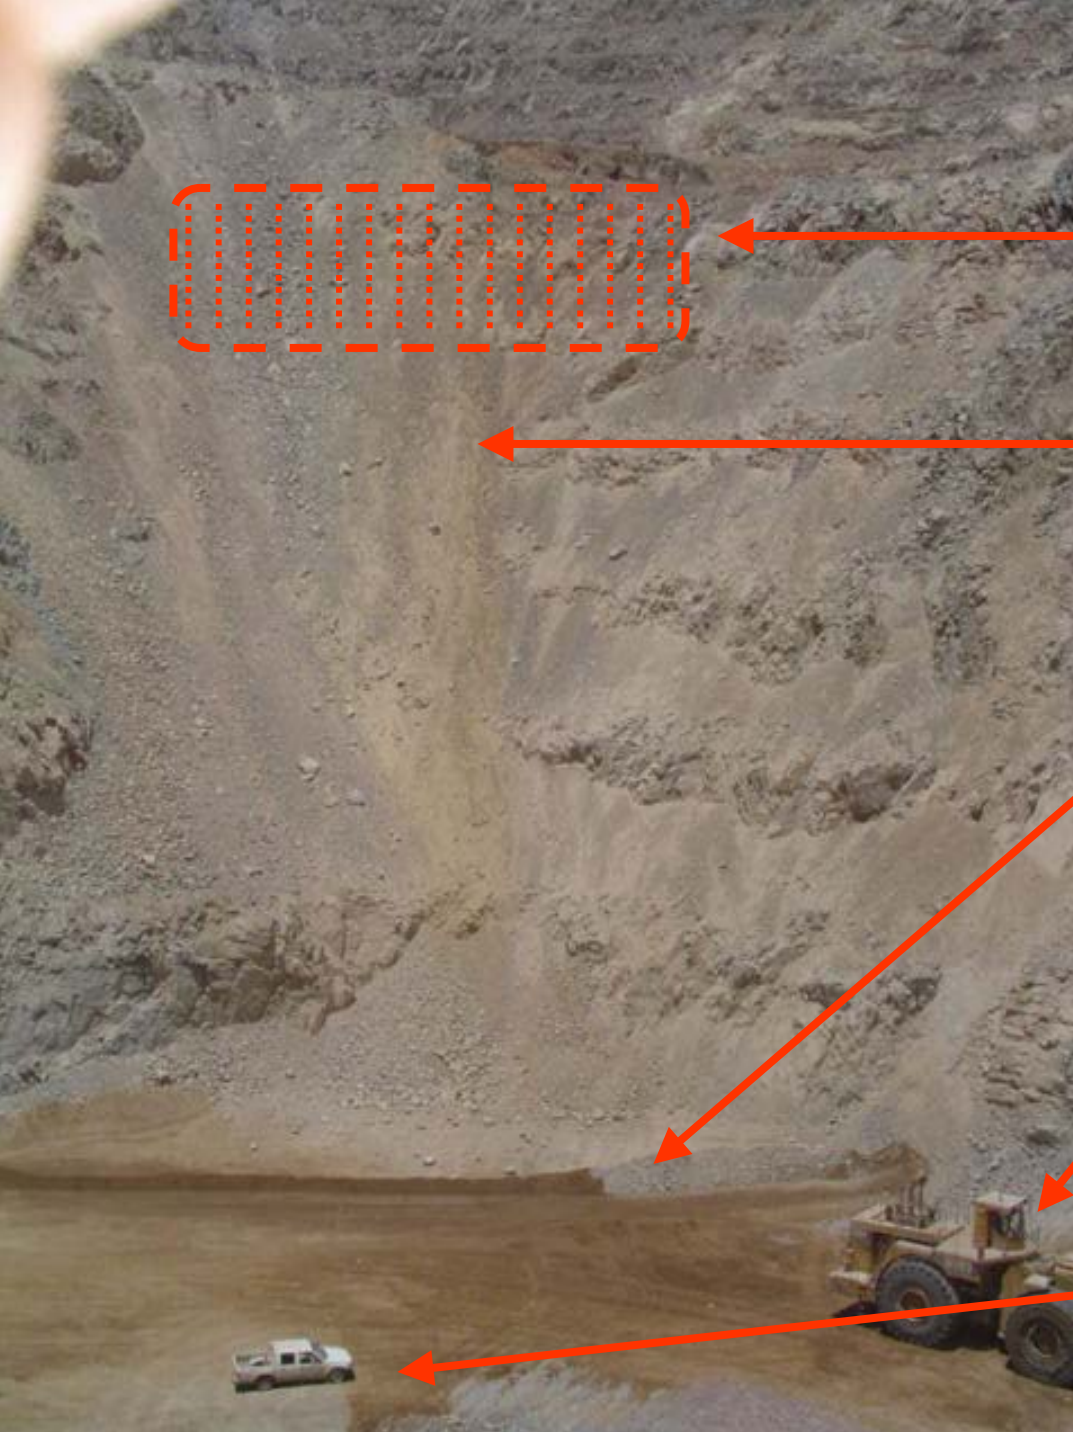
**Frontal view of the sector involved.**

**Area of probable loose rocks.**

**37° slope.**

**Berm that delimits the distance for interaction with the slope in the area.**

**8703 front-end loader, operated by Jorge Campos, to whom they were going to give the clean-up materials.**

**Final position of the damaged pick-up**

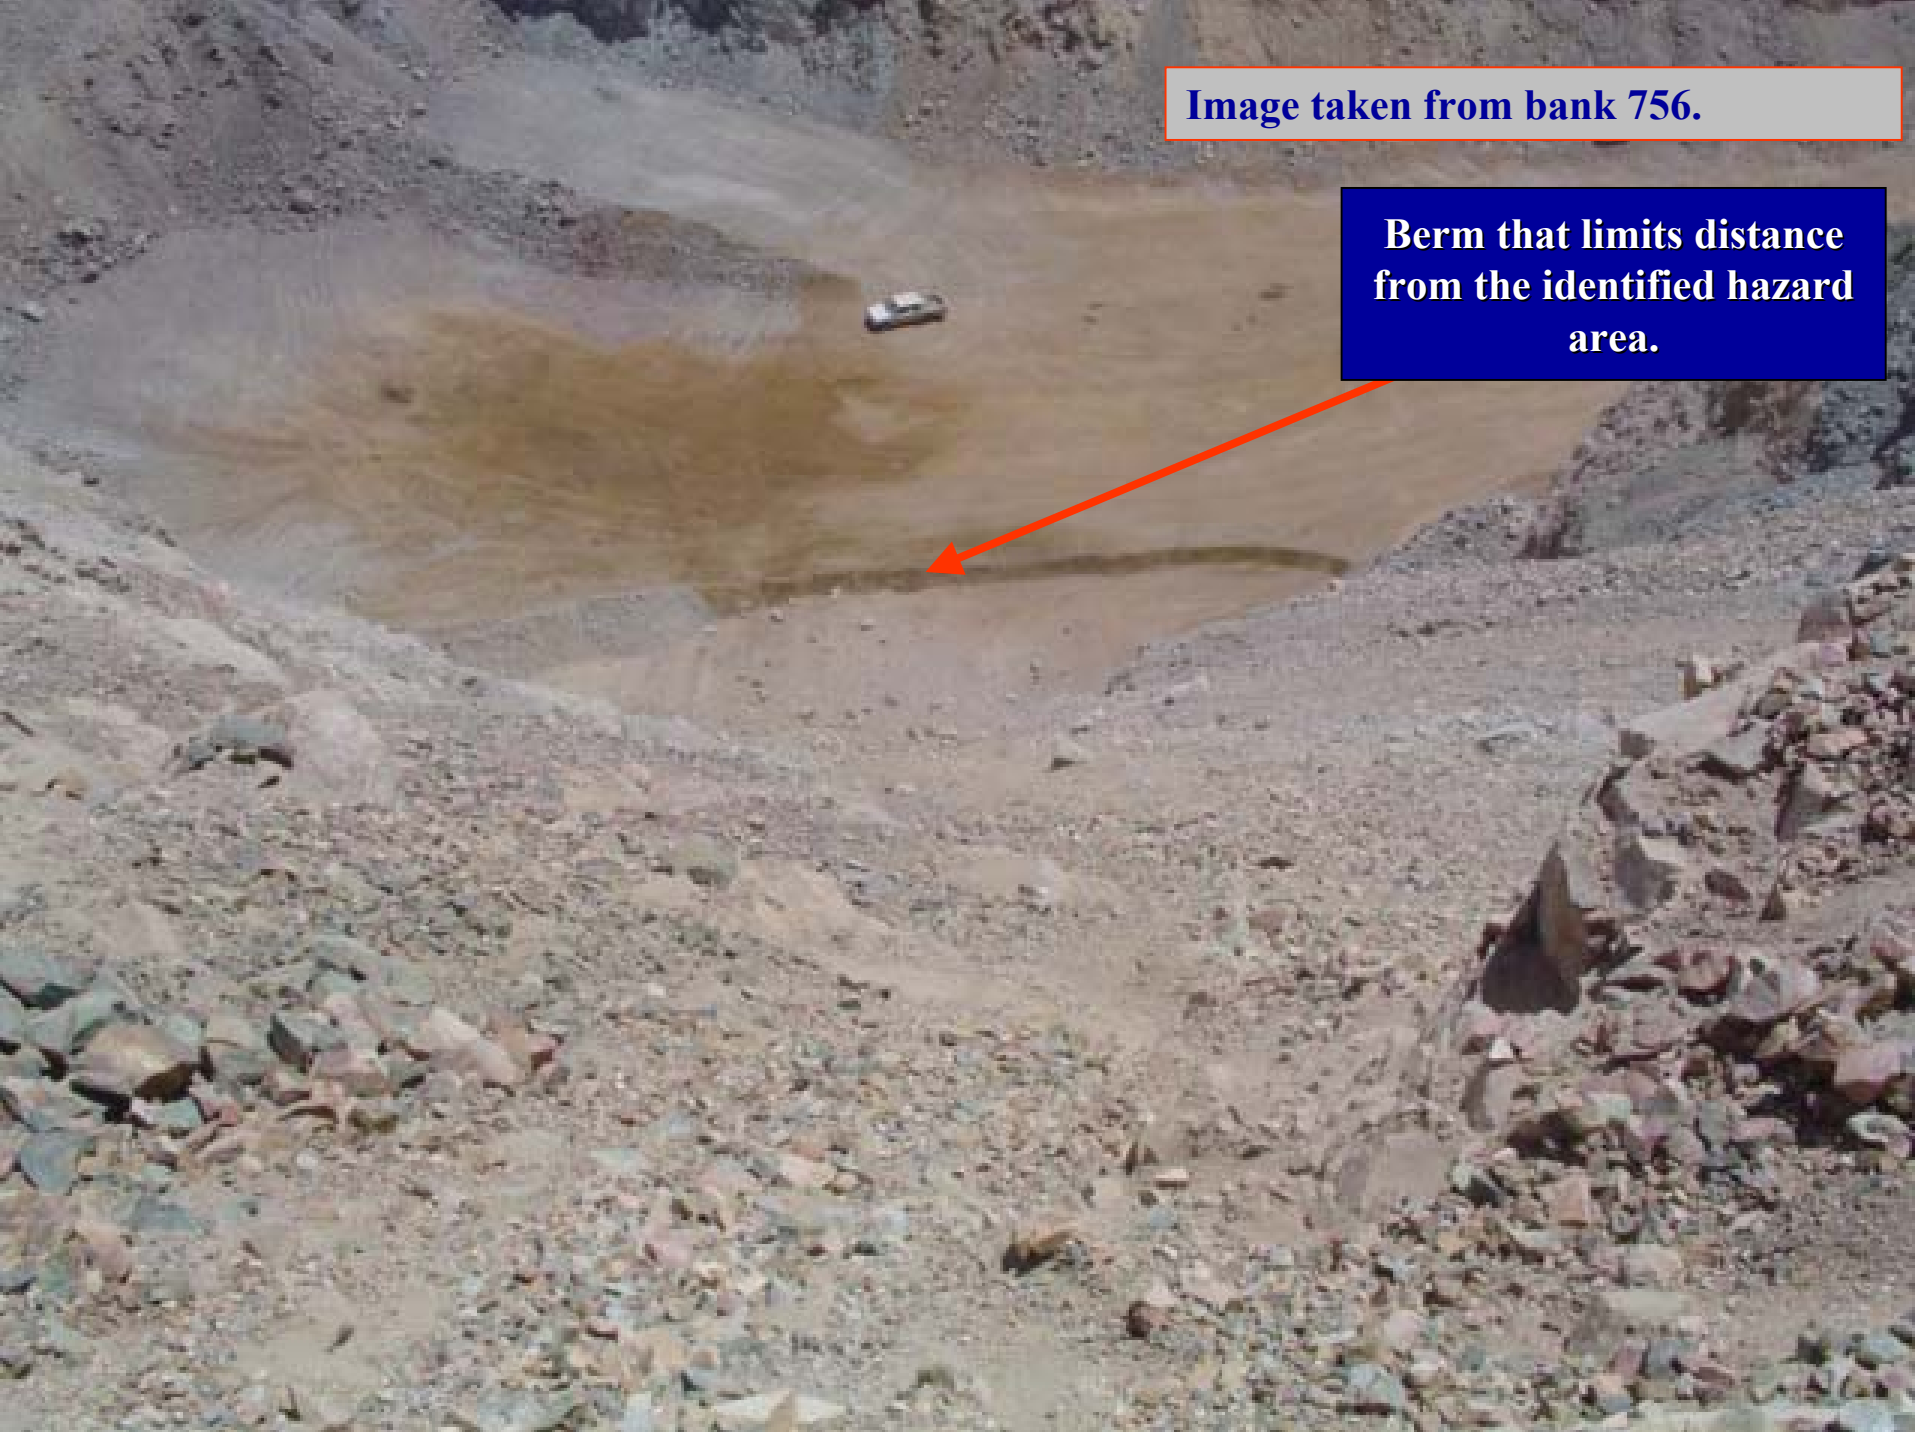
**Image taken from bank 756.**

**Berm that limits distance  
from the identified hazard  
area.**

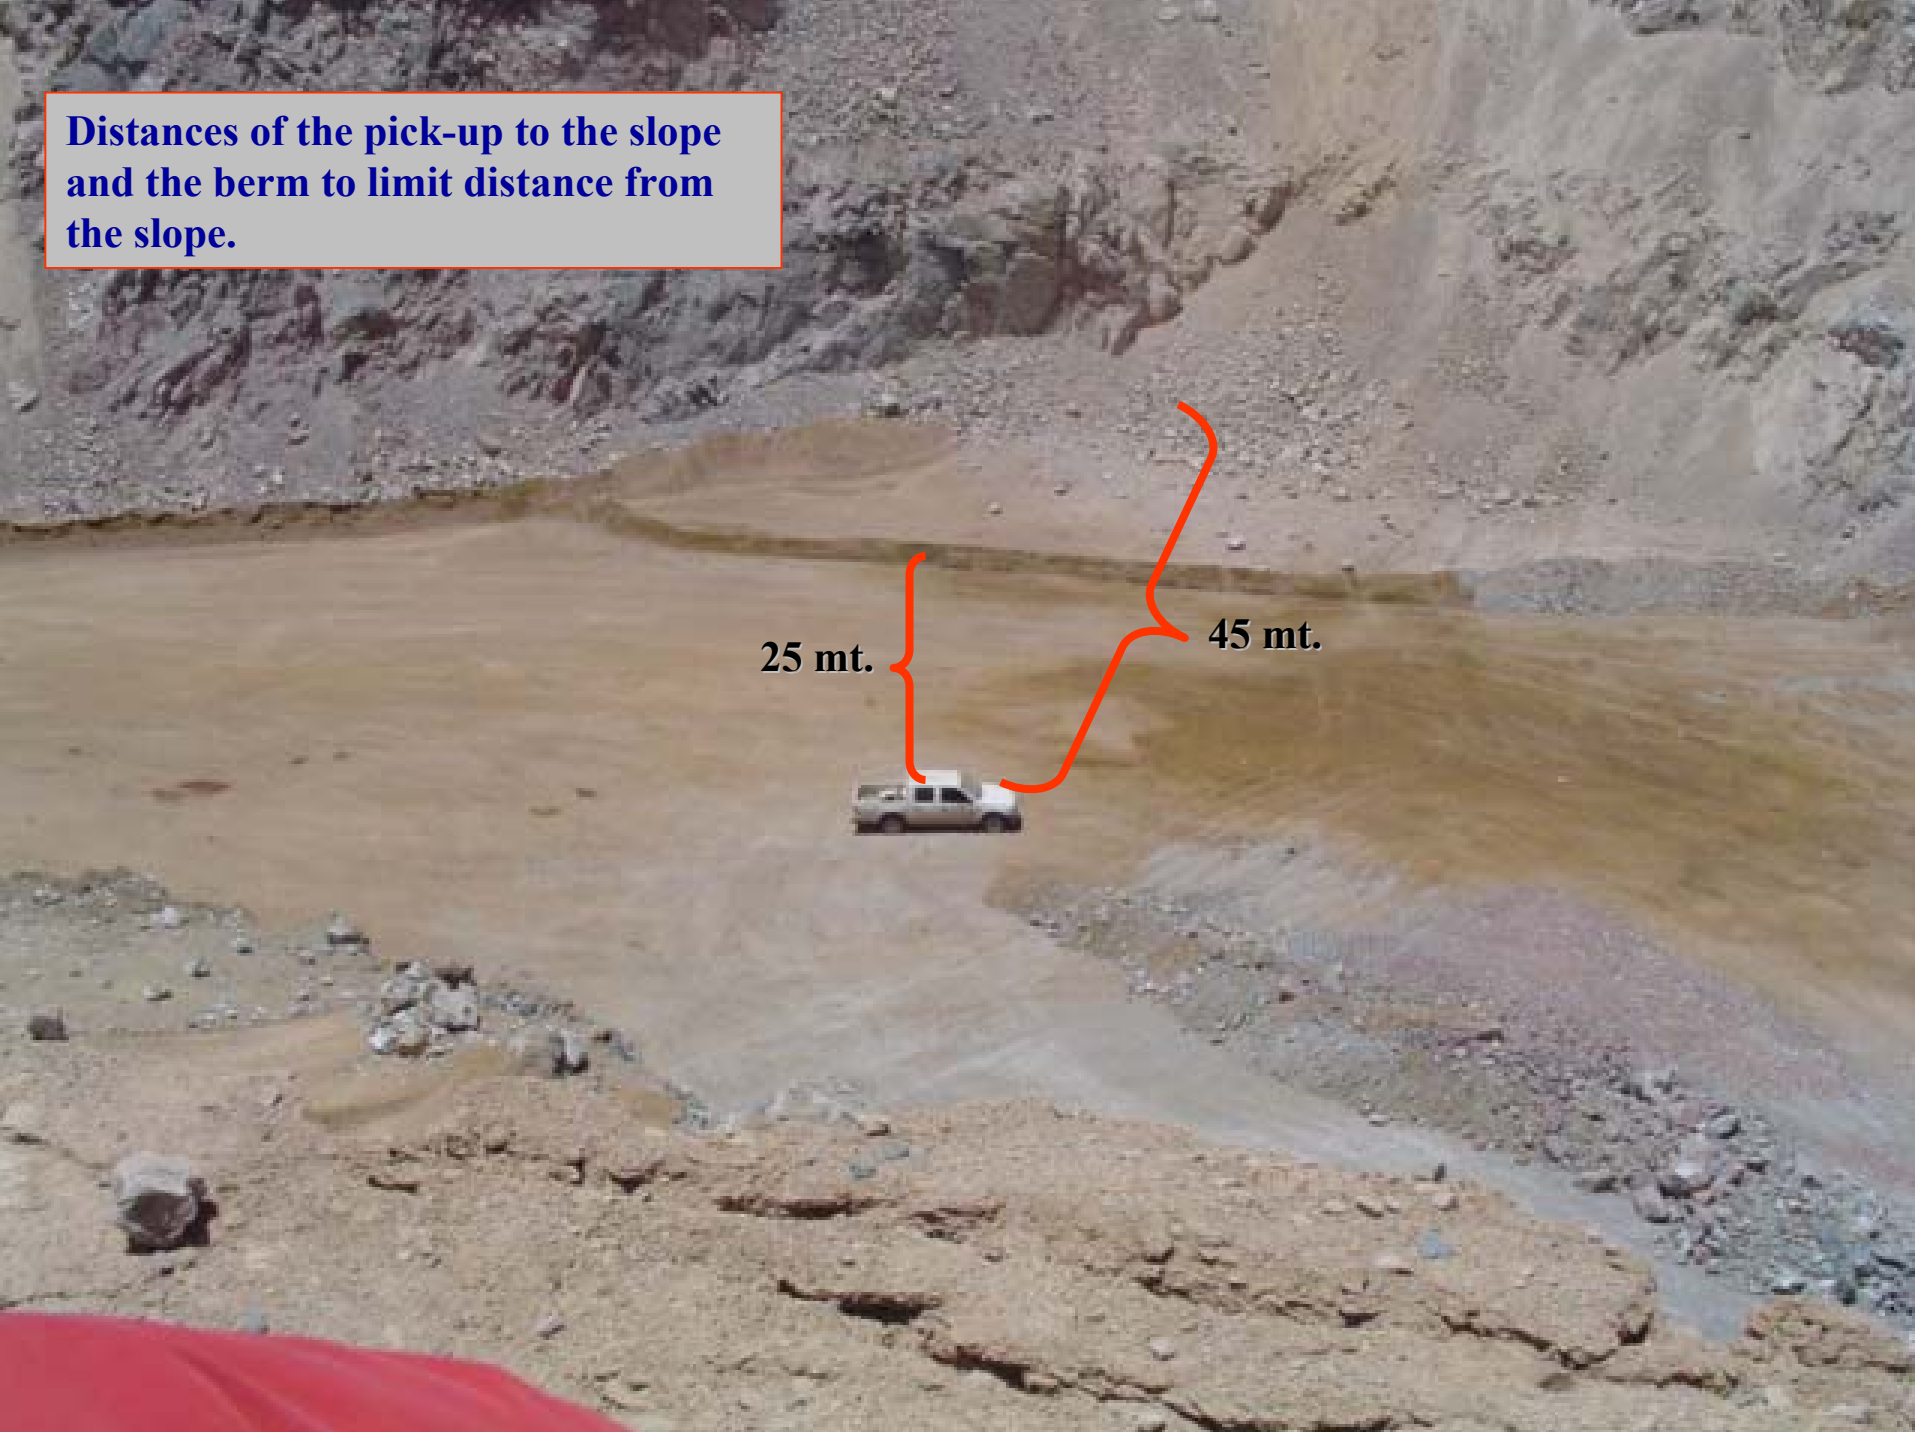
**Distances of the pick-up to the slope and the berm to limit distance from the slope.**

25 mt.

45 mt.

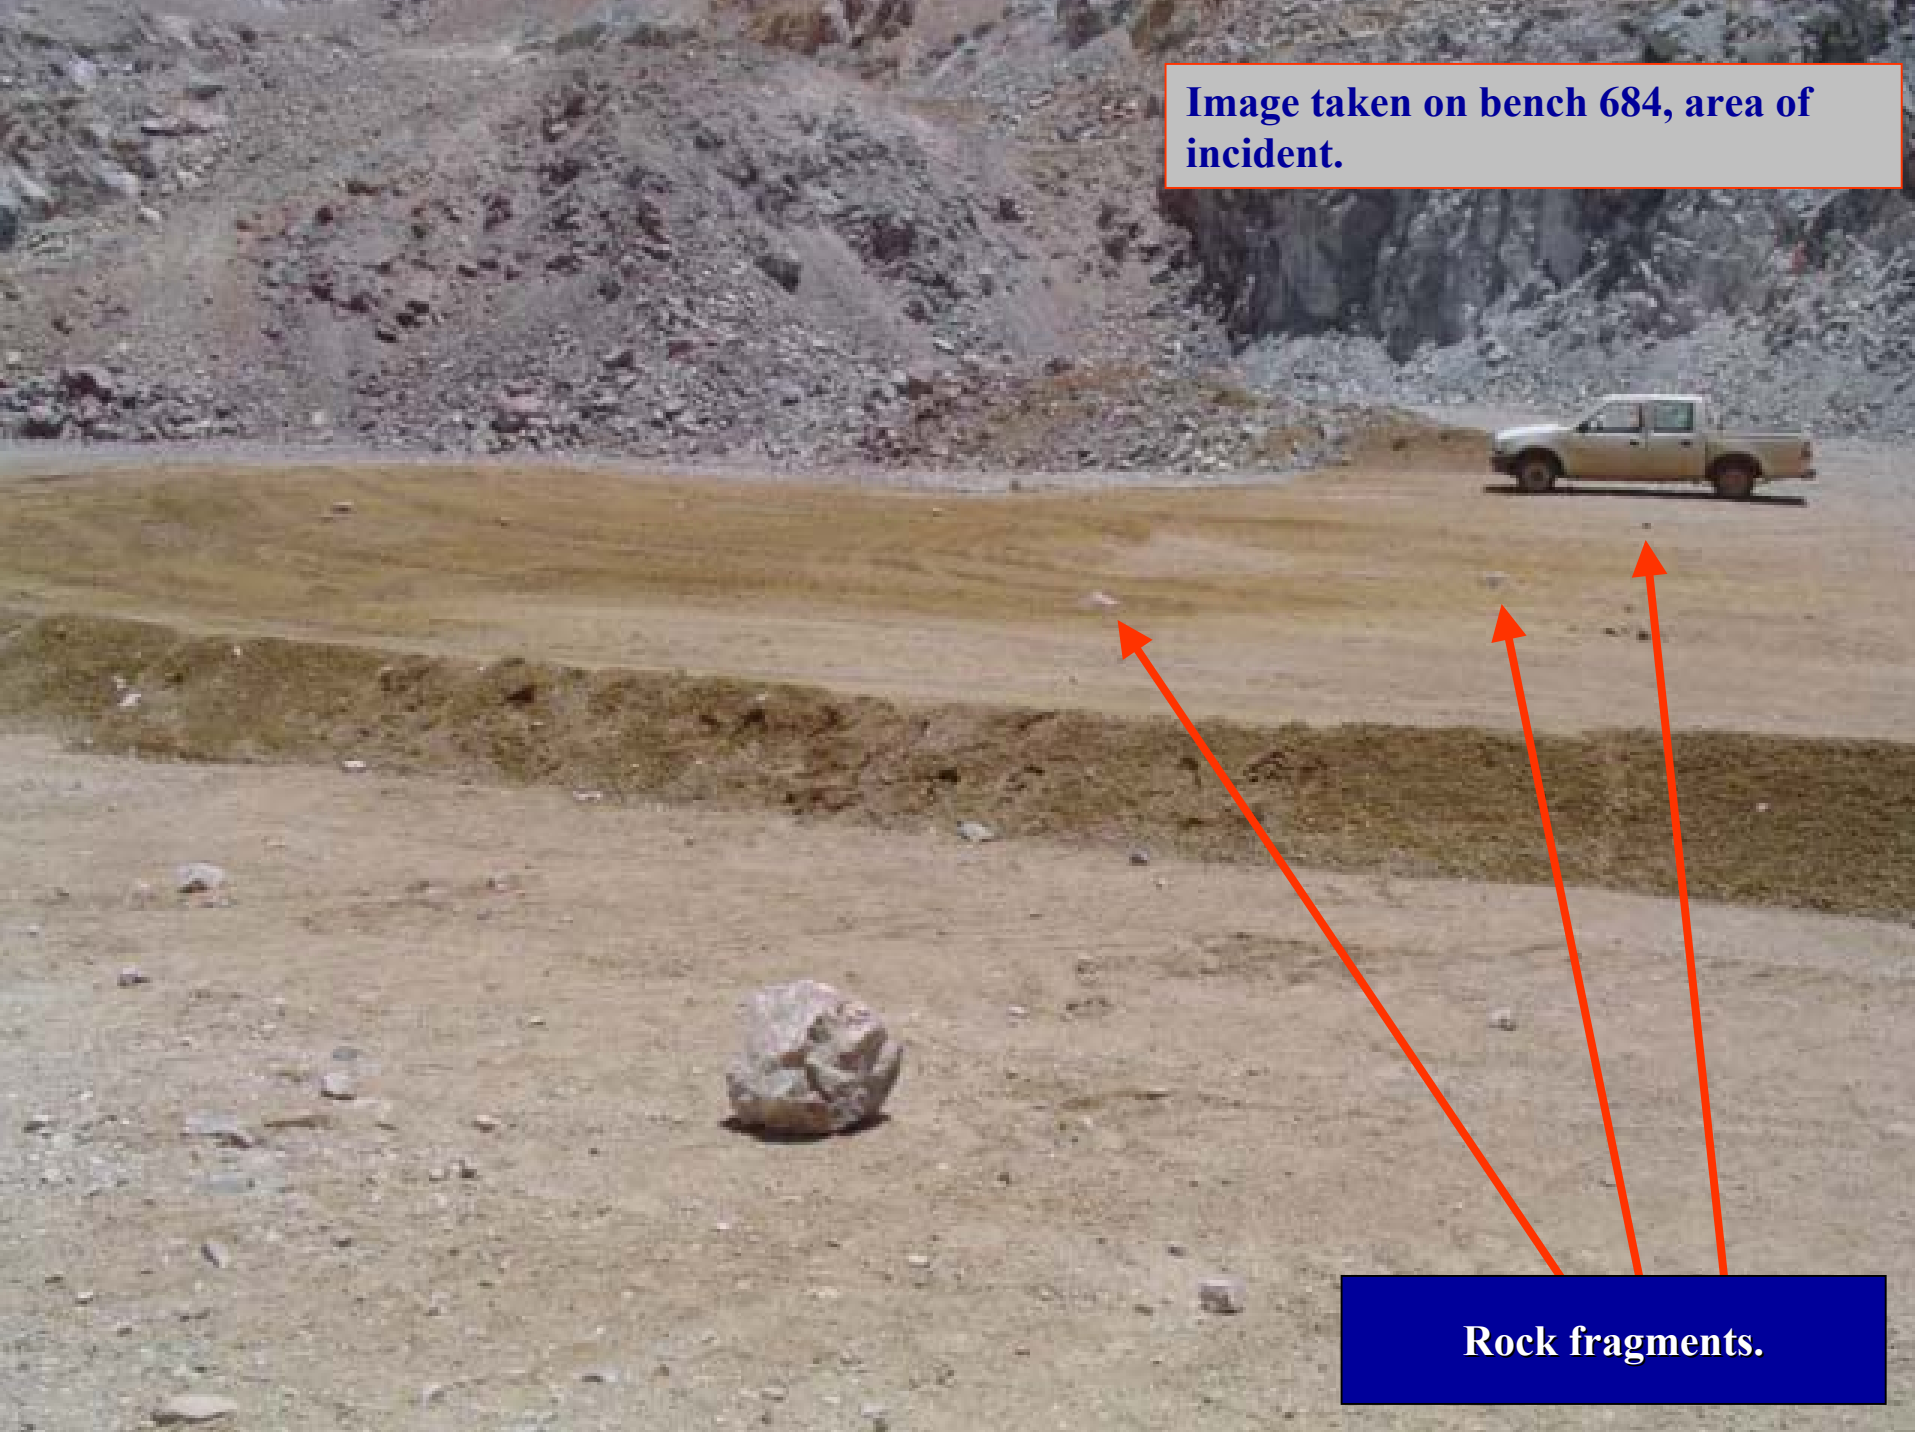
**Image taken on bench 684, area of incident.**

**Rock fragments.**

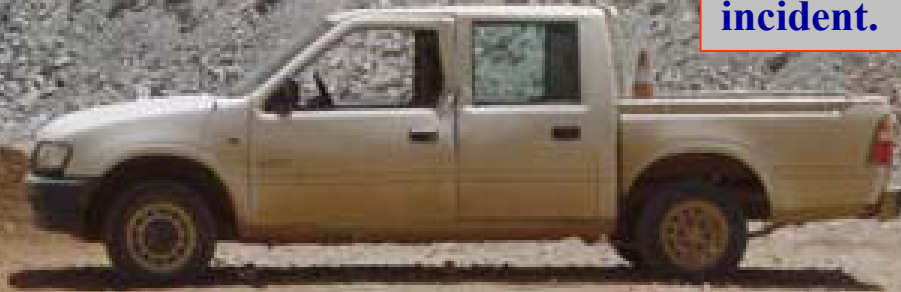
**Image taken on bench 684, area of incident.**

**Rock fragments.**

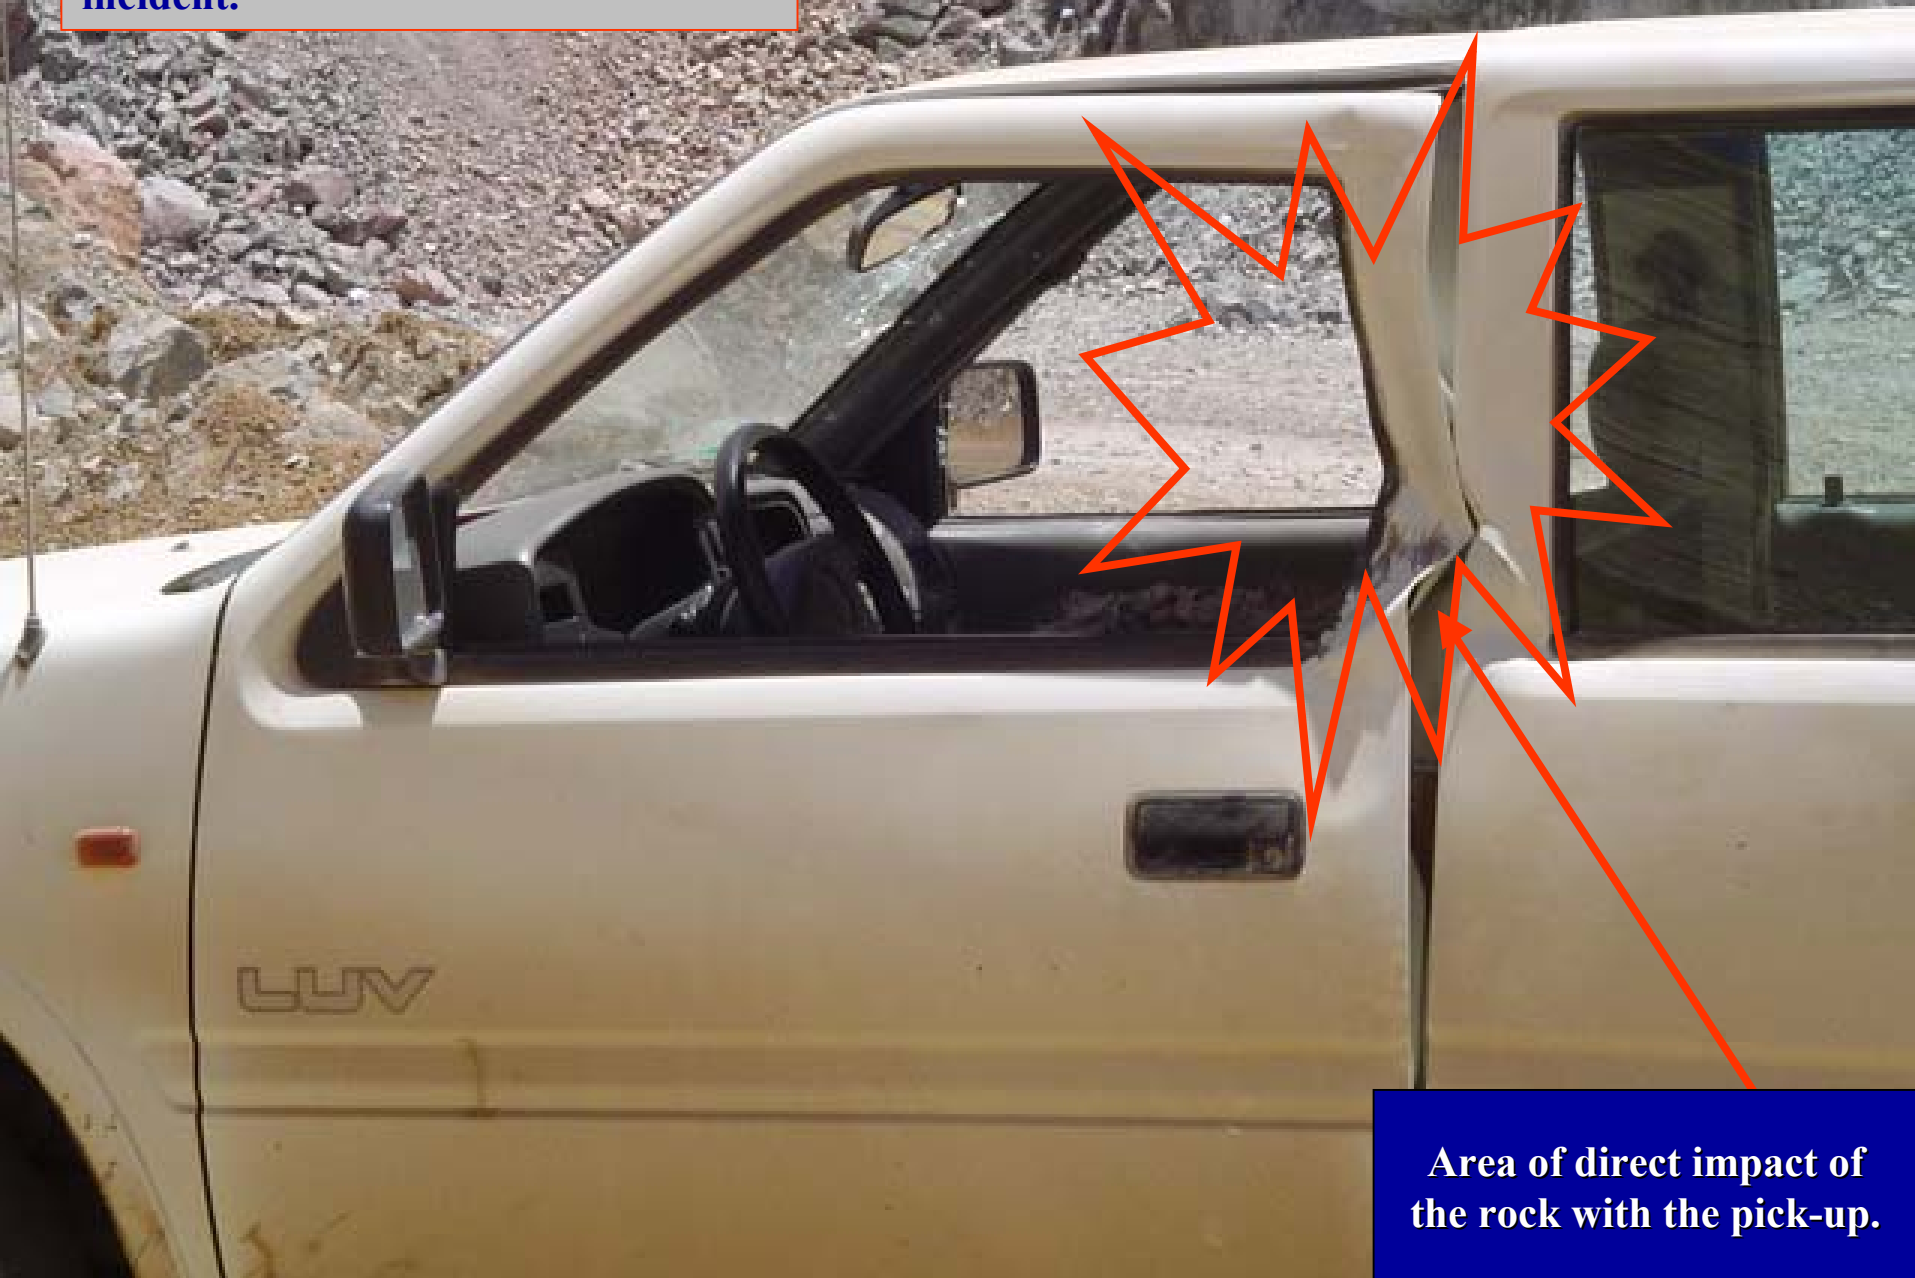
**Area of direct impact of the rock with the pick-up.**

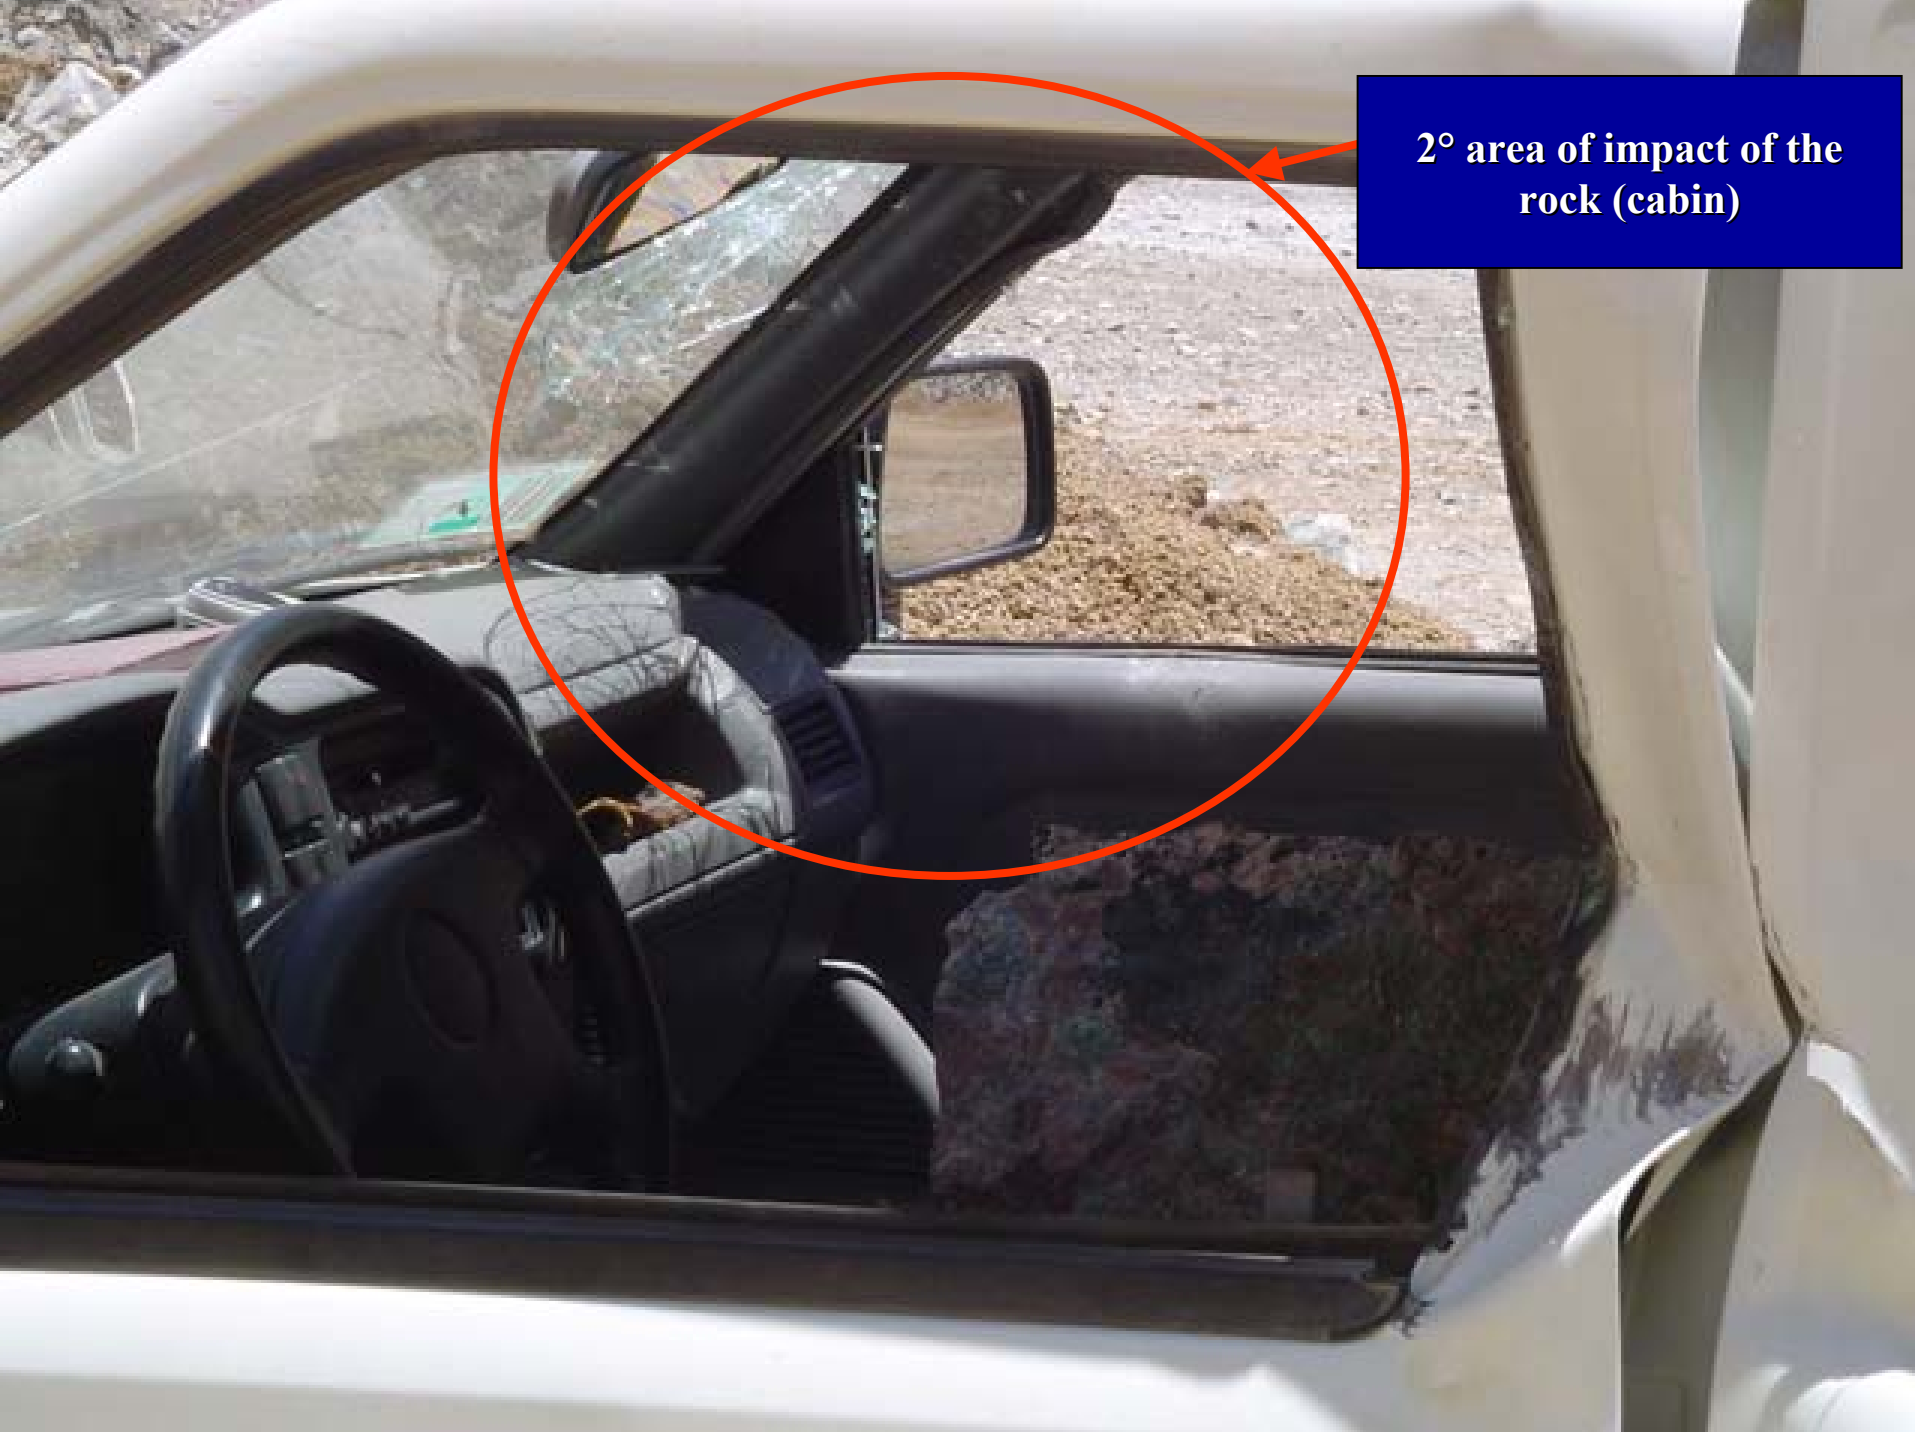
**2° area of impact of the  
rock (cabin)**

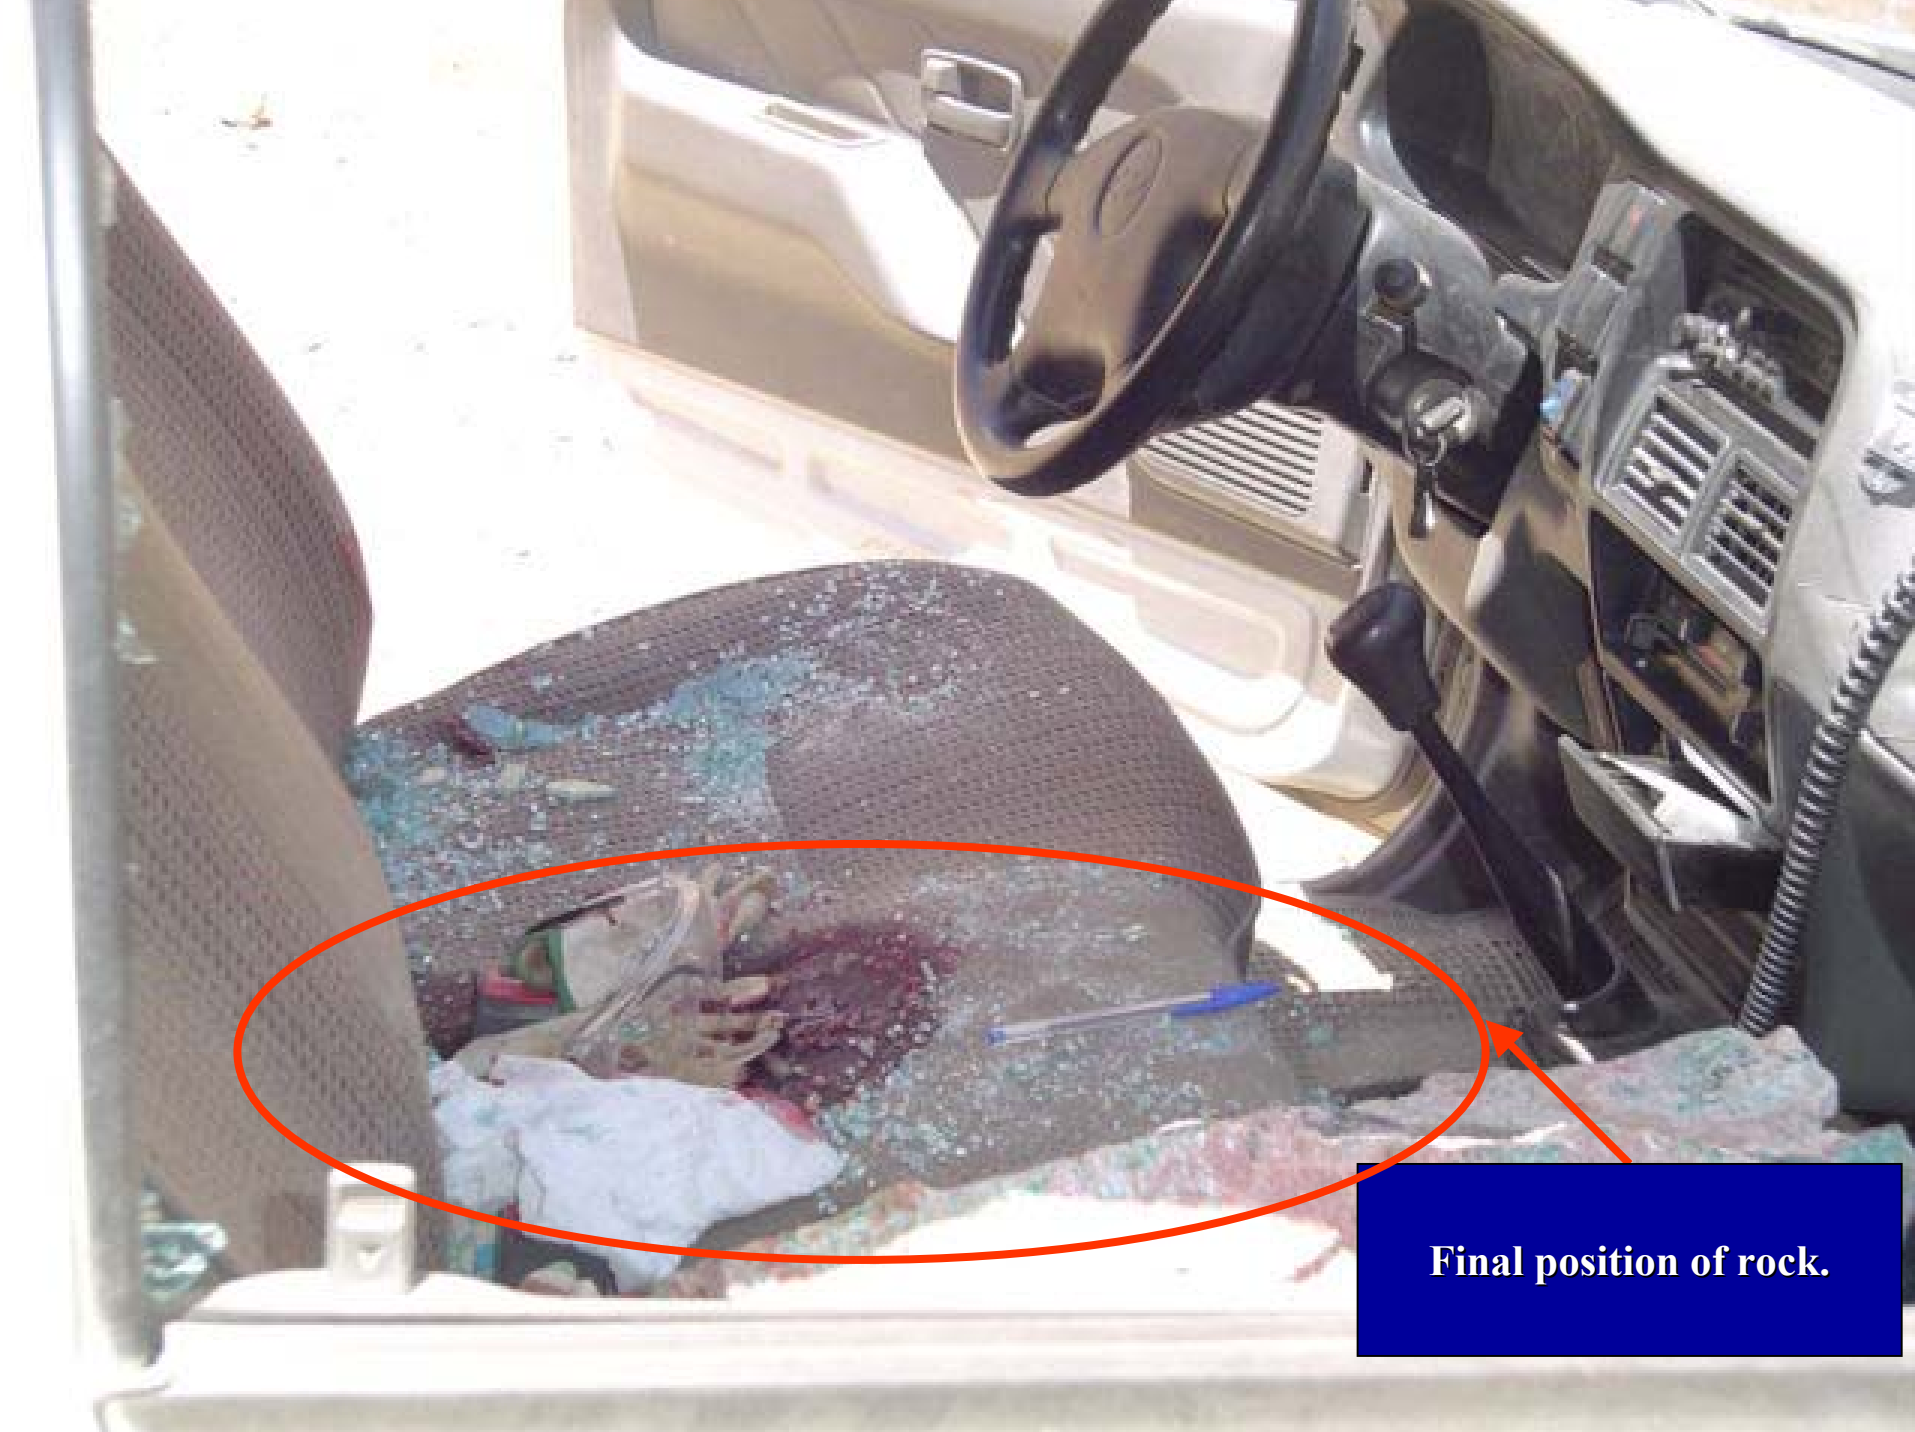
**Final position of rock.**
