REPORT OF INVESTIGATION

**Non-Injury Mine Fire Accident
January 21, 2010**

**Doe Run Company
Viburnum #29 Mine
Viburnum, Washington County, Missouri
Mine ID No. 23-00495**

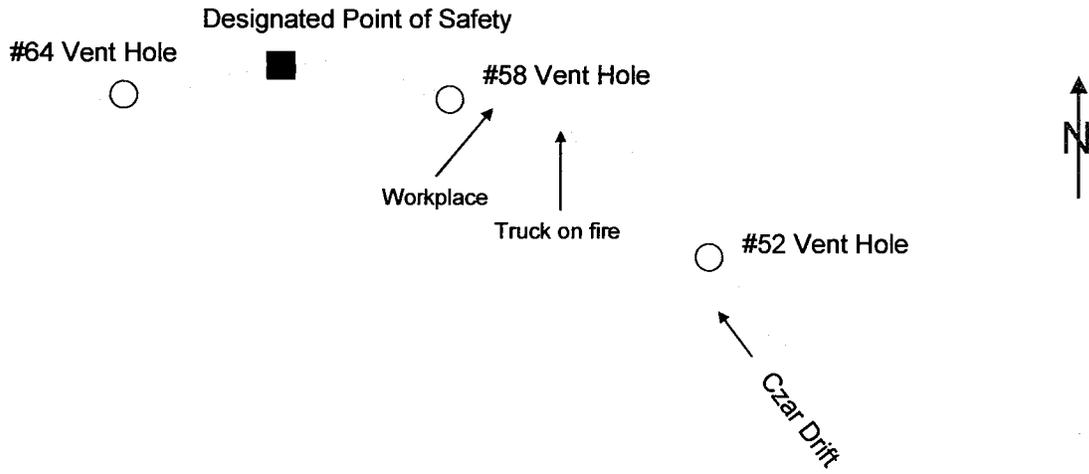
Czar Drift Schematic

The accident occurred in the Czar drift between #52 ventilation hole and #58 ventilation hole (see Exhibit B).
