MINE WATER AND THE ENVIRONMENT, VOL. 14, ANNUAL ISSUE, PAPER 9, 1995, PP 107-130

Mine Inundation-Case Histories

by V.S. Vutukuri * and R.N. Singh**

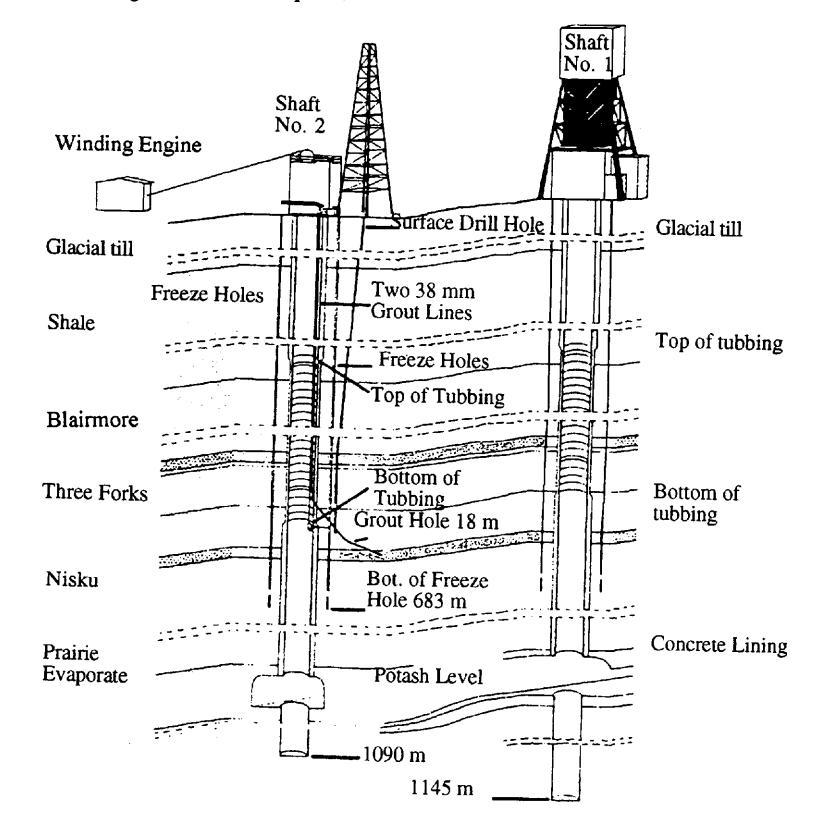
Figure 4 Section through No.1 and No.2 Shafts, Cominco Potash Mine (Prugger, 1979)

On 2nd August, 1970, during routine shaft grouting, a major water feeder was intersected at the bottom of the tubbing column. Water and quicksand under very high pressure entered the shaft at a rate of $65 \text{ m}^3/\text{min}$ (1083 l/s, Prugger, 1979) and flooded the mine including both shafts. Figures 4 shows the cross section through both shaft showing straitigraphical column and the point of intersection.

The breach was sealed with cement grout simultaneously from and within the shaft through a relief hole drilled from the surface. The mine was dewatered, rehabilitated and the equipment was restored and the production resumed two years after the accident. A total of $515,130 \text{ m}^3$ of brine had to be removed before clean-up and rehabilitation of underground mine openings and equipment could begin. To provide access to the mine, $15,000 \text{ m}^3$ of fine quartz sand and mud had to be removed. One low-lying area was not dewatered, but was abandoned.

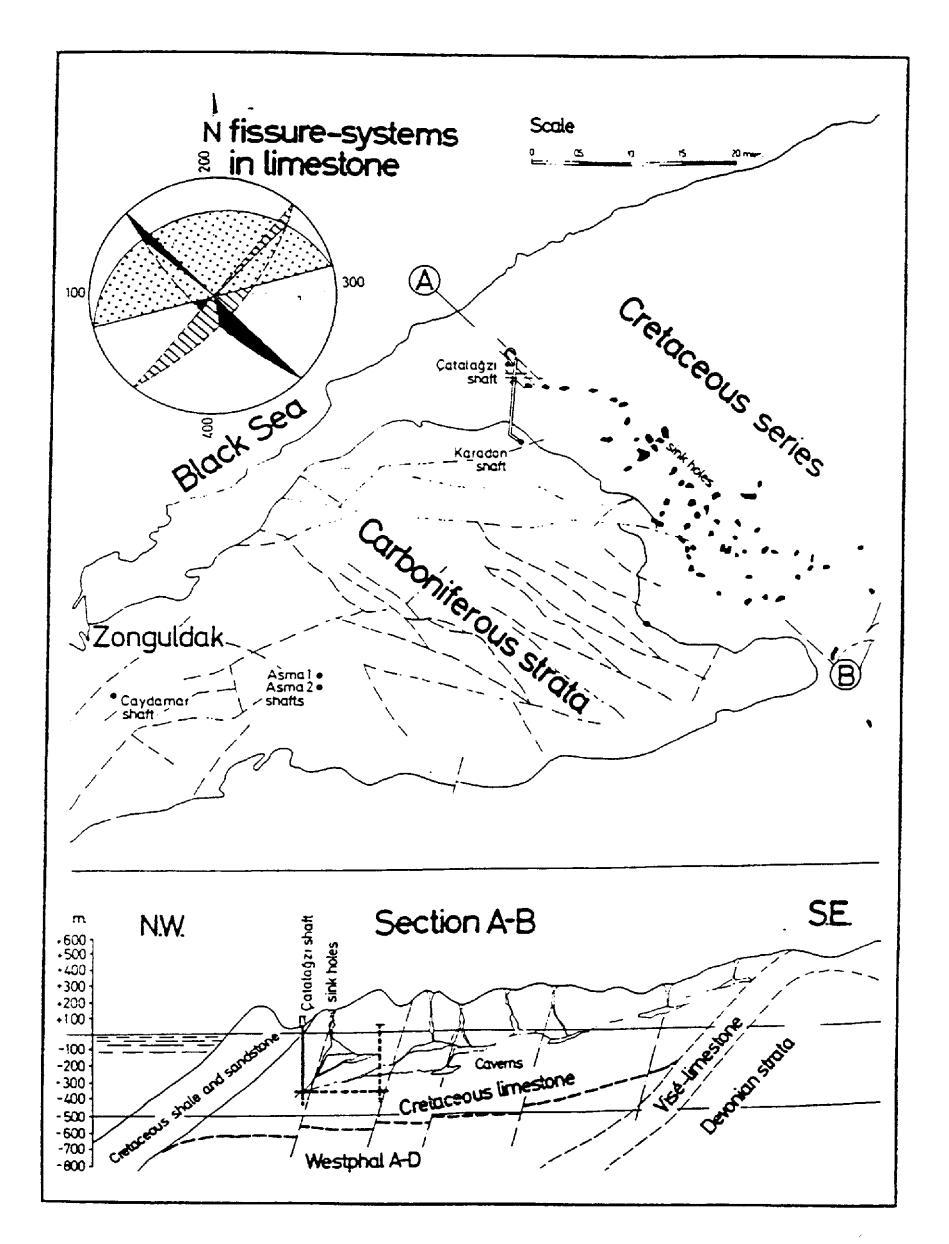
Figure 5 Geological structure of site 2 in the vicinity of Karadon and Catalagzi shafts (Mattes, 1975)

The Catalagzi shaft had an inside diameter of 6.5 m and was concrete lined. As the shaft was sunk through the karstic limestone, extensive grouting work had already caused a delay of 18 months during the sinking due to constant water problems. After sinking was completed the underground loading station loop had to be driven through the vuggy, water bearing limestone and the shaft station had to be connected with the existing mine workings by a main haulage roadway through limestone which dipped at about 30 °. The development work was carried out observing all precautions. Pilot holes were kept in advance of the face and the rock mass was grouted where necessary. After 300 m of drifting through the karst limestone in the loading station loop, a major water inflow occurred. It can be seen in Figure 5 that the karstic limestone forming the basin has many solution caverns and is intersected with major faults. It may also be noted that in spite of these hydrogeological features there were no test holes drilled in the vicinity and at the centre line of the shaft at the time of 32.5 m^3 per minute. As a consequence, the drift was completely flooded and had to be abandoned.

The Catalagzi shaft subsequently filled up with water to a level of 16 m below the shaft collar. The shaft was then dewatered by using 11 stage submersible electric pumps with a capacity of 7.2 m³/ min. It may be noted that the help of a diver was needed to remove shaft debris. After two and a half years and four major floods the shaft was secured by a water dam 120 m north of the shaft. In order to isolate the major feeder intersecting the karst aquifer concrete water dams with watertight welded steel doors were required to seal the water feeder. A second water dam was also built on the south side of the shaft and equipped with a water tight door. Only after the shaft had been protected by these dams, the mining of the main haulage to the Karadon mine started. It rrequired $2\frac{1}{2}$ years using 11-stage submersible pumps and at a cost of \$1.6 million to dewater the mine.

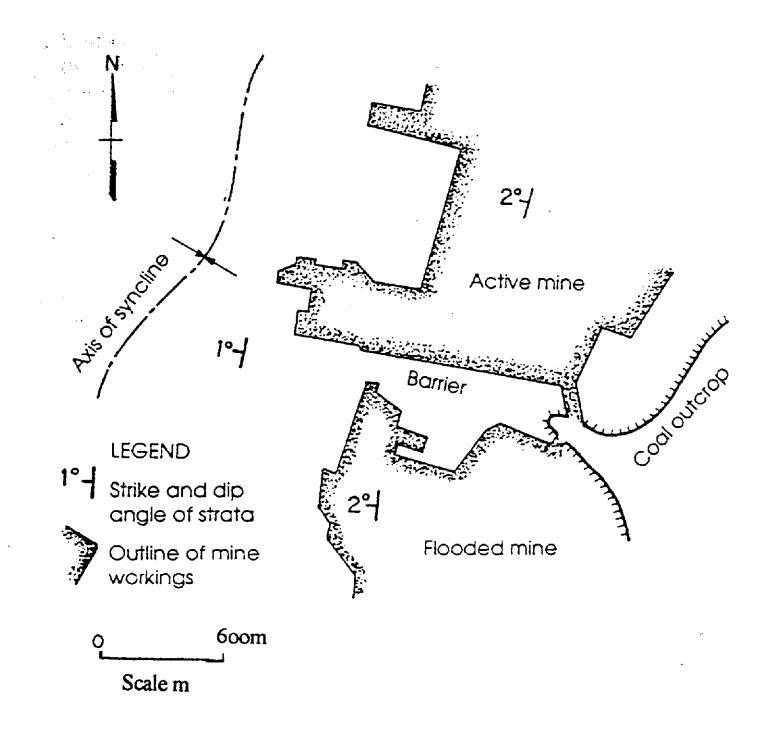
In this mine a barrier of apparently more than adequate dimensions failed to prevent a substantial influx of water from the adjacent flooded mine. Water first entered through roof-bolt holes and slickensides in the roof with only minor seepage through the coal seam. Analysis confirmed that the seepage was mine water rather than ground water. Dewatering the flooded mine was estimated to take a minimum of 180 days continuous pumping at a rate of (63 l/s) without allowing for any recharge.

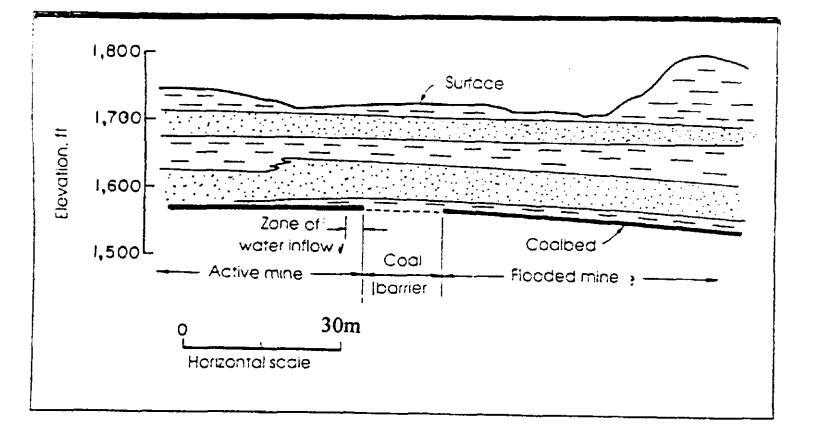
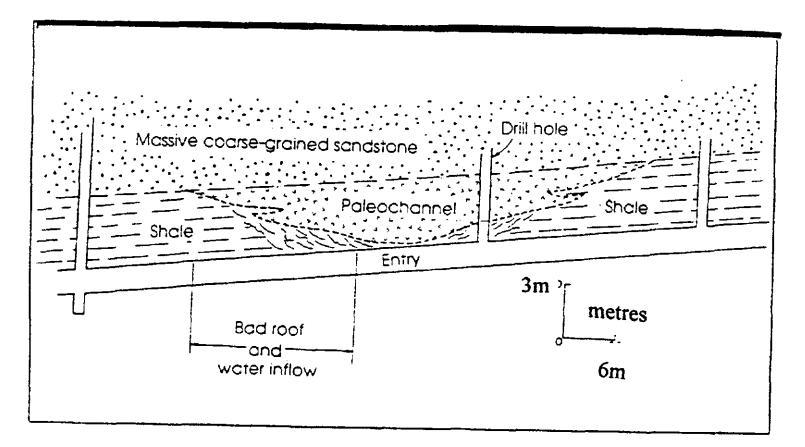
Three bore holes drilled in the mine roof and one from surface revealed a sandstonefilled paleochannel (Figure 8a and b) adjacent to the zone of heavy water inflow. Pathways for the water lay along the margin of the channel where deformation of the roof strata had occurred. Although no evidence was obtained which could confirm the

continuity of the paleochannel across the entire width of the barrier, no explanation other than an anomalous, permeable geological structure seemed warranted.

This case example demonstrated that the barrier pillars between the water logged workings and the active working should be free of geological structures and anomalies.

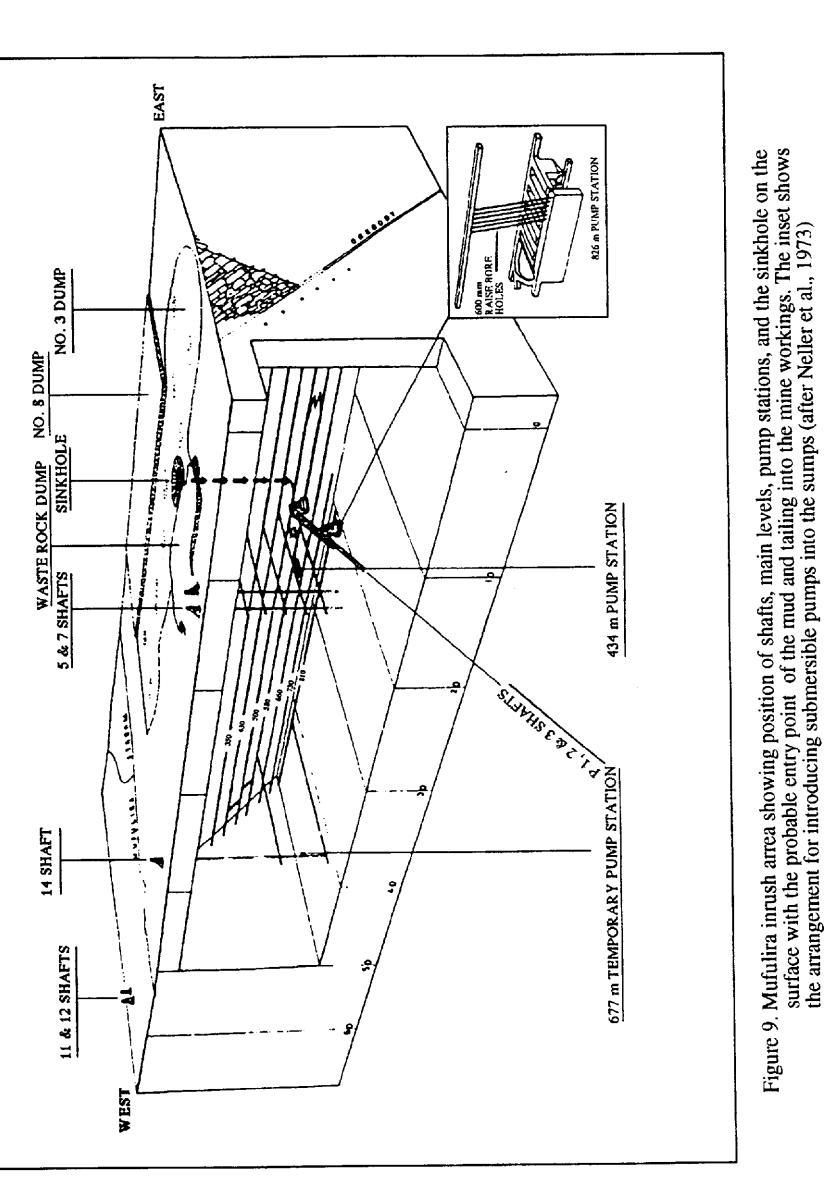
On September 30, 1970, a sink hole appeared on the surface through which a mud flow, composed essentially of concentrator tailings, poured into the mine, killing some 89 miners and causing serious damage to the mine. Within a 15-minute span in the early-morning hours of 25th September, 1970, an inrush of about 453,070 m³ of mud from the surface flooded much of the Peterson section of the mine, trapping and killing miners and wreaking extensive damage to the mine itself (Figure 9). The bulk of this mud originated from a large accumulation of saturated tailings from the concentrator, which had been impounded on subsiding ground above the mine workings. A sinkhole with an associated collapse chimney developed beneath this accumulation, creating channels leading to the underground workings; through these channels, tailings flowed into the mine through several major ingress points between the 500m and 580m levels, and thence to lower levels via ore passes, raises, and the Peterson shaft system. As a result, the Peterson section filled with mud and water from the 500m level downwards.

This inflow of water and mud was a case of accidental inundation unprecedented in the history of mining. The risk associated with bad mining procedures and geotechnical instability of backfill could not be foreseen by the mining officials as well as the government inspectorate. Erroneous beliefs, poor communications and lack of engineering judgment can be attributed as the basic cause of the disaster.

This disaster proves that before starting a new scheme it is prudent to carry out a risk assessment for men, equipment and process before adopting it.

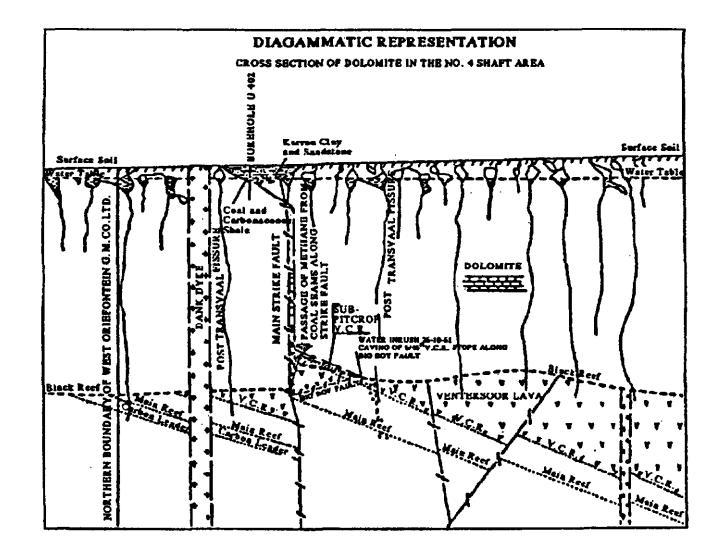
Figure 10 Diagrammatic representation of solution cavities and fissure formation (Coussens and Garret, 1969)

On the morning of 26th October, 1968, an examination of the hanging wall in a stope between 4 and 6 level, No. 4 shaft (Figure 10) at a depth of 863m below surface,

indicated some movement and a small amount of water inflow. At 9.30 a.m. a fissure opened in the stope and large quantities of water rushed into the mine.

In considering the design of the plugs, some major factors had to be taken into account, the most vital of which was the need for speed - which was complicated by difficulty of access to the plug site because of the huge volumes of water flowing in the drives. How this difficulty and other problems were overcome was also detailed in the paper. This incident highlights the notion that strict management system and technical expertise are necessary to detect and control ground water inflow potential when mining underneath a major karst aquifer. In addition to drilling advanced boreholes to locate a large reservoir of water, a large sump and installed emergency pumping capacity and management plan are necessary to meet such emergencies.

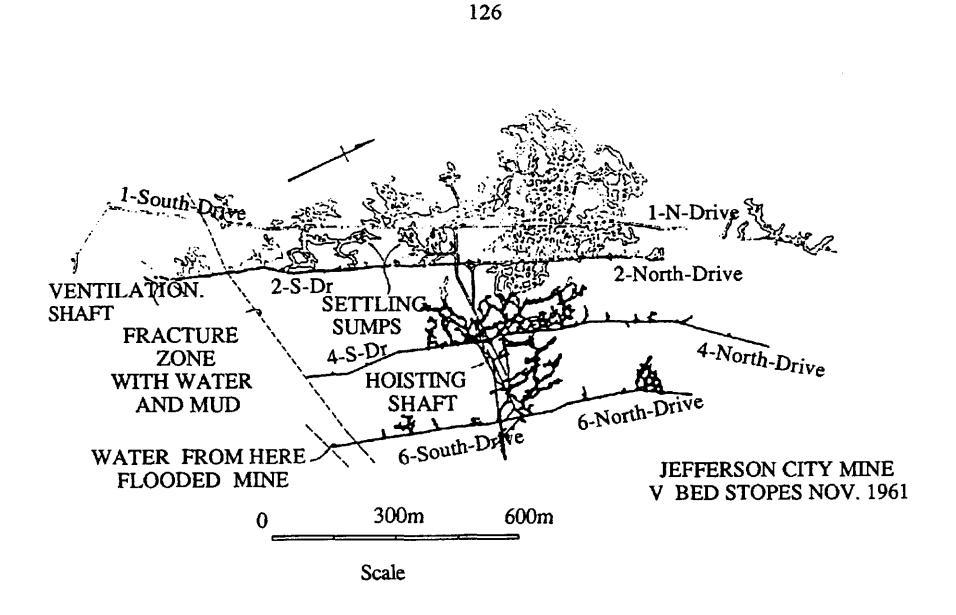
Figure 11 Cross section through Jefferson City Mine (Miller and Jolley, 1964)

On the south western part of the mine a highly fractured water bearing zone comprising steeply dipping fractures and faults with minor displacement s was known to be present. Examination of the exposed fracture zone reveals a series of lenticular voids up to 152 mm in width with the rest of the zone water tight. The pattern of the voids in the plane of the fault resembled a lacy structure. Water, heavily charged with mud and sand, had been encountered within this zone by drill holes during drivage of 1-S, 2-S, and 4-S drifts. Each time the water was controlled by placing packers in the holes. Drilling of precautionary pilot holes in advance of the drift face was, therefore, unreliable. It was believed that at greater depth this zone would be comparatively dry because the fractures and voids would have tightened with depth.

In driving 6-south drift, in moderately oxidized minor fault zone, a newly exposed face intersected the known water bearing zone. There were two or three small lens shaped voids up to 102 mm wide along the fault plane which yielded some 4 to 7.5 l/min of water. The water potential of this fracture zone was under-estimated and proved to be far in excess of any previously known in the district. On 7th November, 1961, a night crew started drilling a round in 6-S drift 472 m southwest of the shaft crosscut and 372 m below the surface, when the drift hit watery ground. Their jumbo had 3 drills which were simultaneously drilling the first bore holes, all 32 mm in diameter. Four 4.3m pilot holes drilled in advance of the previous round had not encountered water. The left bore hole and the central hole had reached a depth of 2.4 to 2.7 m. At a depth of about 0.9 m, the right bore hole encountered mud and water. Initial inflow was estimated at 19 - 26 l/s at an approximate pressure of 3.1 - 3.5 MPa. The first attempt to insert a packer was unsuccessful due to a lack of clearance between the packer and the hole, and as a consequence a leak developed in the packer. Subsequently, another packer was inserted and the water shut off for about 4 hours before a leak developed. The abrasive sand and mud badly eroded the packer, culminating in complete failure 8 hours later. All further efforts to secure a packer in the hole were unsuccessful due to

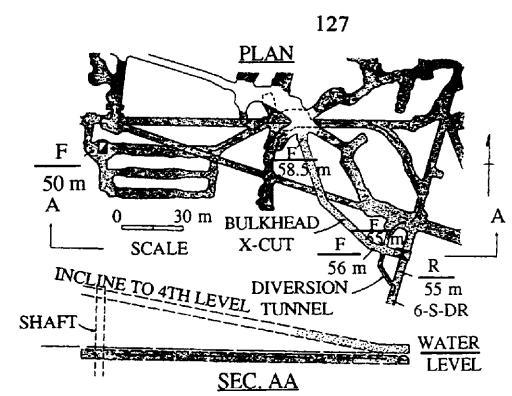
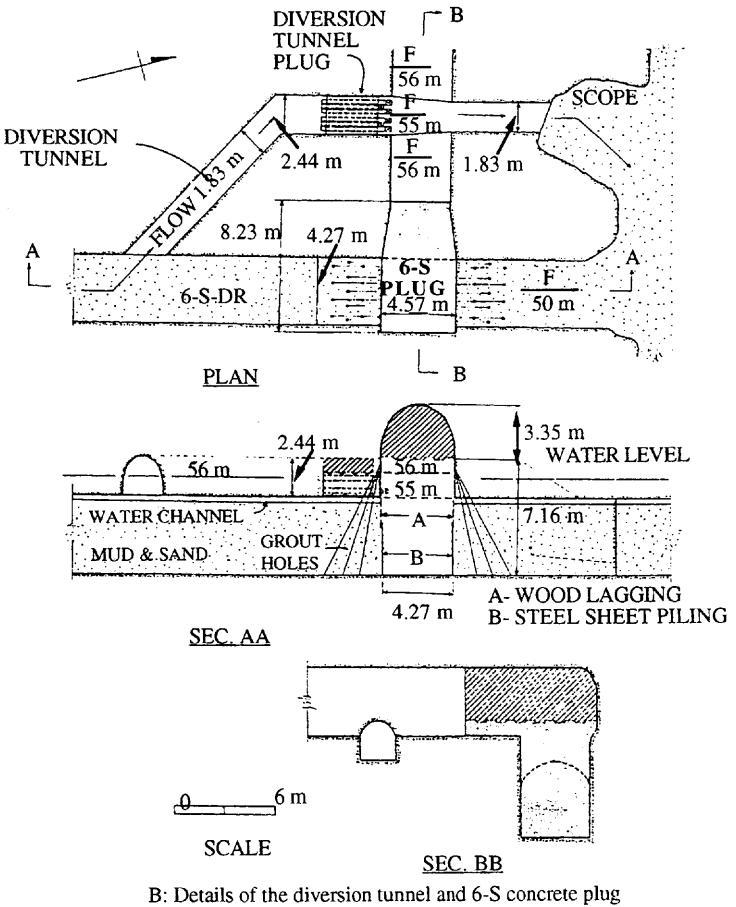
Figure 12 Details of access drivage to make a friction plug in 6 level south.

A: Development (stipled area) for 6-S plug required driving a 81 m cross-cut an 25 m diversion tunnel that connected with 6-S drift. Shaded areas represent working full mud

At this point of time, it was decided to build a friction type plug at 6-level South to seal the inflow. To achieve this end, a plan was devised for plugging off the 6-S drift without the need to lower the water level below a 55m datum viz. 6 m above the 6th level station. This plan involved building a large concrete plug in the 6 level south drift from the top of the drift and a small concrete plug with valved pipes in an adjacent diversion tunnel. Both plugs were the friction type with no hitches or reinforcing steels except for some steel pins in the diversion plug. A crosscut 82 m long was driven from a stope which had been cleaned of mud at elevation of 57m, to a point 1.5 m above the back of 6 level south drift. At the elevation of 55m, a 1.8m by 2.4m diversion tunnel 25 m long was then driven both north and south to within one round of connecting with the 6 level south drift. The elevation of the diversion tunnel and the 6-S concrete plug is shown in Figure 12. This operation virtually stopped the inflow and the mine was ultimately dewatered and restored after interruption of production for a period of 10 months.
