UNITED STATES
DEPARTMENT OF LABOR
MINE SAFETY AND HEALTH ADMINISTRATION
COAL MINE SAFETY AND HEALTH

CAI-2001-20 through 32

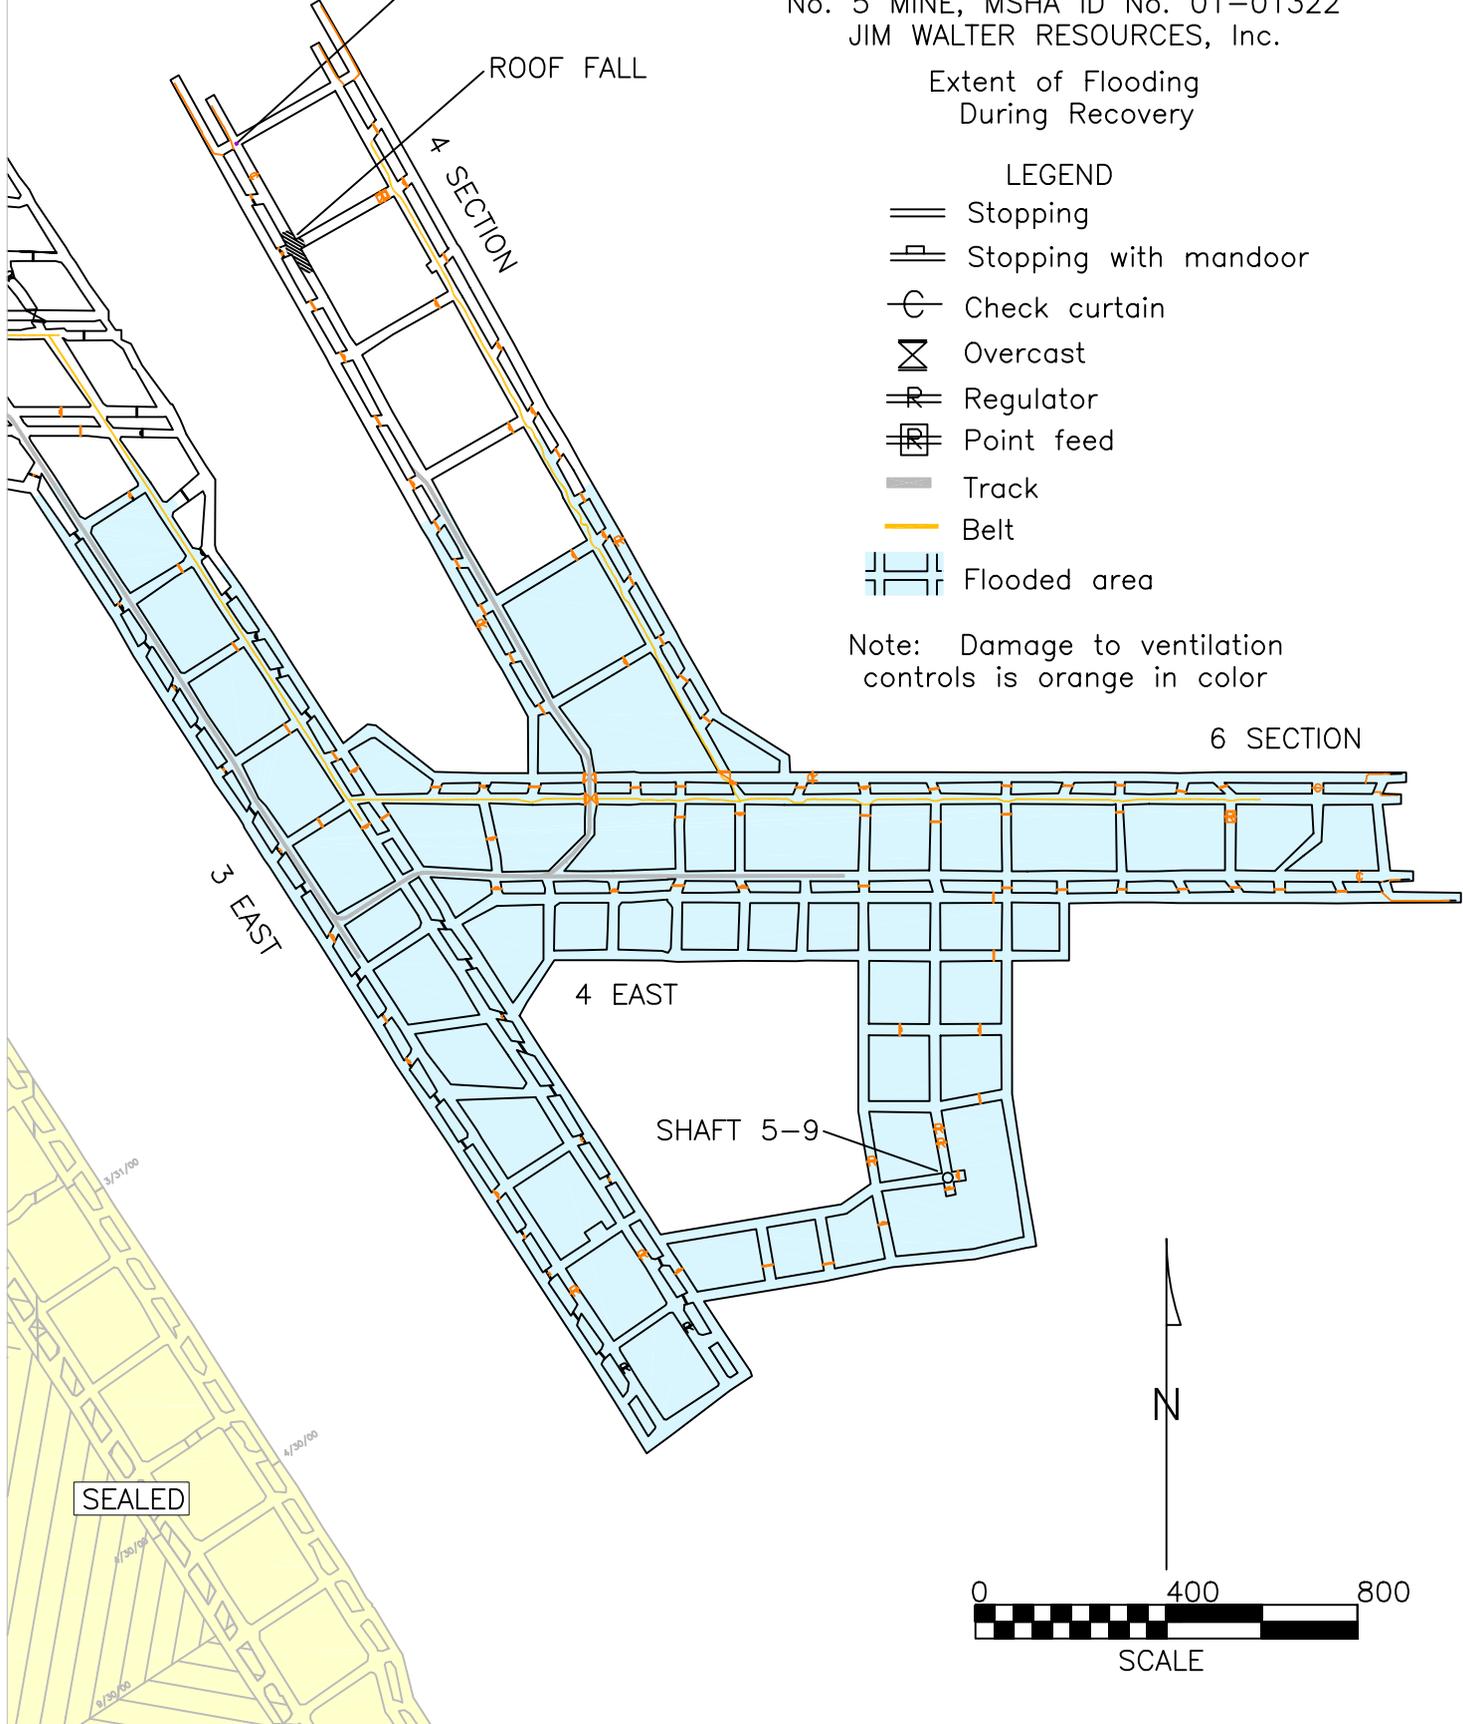
Note: Damage to ventilation
controls is orange in color

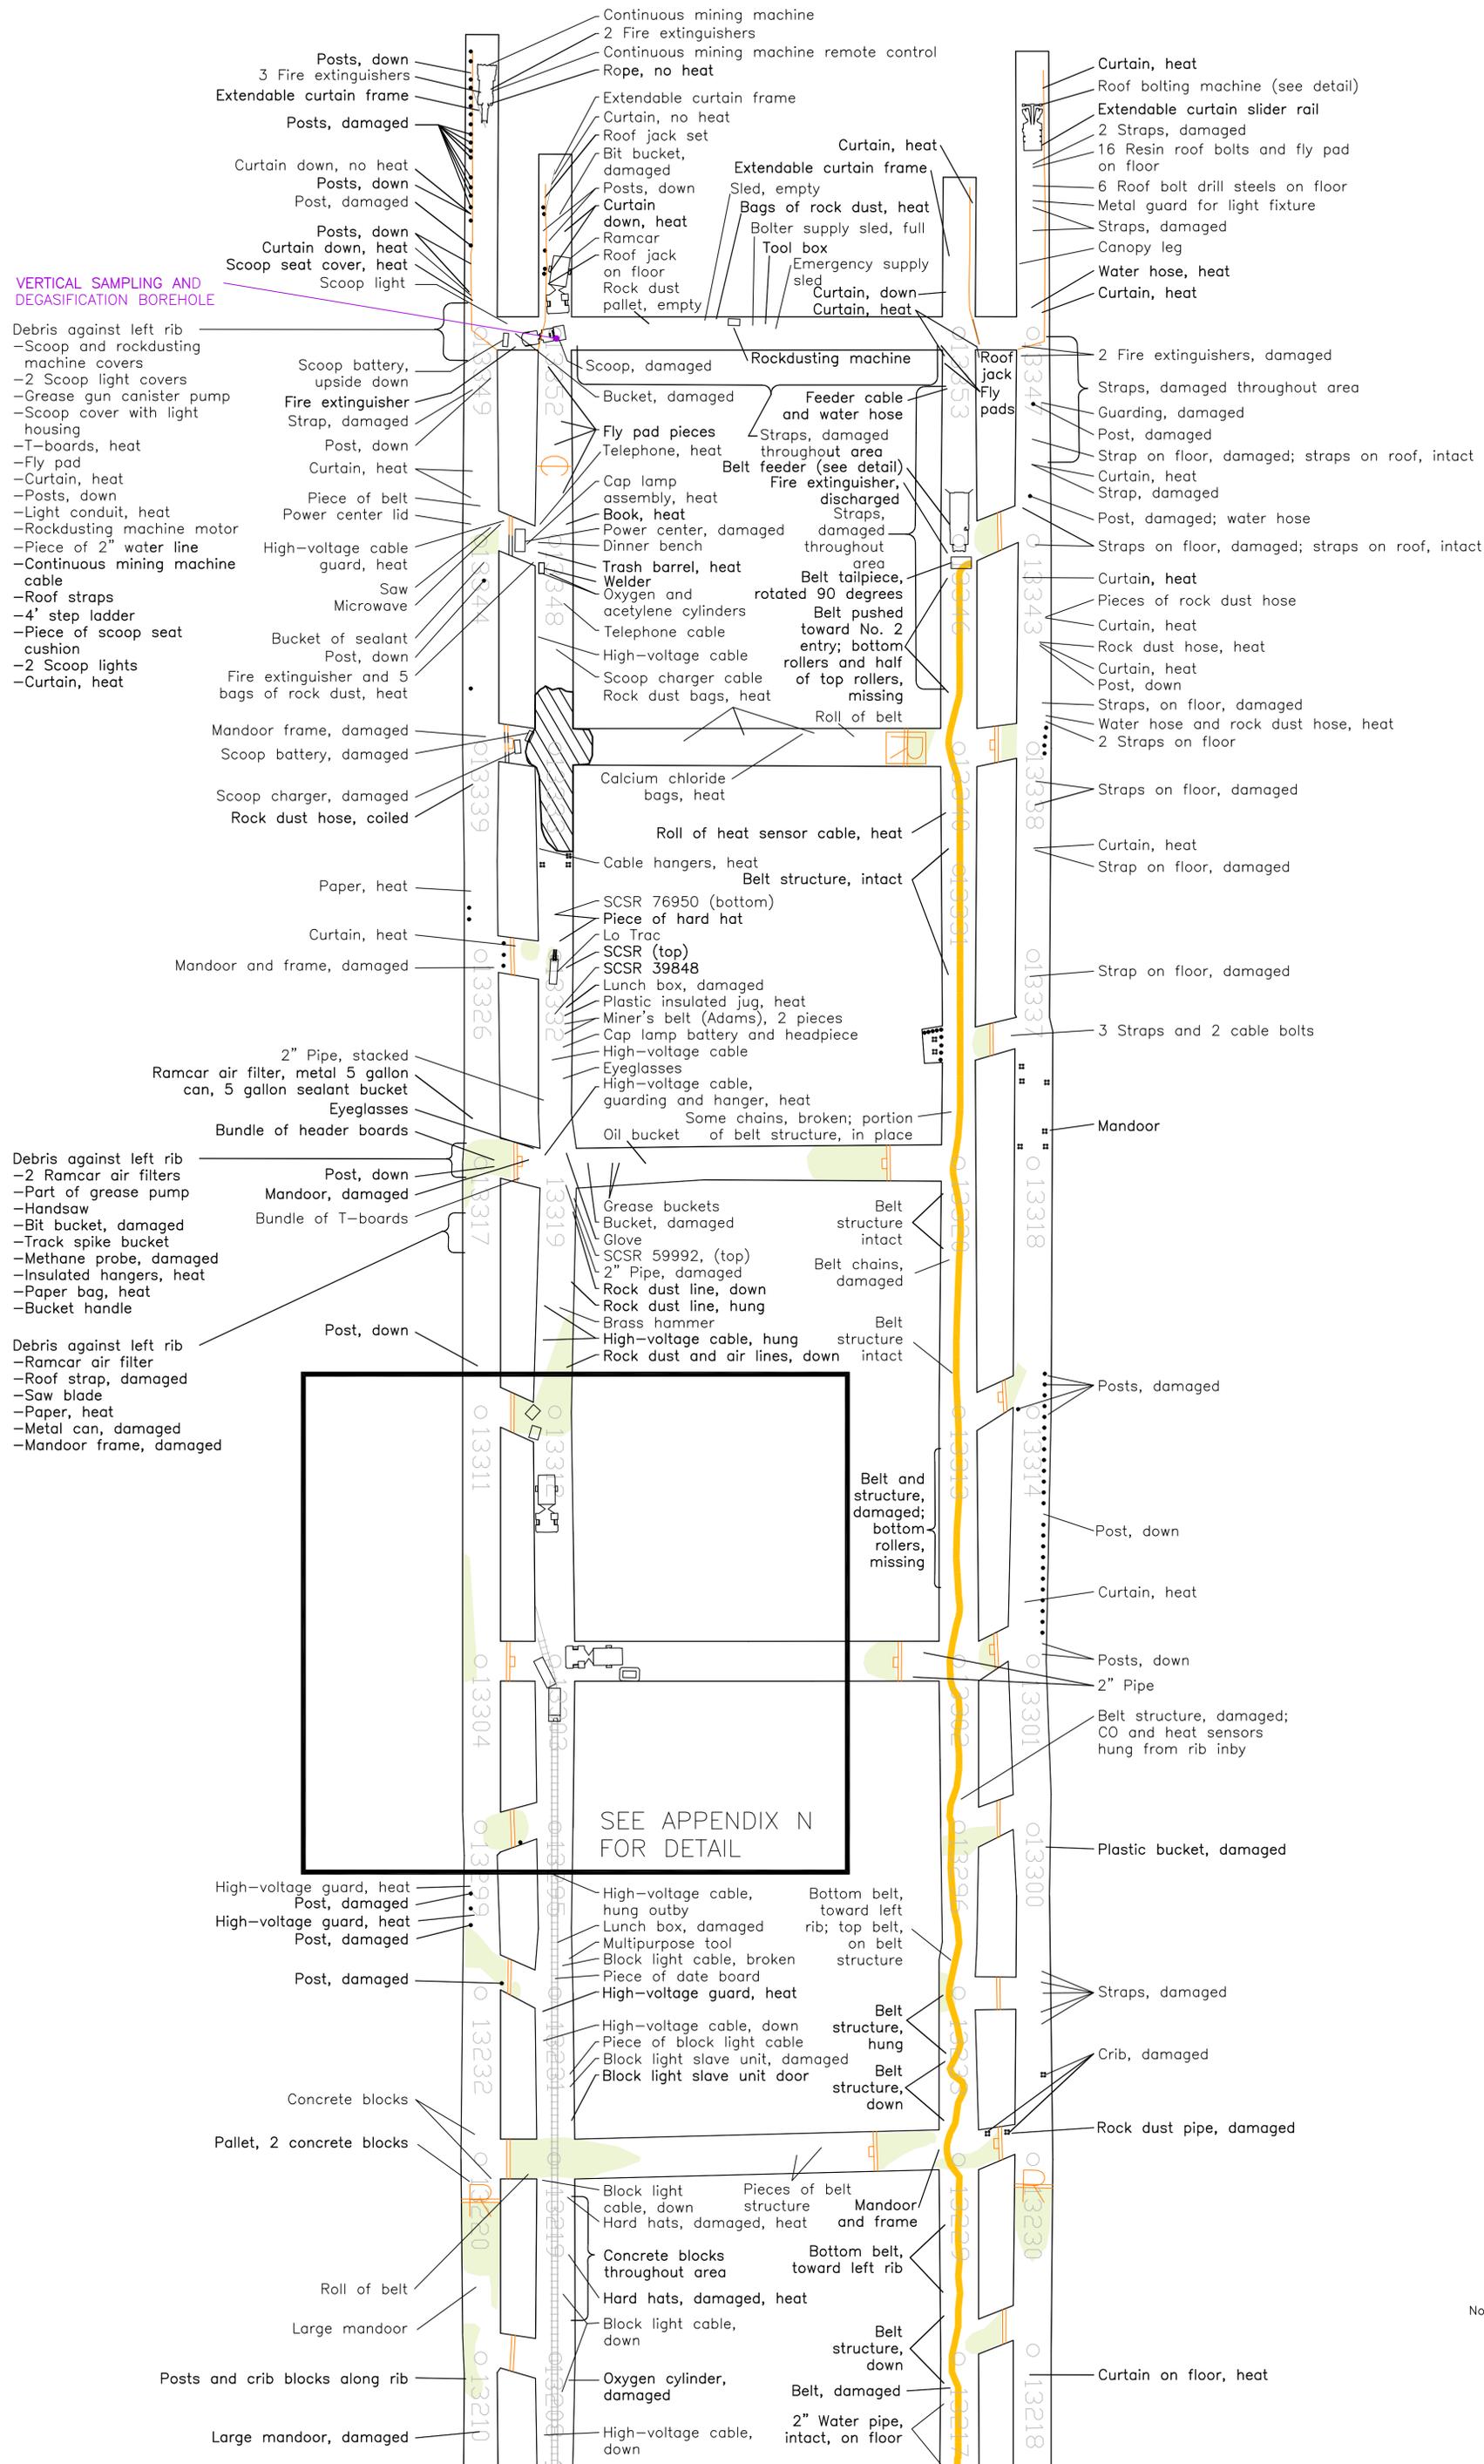
- Roof Bolting Machine**
- Power cable pulled out
 - Canopy broken and collapsed
 - Right-side bolting tray missing
 - Several controls, damaged
 - Machine covers, torn off and overturned
 - Cooling fan, damaged
 - ATRS lights, damaged
 - Tail reflectors, damaged
 - Resin tube, heat
 - Lighting diagram, heat

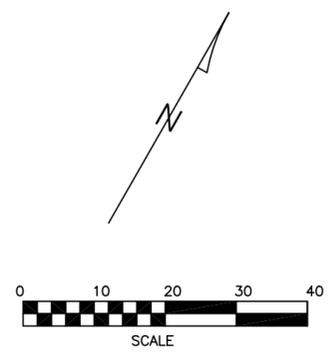
Note: Damage to ventilation controls is orange in color.
Locations of specific items shown on the map are approximate.

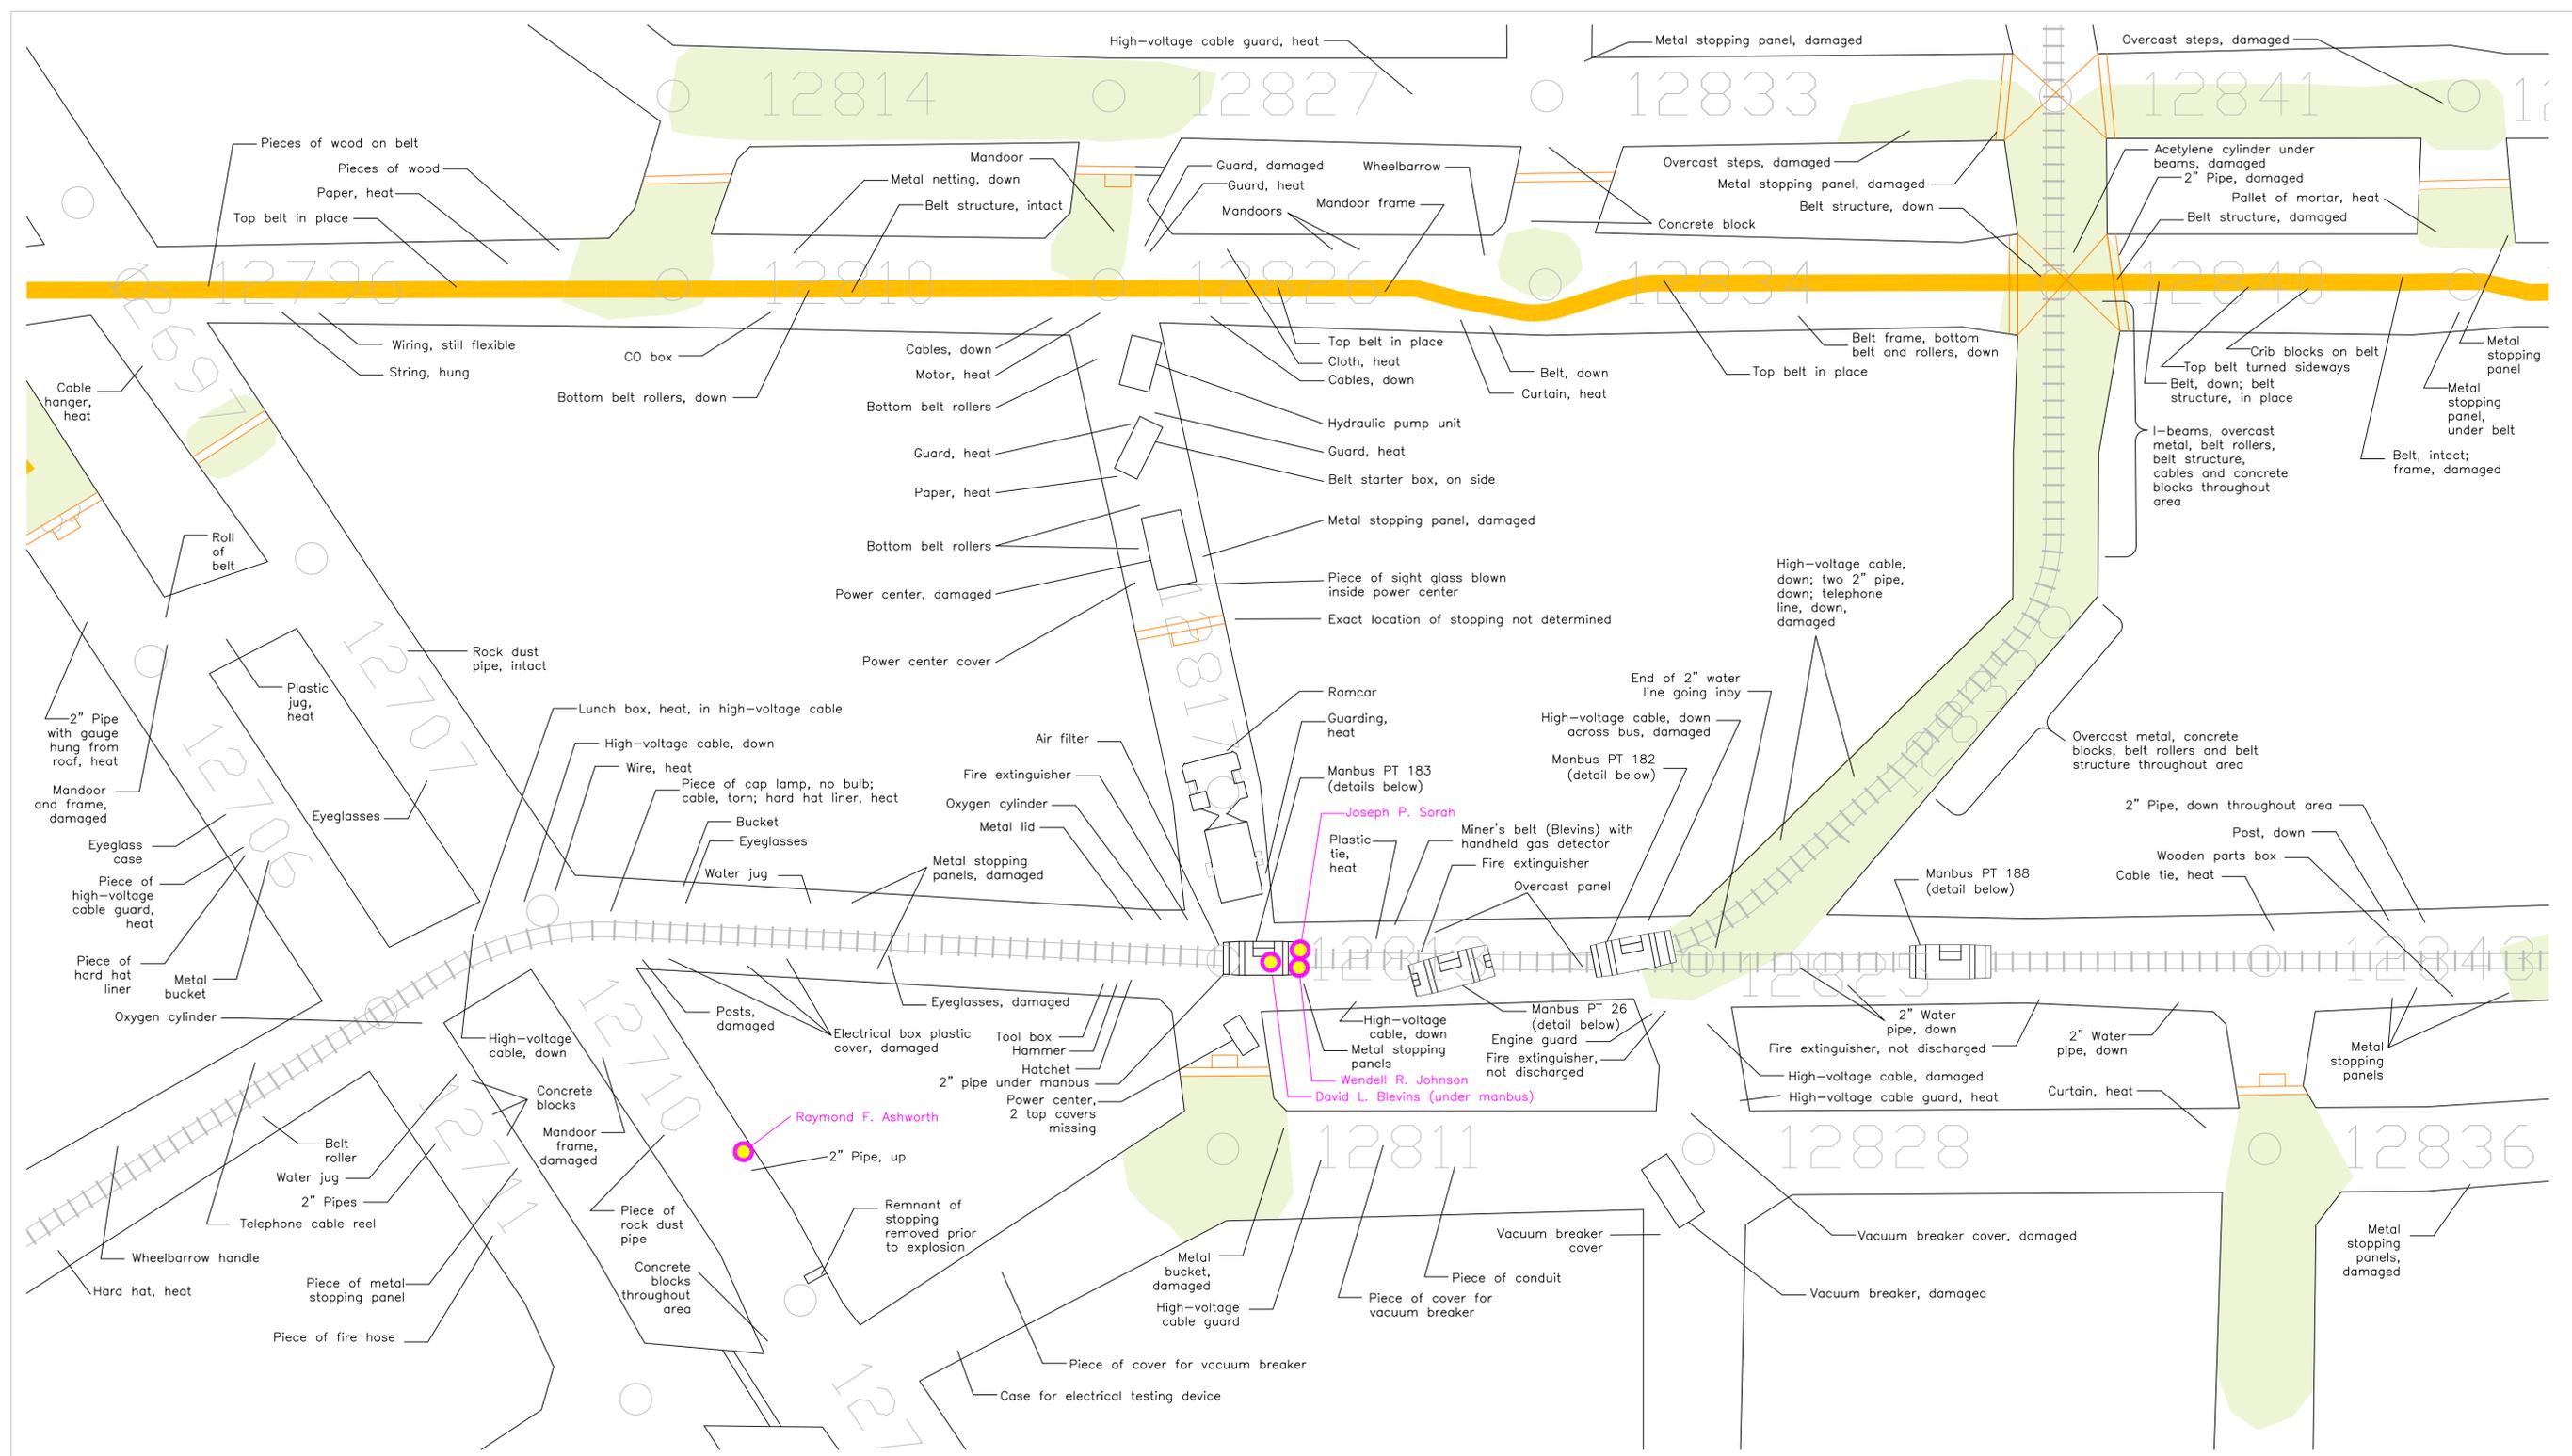
APPENDIX O
 MINE MAP
 No. 5 MINE, MSHA ID No. 01-01322
 JIM WALTER RESOURCES, Inc.
 Affected Area of Mine -
 Detail of Area Surrounding
 4 Section Switch

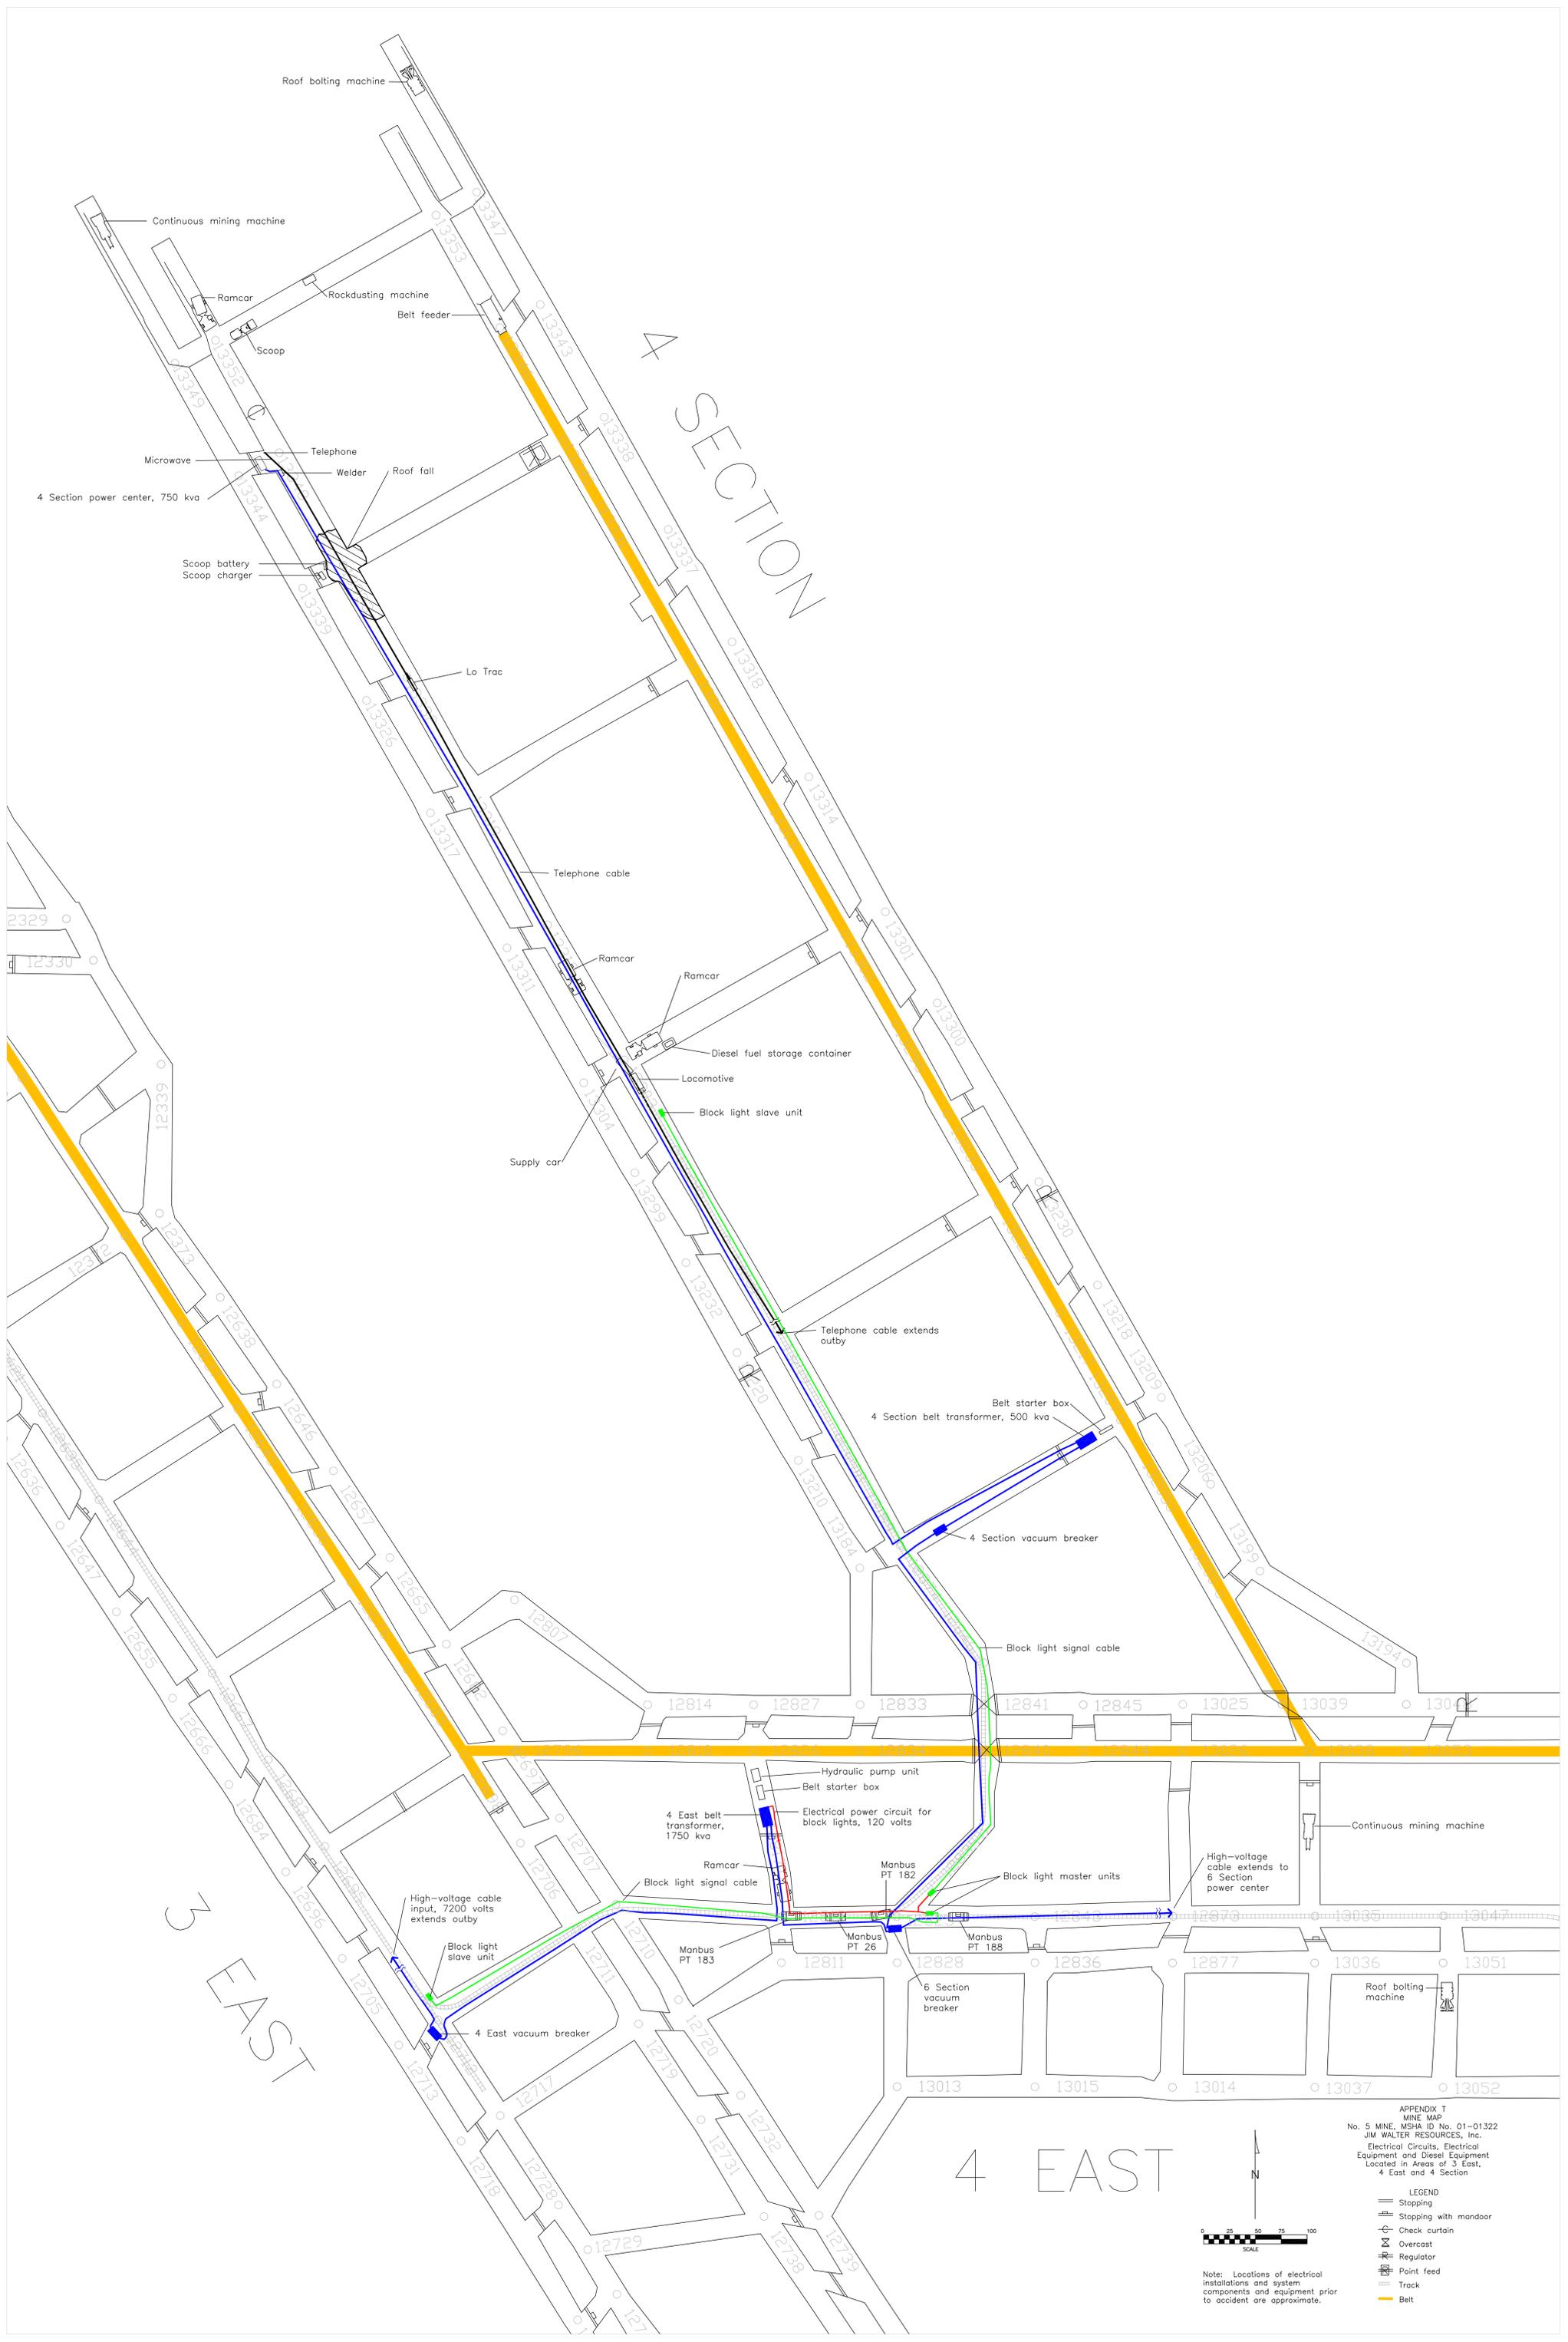
Roof bolting machine

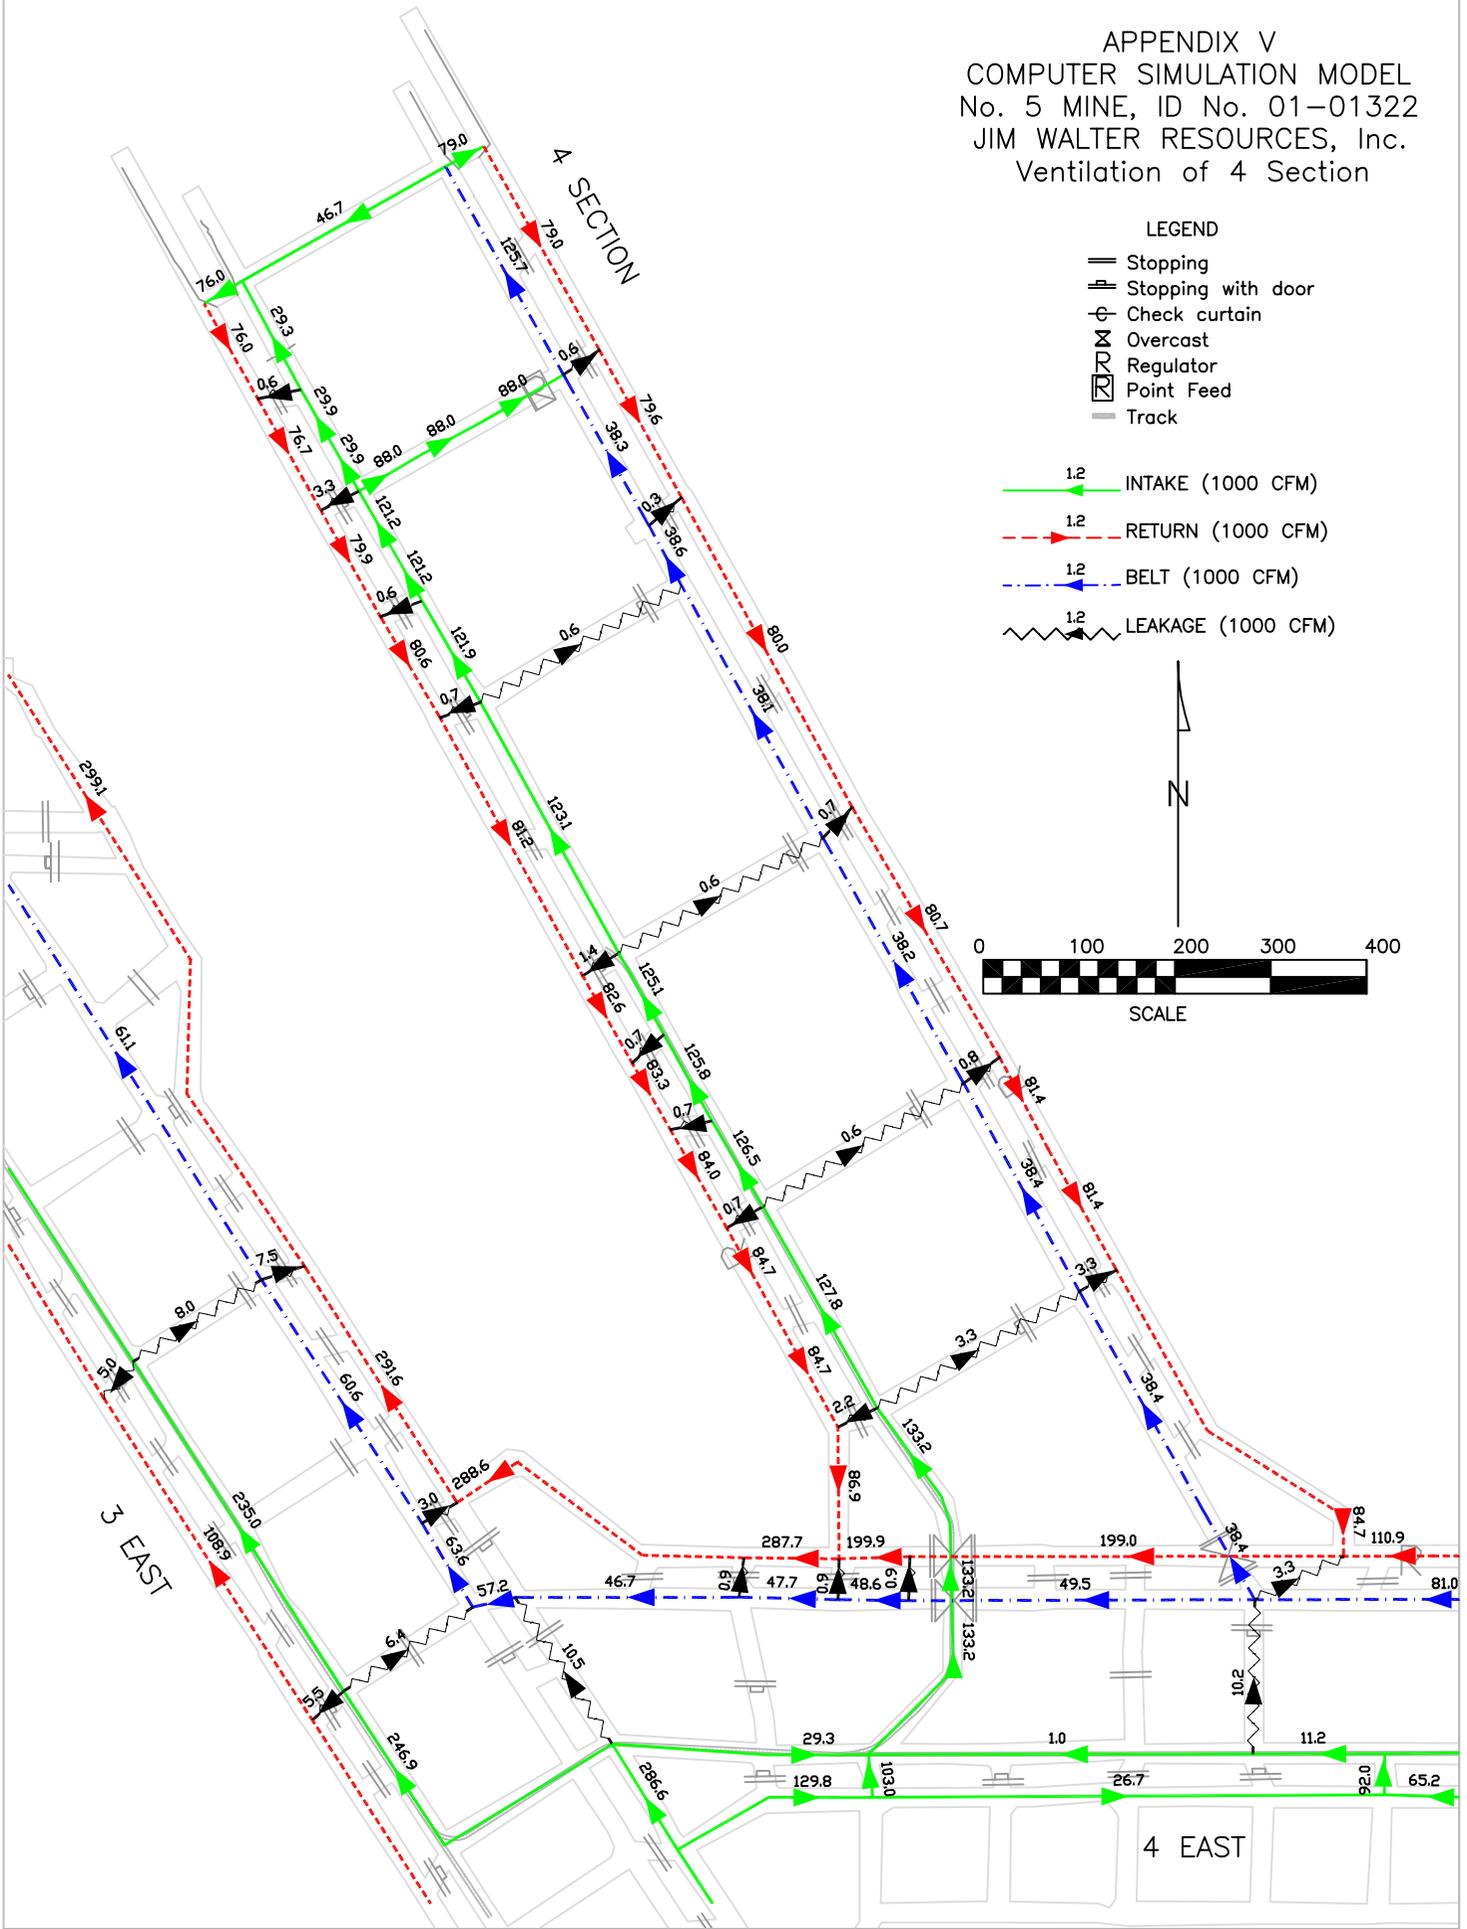
APPENDIX X
 COMPUTER SIMULATION
 No. 5 MINE, ID No. 01-01322
 JIM WALTER RESOURCES, Inc.
 Ventilation of 4 Section After
 First Explosion

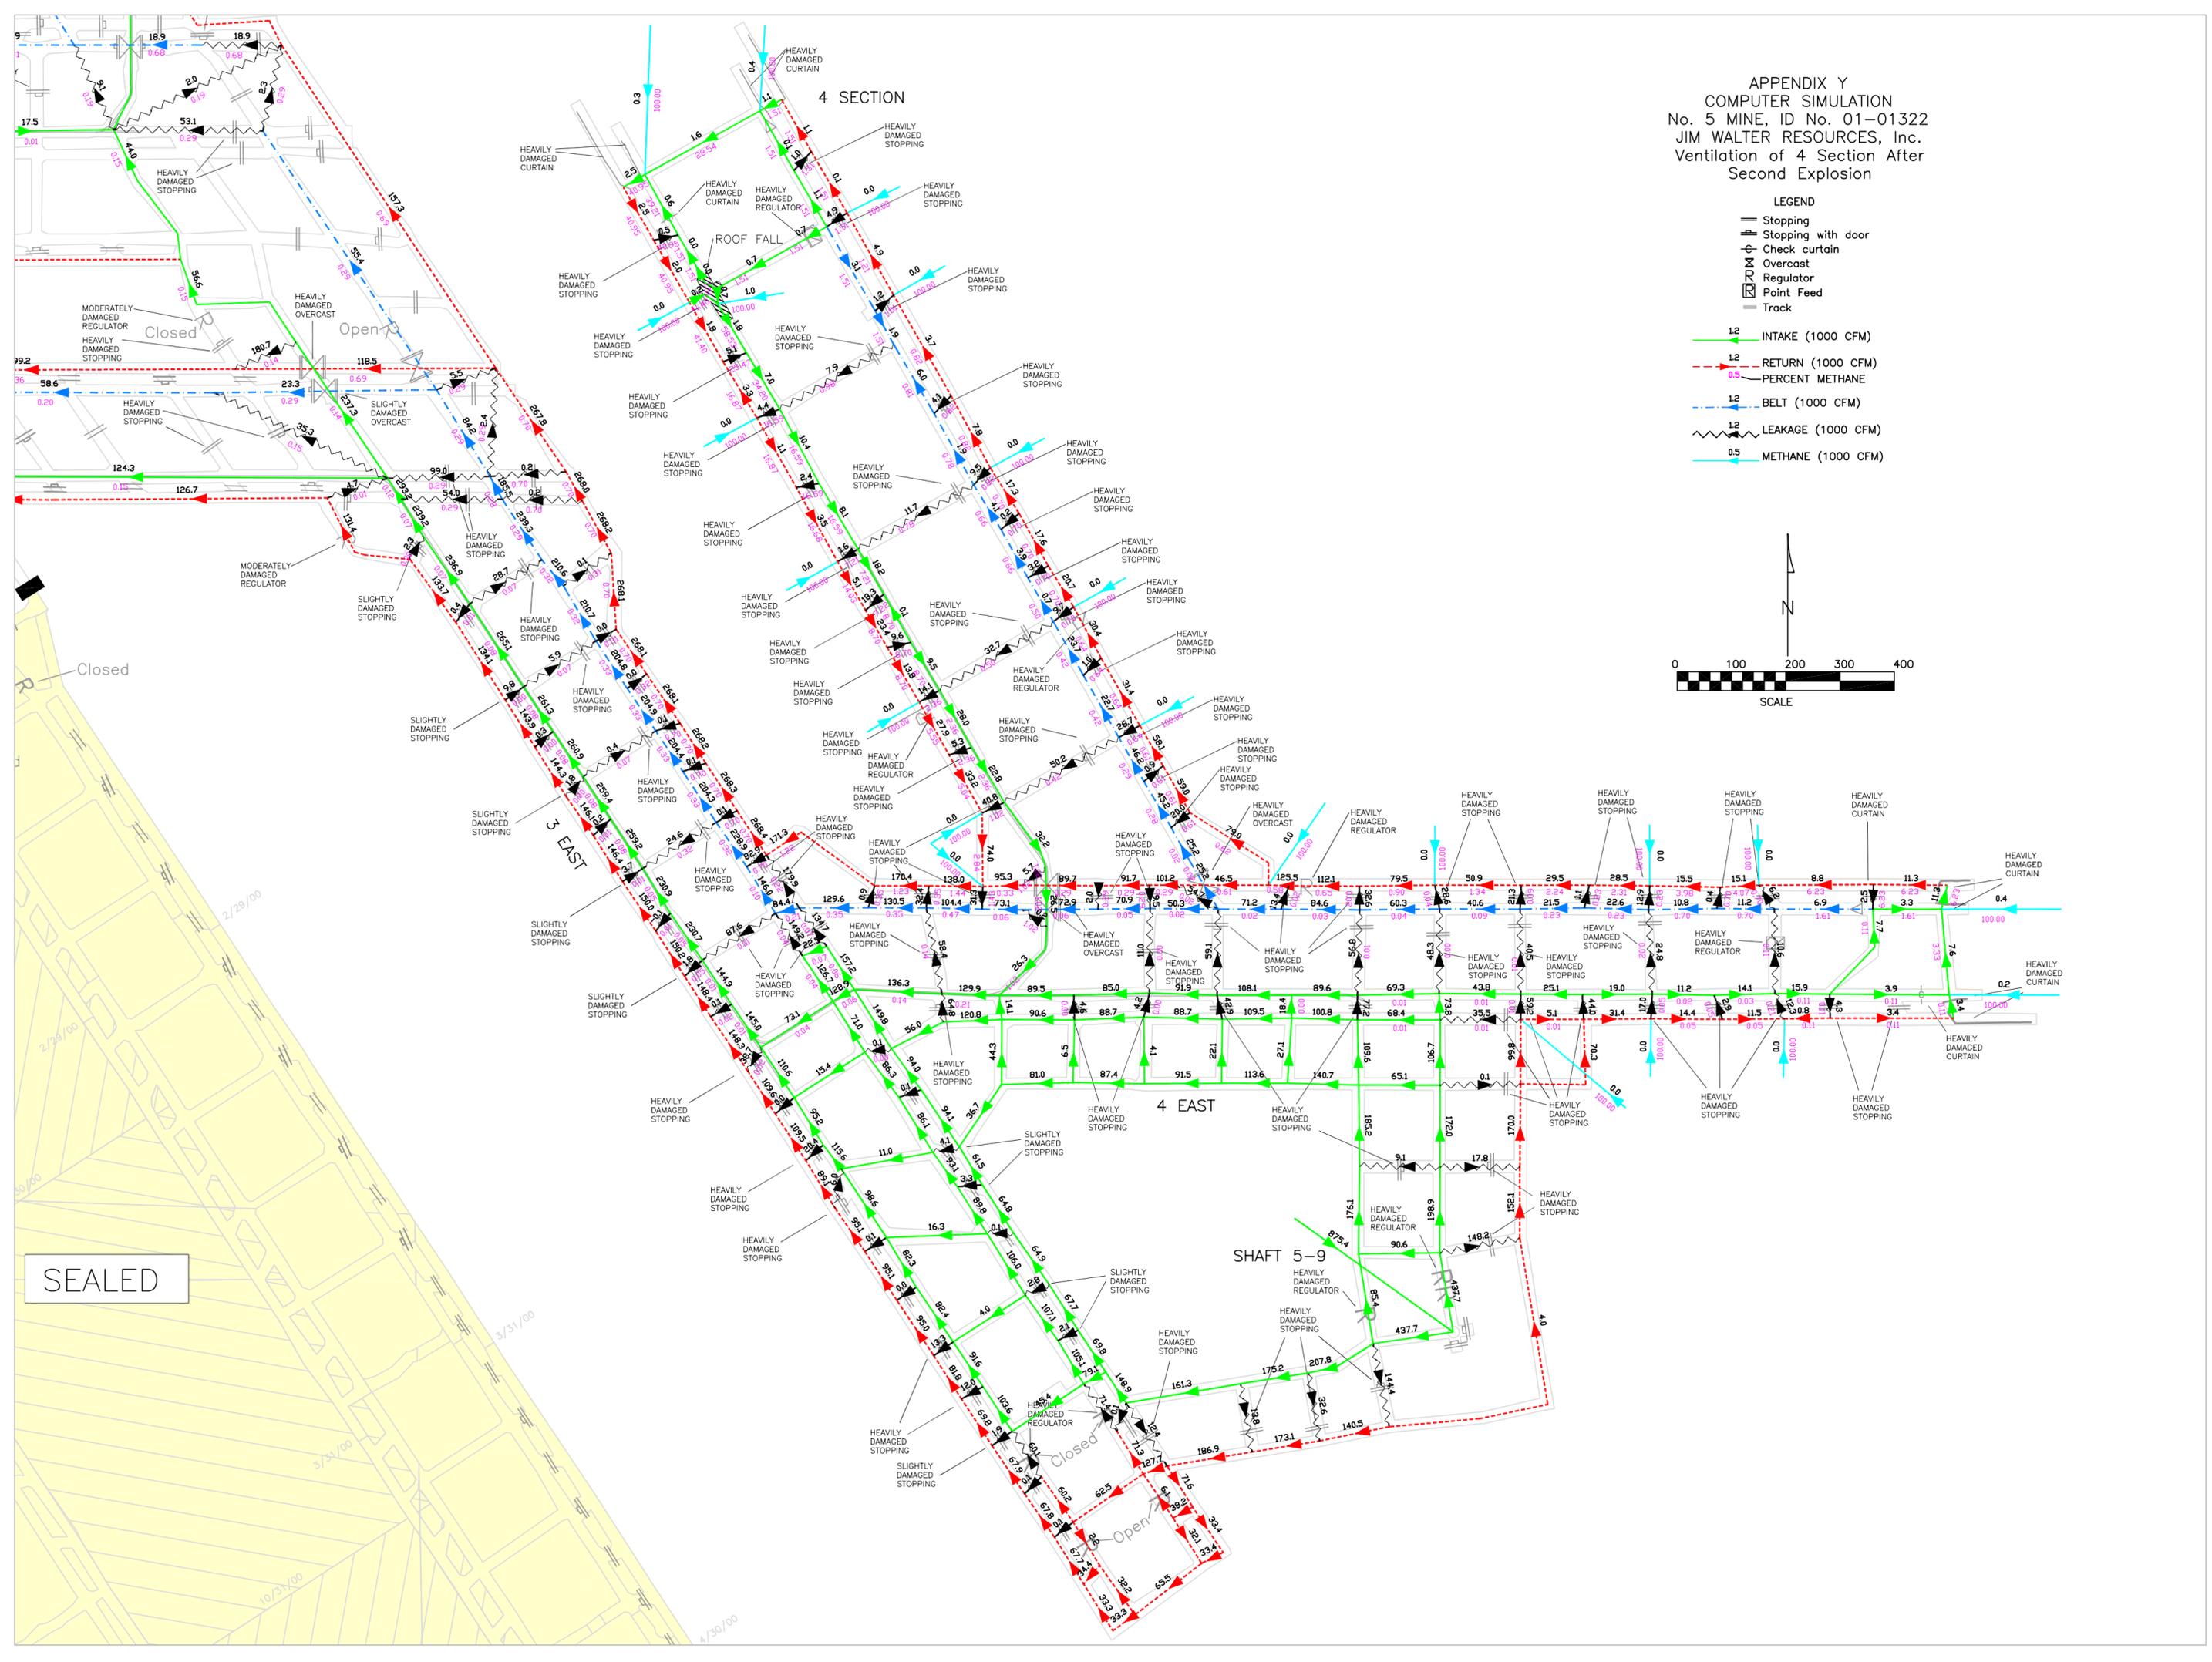
Appendix Z - Fan Shaft 5-7 Fan Pressure Recording Charts

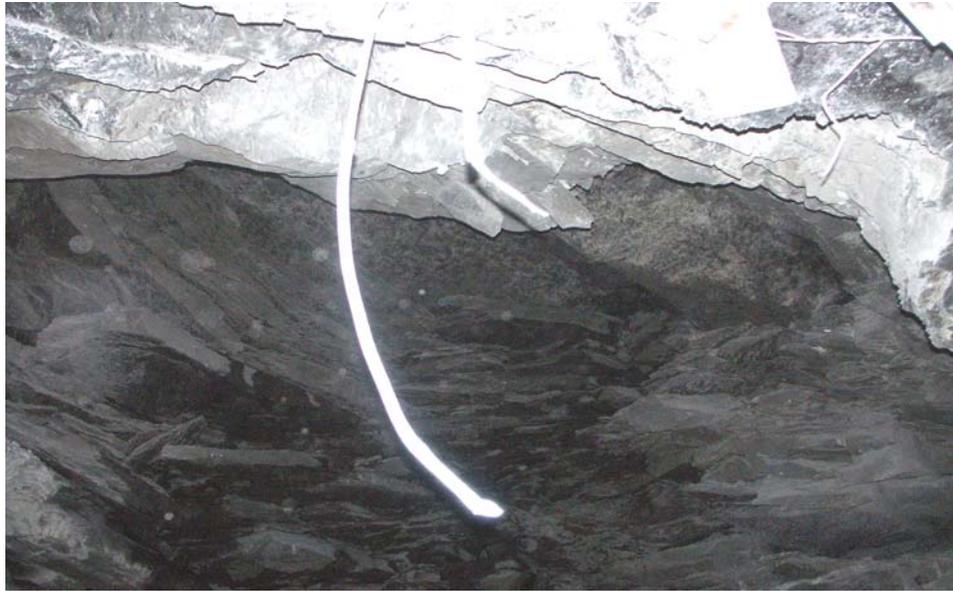
View of rock fall in No. 2 Entry of 4 Section showing broken cable roof bolt.

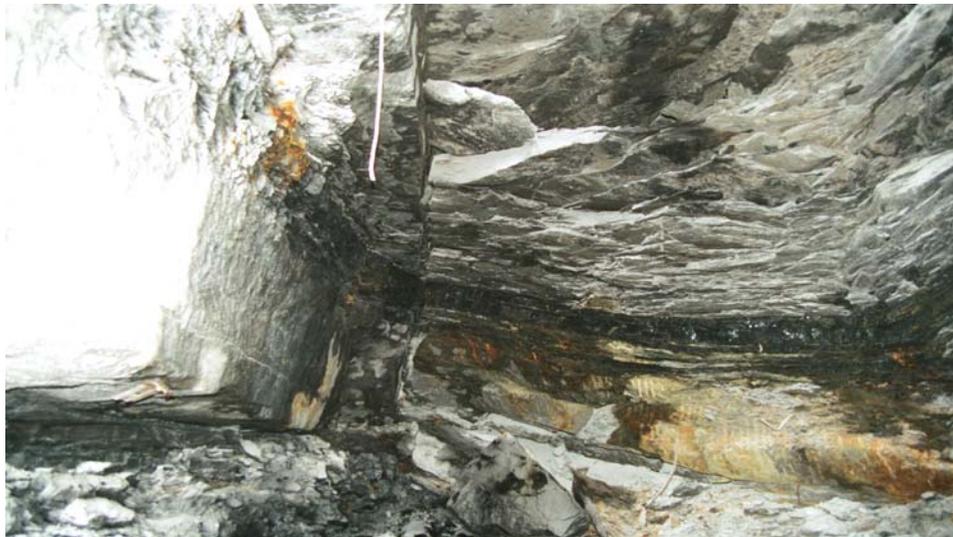
View of rock fall in No. 2 Entry of 4 Section showing the Mary Lee coal seam in the mine roof.

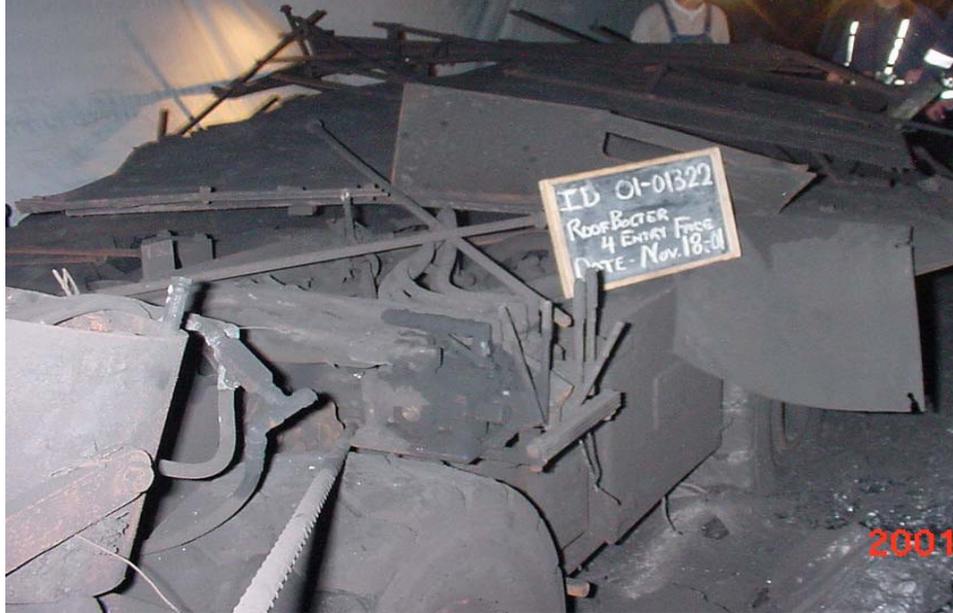
Face of No. 4 Entry showing damage from forces at roof bolting machine in 4 Section.

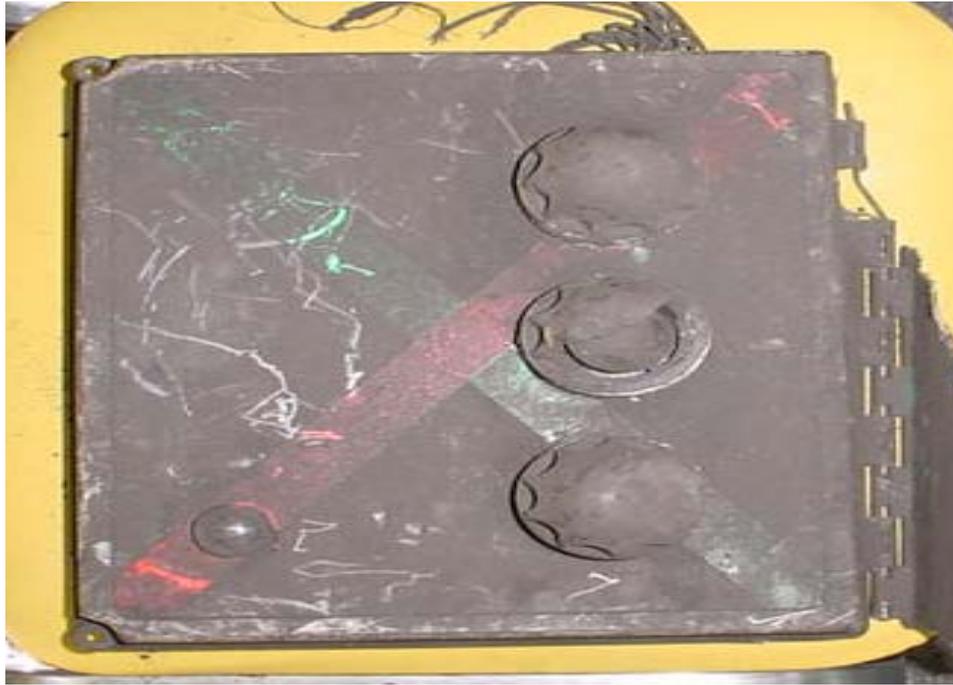
No. 4 Section track entry block light showing front of block light.
