UNITED STATES
DEPARTMENT OF LABOR
MINE SAFETY AND HEALTH ADMINISTRATION
COAL MINE SAFETY AND HEALTH

CAI-2001-20 through 32

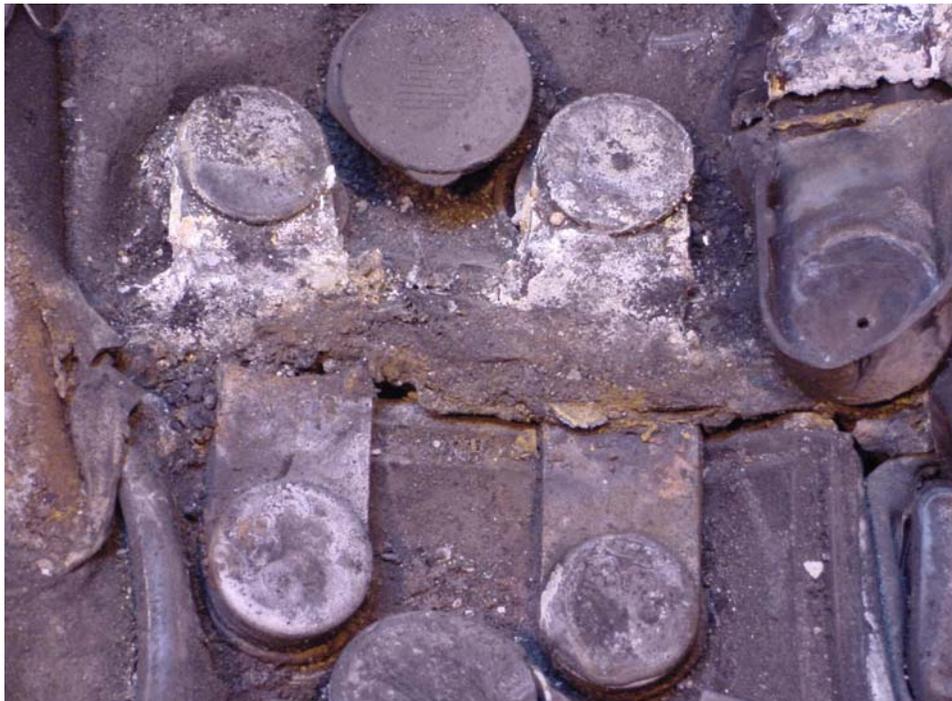
Scoop battery from under rock fall on 4 Section showing terminal damage.
