TOTAL FINA ELF

SAFETY FEEDBACK NOTICE 16-2002

THE HAZARDS OF PRESSURE TESTING

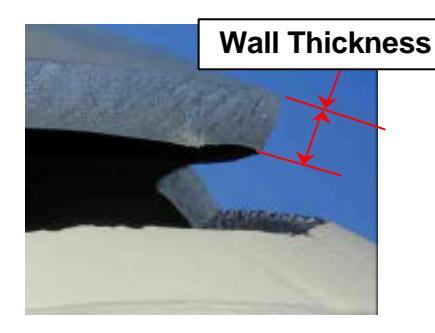
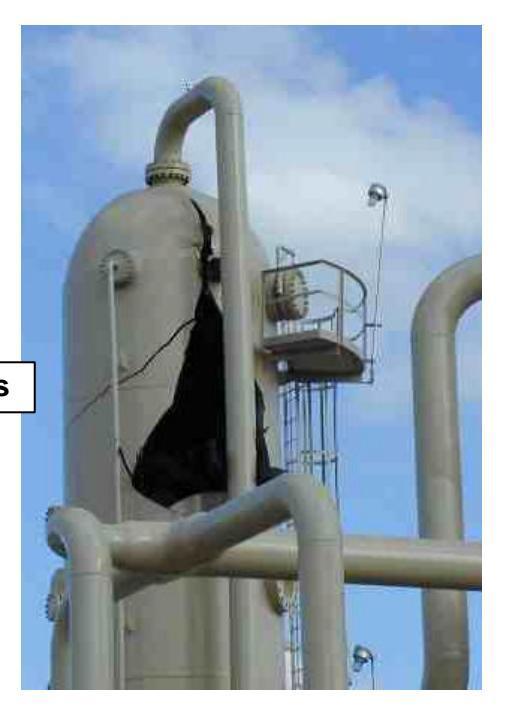
<u>1.</u> Hydro-test of a new vertical vessel

The root cause of the incident is not fully known but there was some thought that hydrotesting with "very cold" water was a contributing factor.

Fortunately no injuries occurred.

1st **incident** : Water temperature is critical when hydro testing. TFE specification (GS PVV 211) states that both metal and water temperature during pressure testing shall be maintained at least at 16°C or at least 10°C above the impact test temperature of the metal.

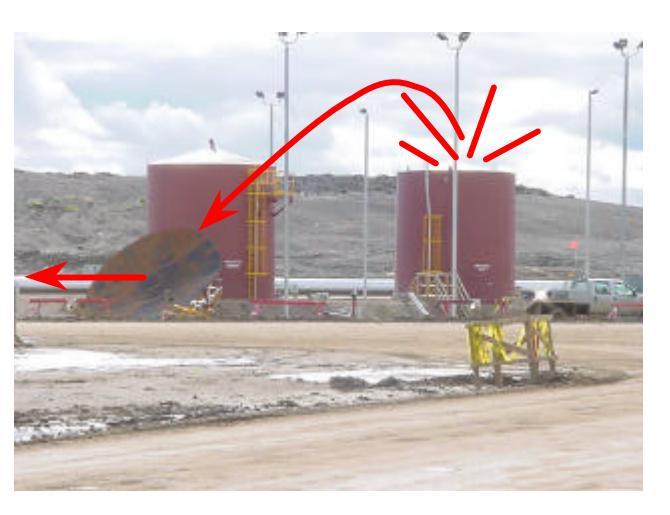
2. Filling of a vertical tank

The filling of the tank was made with water from a fire hydrant.

The top of tank blew off because the relief valve could not displace the air fast enough for the volume of water that was being pumped in.

Fortunately no injury happened, but an operator was on

top of the tank a few seconds before.

2nd and 3rd incidents : venting systems shall be inspected and checked before filling and emptying operations.

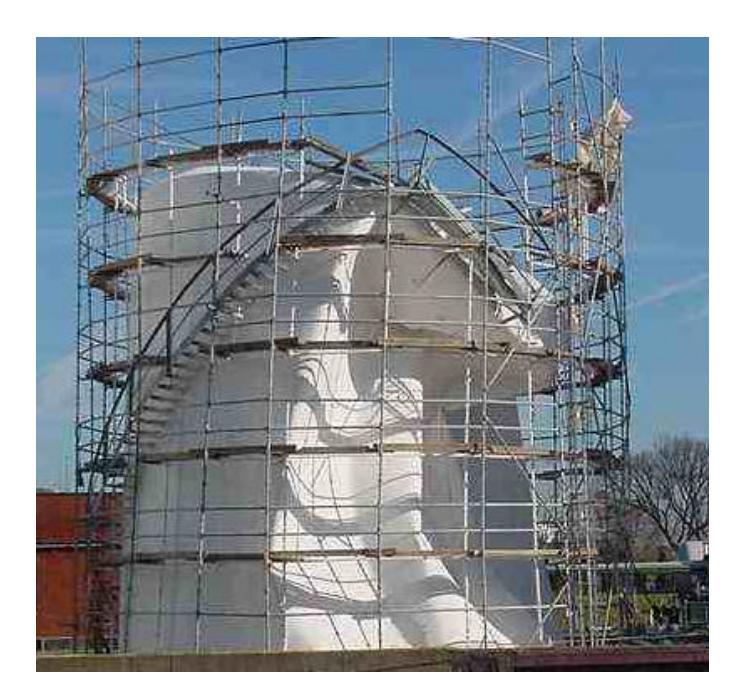
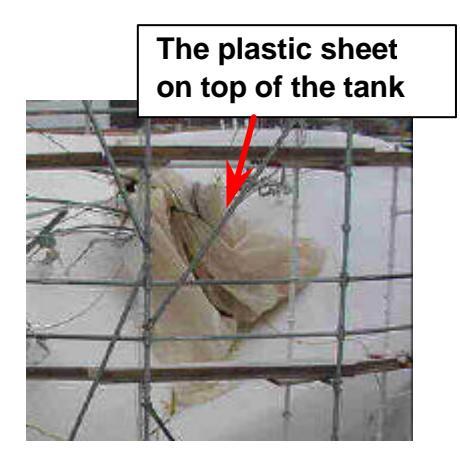
3. Emptying of a vertical tank

The collapse of this tank happened while it was being emptied. A plastic sheet protecting the

roof was trapped in the vent; hence a vacuum was caused.

There was no injury. It should be noted that this type of incident is not that unusual.

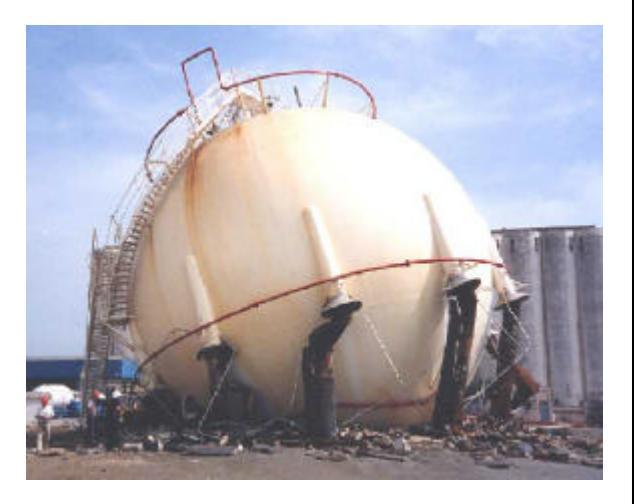
4. Sphere collapse

The accident happened during the filling of a 2000 m³ LPG sphere. Its legs collapsed. **One person was killed and one seriously** injured.

At the time of the accident, the sphere was approximately 80% full of fresh water.

The vessels last hydro-test was 10 years ago and the last inspection of its legs was 5 years ago.

Severe corrosion of the legs under the concrete fire protection was the main cause. The corrosion occurred due to water ingress between the concrete and the steel legs.

The water protective cap located over the concrete was not sufficient to keep the water out. After the accident, it was verified that the steel legs had thickness reductions of up to 8mm, with pitting holes of up to 10cm².

Water caps over the fire-proofing concrete were of poor design thereby letting water penetrate between the steel beams and the concrete.

- Vertical cracks in the concrete let water in.
- Repairs had been done to the concrete, but with poor workmanship.
- The new concrete had not adhered to the old concrete, again letting water in.
- The deluge system had been tested with salt water, increasing the possibility of corrosion.

4th **incident** : Is a maintenance problem ? Before testing an old vessel, a complete inspection must be performed visually and with NDT. This inspection shall include the vessel, nozzles, appurtenances, and supporting structures.

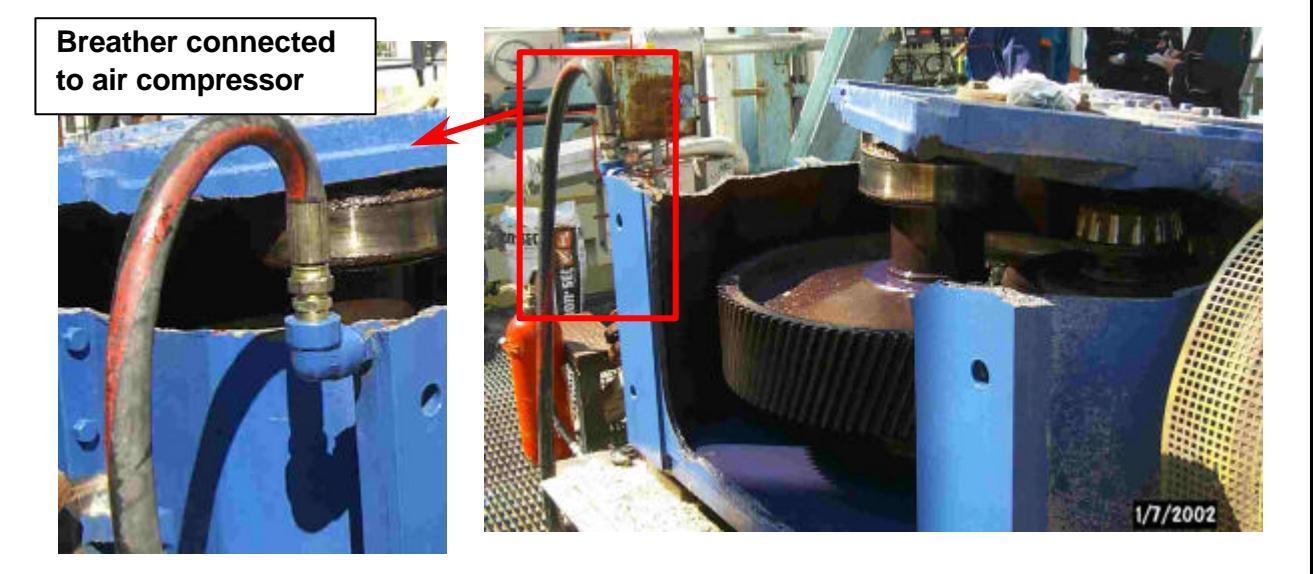
5. Emptying of a gear box

To speed up the removal of 250l of oil from a gear-box, the gauge hole was plugged and the breather was connected to the 6 bar air network.

The gear box exploded, and threw missiles around seriously damaging surrounding piping and structure. Fortunately there was no injury.

5th **incident :** obviously a gear-box is not a pressure vessel, but productivity may lead to a risky attitude.
