Safety Alert

ALERT 09 – 10

DAMAGED ELECTRIC CORD RESULTS IN WELDER ELECTROCUTION

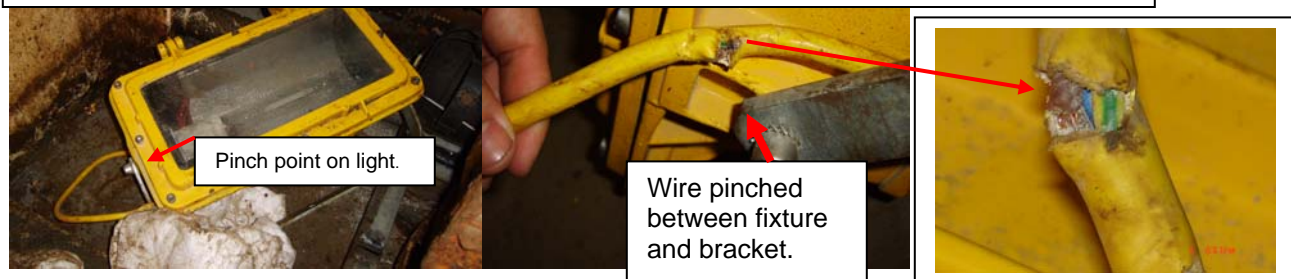
Fig. 1. 220 Volt floodlight with cord that had been pinched between the lamp fixture and the mounting bracket while it was being positioned by welder 1 for the job.

1. During the investigation it was discovered that the power cord was pinched and partially cut between the light fixture and the bracket. (See Figure 1 above.)

2. Based on the observation of Welder 2 that Welder 1 was leaning against the floodlight, it was concluded that Welder 1 made contact with the exposed wires and / or the fixture's metal frame.

3. The deceased contacted electrical current from the 220 V power cord of the floodlight.
4. The floodlight was designed for a fixed installation and not suitable for use as a portable light.

5. The rig has a floating 220 V system ("delta based" - 2 conductors and no common "ground" system); if only one conductor is cut, the other conductor remains "hot" and will not trip the 10 amp breaker. More guidance will be published by Asset Manager and Engineering on Ground Fault Circuit Interrupters and related electrical safety issues.

1. Instructed rig personnel to conduct "Hazard Hunt" of entire rig fleet with emphasis on portable lights / electric cords / power tools. Ensure all portable electric equipment is registered and inspected, looking at the entire "system", not only the electrical parts. Chief Electrician to schedule periodic Hazard Hunt of portable electric equipment, using other Heads-Of-the Departments (HOD) to assist

4. Procure low-voltage / pneumatic lights for portable requirements.
5. Investigate use of Ground Fault Interrupter (GFI) devices to work with portable electric equipment.

8. Use only low voltage lighting—especially in confined spaces.
9. All tools (Company's, contractors and third party) are to be inspected and tested prior to use.

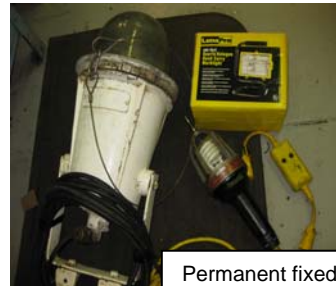
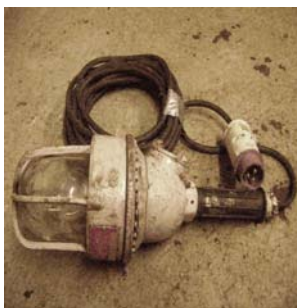
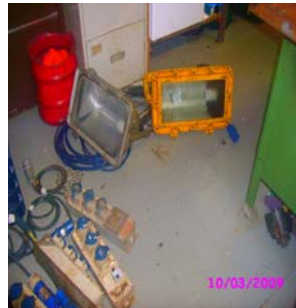
10. **Instructed operations personnel that all the below lights have metallic cases or enclosures and are prohibited as Portable Lighting**

Permanent fixed light not to be used as portable.

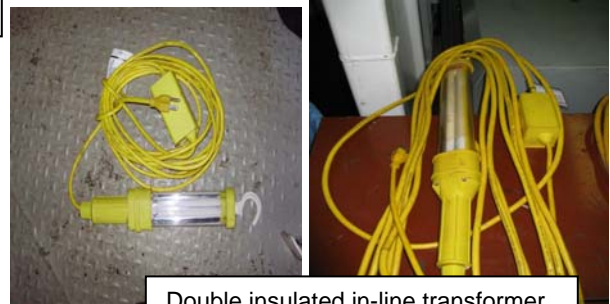
ACCEPTABLE *PORTABLE* LIGHTING

All have plastic enclosure (except air-powered unit)

Battery Powered

Double insulated in-line transformer.

1. **Primary Preferred Method: Air-driven**
2. **Secondary Preferred Method: Battery-operated**
3. **Approved (NOT preferred): Low-voltage (50 Volt AC and below) with in-line transformer**
4. **LAST RESORT (must be approved by Rig Manager / Electrical Supervisor prior to use): High-voltage (above 50Vac) must be rated for portable service as well as double insulated**
