# ACCIDENT ALERT

Recently, a miner was seriously injured when he opened a filter backflush valve for a longwall shield hydraulic system. The discharge end of the backflush hose was installed through a hole in the stageloader cover plate without being securely fastened. When the miner opened the valve, the discharge end of the hose whipped out of the hole in the cover plate and struck the miner in the face.

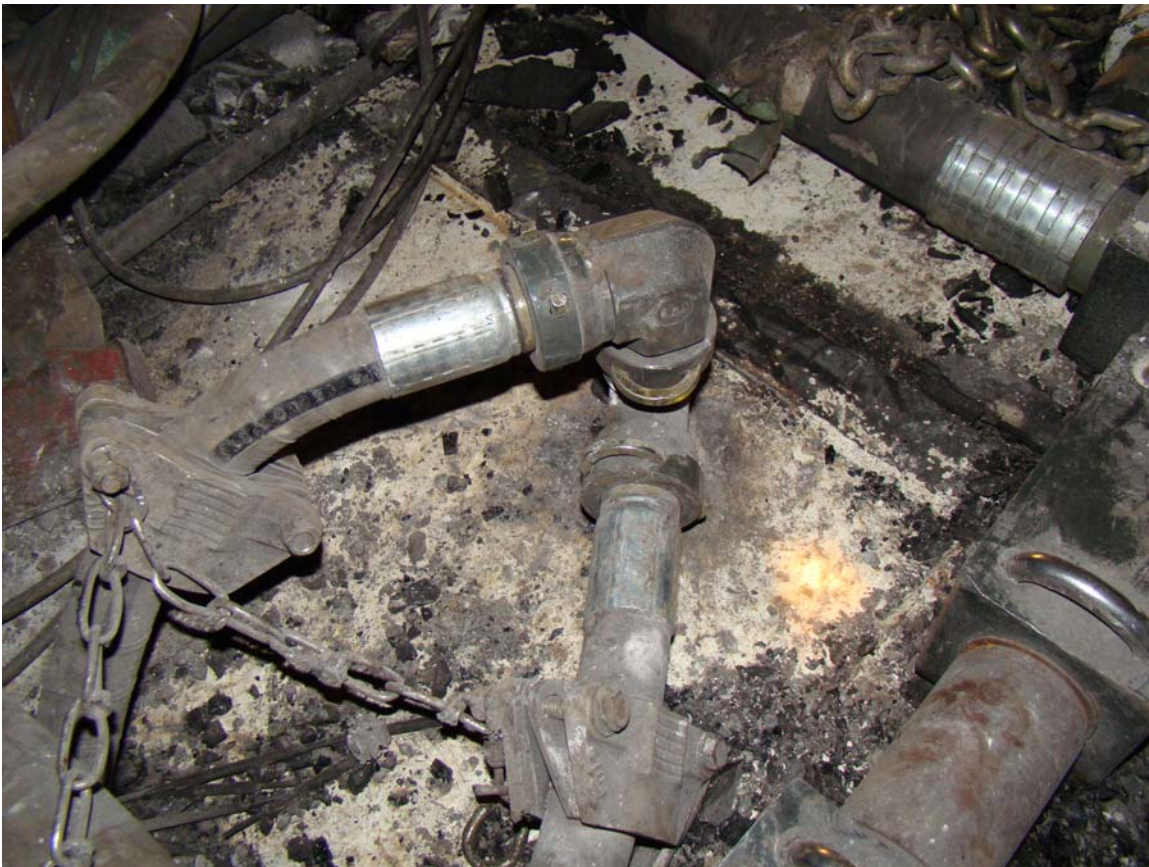
The photograph below shows the corrective action implemented by the mine operator to prevent a similar occurrence.

- Properly secure **each** side of the connection point in a **substantial** manner in the event of fitting failure or rupture.  
Ask yourself, "**If this line breaks am I protected?**"
- Inventory all hydraulic hoses to ensure the discharge ends are secured.
- Consider the installation of whip checks as an added measure of safety.
- Open valves slowly to minimize surge pressure.
