## Health & Safety Alert

Contractor:	Activity
Contractor Iron Workers	Erection of Scrubber Structure

### ***Preliminary Report - Subject to change upon further investigation***

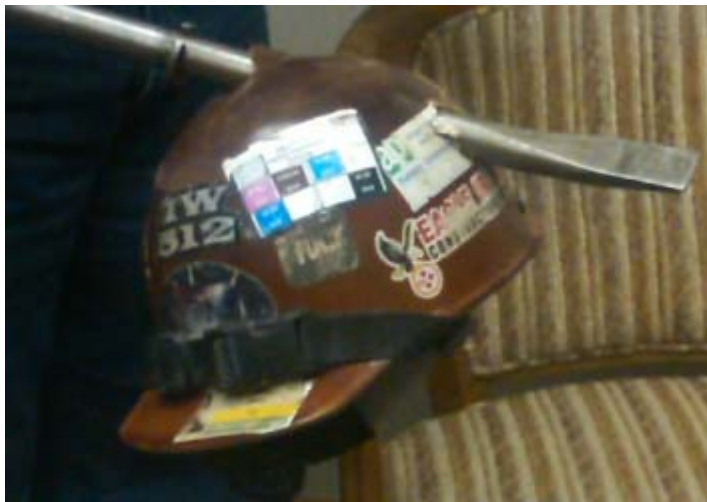
### Photograph:

As the co-worker was maneuvering the basket of the aerial lift, and properly tied off, his safety lanyard got caught on his tools (attached to his tool belt) and flipped the slever bar sideways in its sheath – causing the bar to flip out and fall. The bar fell and struck the hard hat of the employee below – piercing through the hard hat as depicted in the attached photo. The hard hat fell off the employee, and fell an additional distance to the ground below. The employee was not injured.

1. An immediate safety stand down with the crew to discuss the incident and implement a number of the corrective actions listed.
2. Vendors who manufacture slever bar holders and other such tool holders will be contacted to discuss design changes to prevent tools from being dislodged from holders.
3. Only tools essential to complete assigned tasks will be carried in tool belts.
4. Given the potential for slever bars, spud wrenches, etc to become dislodged from their holders, if any unprotected overhead work requires use of such tools, employees will not be present below unless a protective deck or safety net system is installed.

5. All employees have been instructed on the importance of full communications and heightened safety awareness when working in areas where overhead fall object hazards exist.
6. Met with [REDACTED] Safety Department to discuss the incident and get input for corrective actions and a joint effort to address this safety concern among contractors and company employee activities.

- [REDACTED]
1. Communicate an initial Tool Box Safety Discussion for all its employees on the importance of PPR – hard hats in particular.
  2. Communicate an expanded Tool Box Safety Discussion to the same employees relative to PPE, tiered work, and potential for dropping tools – whether it be from tool holders, other structures such as EOT Cranes, Aerial lifts, etc., - with a strong reminder that all loose tools must be managed and secured properly.
  3. Communicate this event and corrective actions to other contractor firms supporting [REDACTED]
  4. Seek feedback via this communication from other business units across [REDACTED] operations relative to best practices.
