PRODUCT NOTICE — SNAPHOOKS

Capital Safety is aware of an assembly issue with snaphooks manufactured by a supplier. These snaphooks are widely used components in fall protection products. The issue concerns missing or improperly installed rivets (see photograph below). The manufacturer symbol is a stamped “Y” as shown in the photograph.

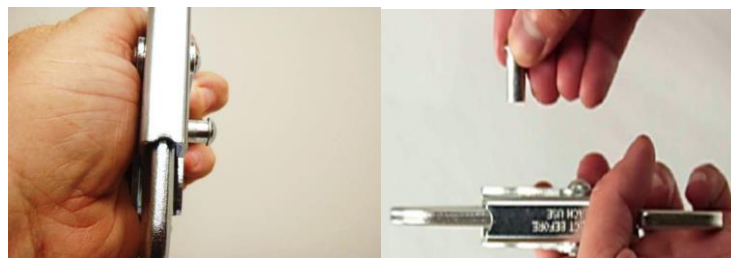
Figure 1: Loose rivet may protrude from hook.

Figure 2: Loose rivet can separate from hook.

We want to remind users to conduct a pre-use inspection of all fall protection safety equipment prior to use as per instructions in the user manuals. If a missing or incompletely installed rivet is identified in a snaphook on a Capital Safety product, the product should be removed from service and returned via distribution for replacement under warranty. (See figure 1 & 2 below.)
