COAL MINE - PERMANENTLY DISABLING ACCIDENT On July 11, 2009, a Longwall Trainee Supervisor received crushing injuries to his foot that resulted in the amputation of his leg below the knee. The supervisor was located at the 140 shield when a shield puller informed him and another miner at the 141 shield that he was going to advance a bank of five shields, which included the 140 and 141 shields. As the shields advanced, the shield relay bar, which connects the shield to the face conveyor, trapped the supervisor's right foot. The shield base or pontoon advanced into his foot and crushed his heel. The shield puller saw that the shield was advancing on the supervisor and activated the emergency stop. The shield was then depressurized to free the supervisor's foot. The miner on shield 141 had positioned himself on the pontoon and was not injured.

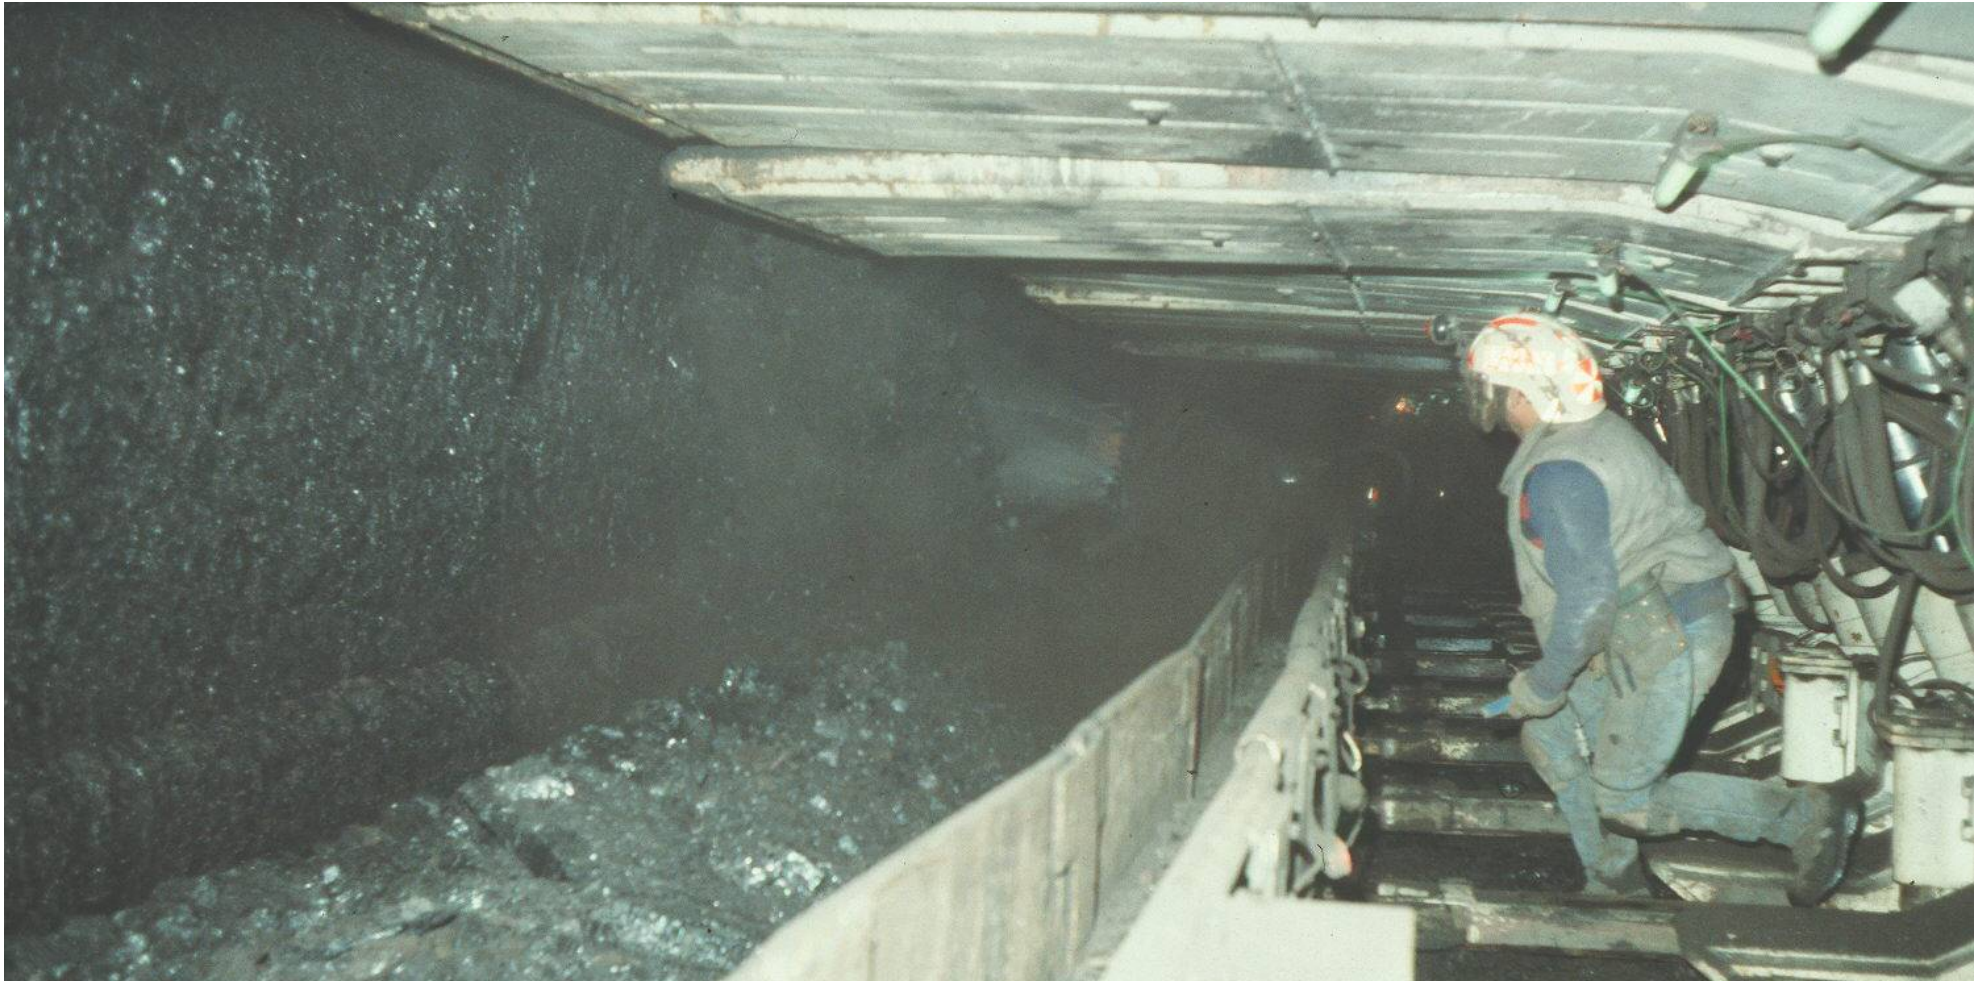
Photo is not of accident site

- Be aware of your surroundings and potential pinch points.
- Do not position yourself in the area of the pan line as a shield or a batch of shields is advanced. Instead, position yourself to one side of an advancing shield or batch of shields.
- Take extra care when communicating safety issues with new and/or inexperienced miners.
- Communicate actions to personnel clearly, so they are aware of and understand the hazards involved.
