# Highwall Hazards

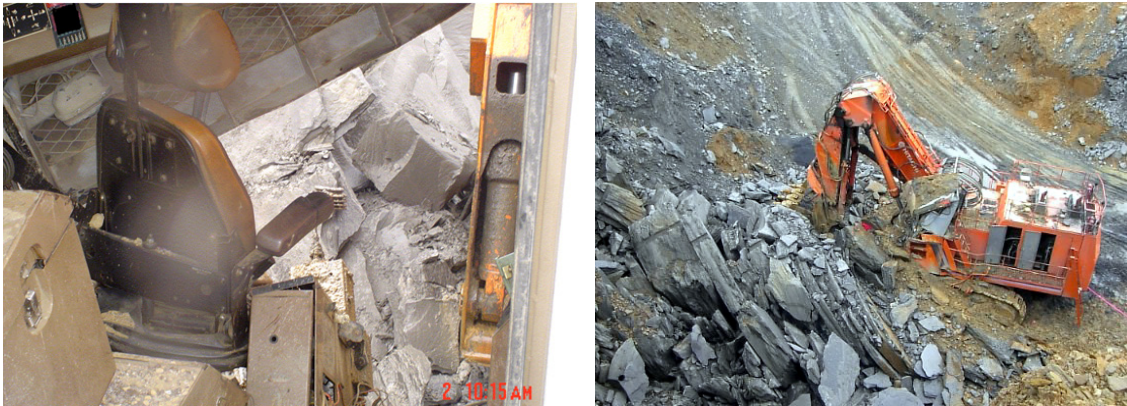
On August 30, 2003 a mobile equipment operator was injured while working at a surface coal mine. The miner was operating a Hitachi hydraulic shovel when a 35-foot wide by 35-foot high section of the highwall toppled onto the operator's cab, pinning him inside. The victim was removed from the shovel and transported to a hospital where he was treated and released.

The left image, below, shows the inside of the operator's cab after the accident. The front of the operator's cab is completely missing and the roof is caved in over the operator's seat.

- Train all employees in highwall hazard recognition.
- Conduct examinations prior to beginning work around highwalls, and as frequent as necessary to ensure safety, especially during periods of changing weather conditions. Inspect the top and bottom of the highwall for cracking, spalling, sloughage, loose ground, and large rocks that could be hazardous.
- Communicate changes in mining methods or blasting issues to oncoming shifts.
- Ensure loose material is scaled prior to performing work. To safely scale using the shovel, maintain the highwall height within the reach of the bucket.
- Position the shovel and trucks so that the shovel cab swings away from the highwall when loading.
