# SAFETY ALERT

## Stockpile Collapses on Loader Driver

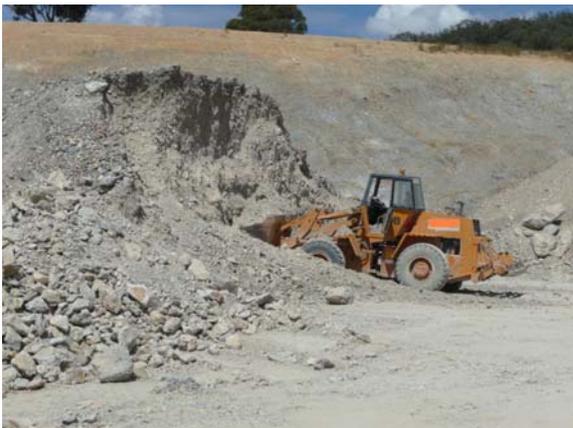
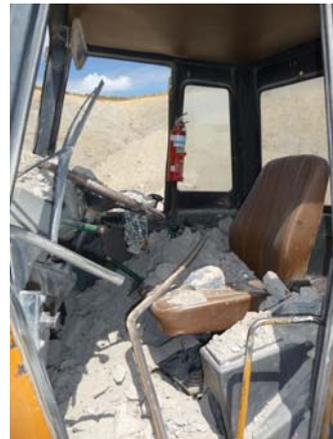
A 17 year old trainee front end loader driver suffered deep lacerations to the left forearm when the face of a stockpile he was loading, collapsed and crashed through the front windscreen. Material from the stockpile, consisting of shale and gravel, partly filled the loader cabin.

Material from the stockpile, approximately 6m in height, was being loaded to fill a nearby screen. The trainee front end loader driver, who was working alone at the time, was loading from the edges of the stockpile at first and then decided to remove material from the vertical face of the stockpile. The stockpile collapsed and material crashed through the front window injuring the trainee. The trainee then ran to a nearby property approximately 400m away to seek attention and call an ambulance.

After investigation, there were several contributing factors that came to light. These included:

- The trainee had been operating loaders for less than a week. The log book contained two entries that involved operating the loader.

- There was no supervision at the time of the incident. The production manager was off site at the time of the incident.
- An excavator, that was used to manage the stockpiles to a workable height, was offsite having repairs done at the time of the incident.
- The trainee, although inducted into the mine site, did not understand the hazards associated with stockpiles.
- The workplace inspection checklist did not include hazards associated with stockpiles.
- There was no formal training program in place for trainee plant operators.
- Emergency procedures failed to work as planned.

- Trainee workers must be supervised at all times until they are deemed competent for the task.
- Stockpile heights need to be managed according to the nature of the stockpile material. Where the stockpile material is likely to “hang-up”, an excavator or dozer should be used to break-up the stockpile face to ensure it is safe to load.
- There is a need to include stockpile hazards on a workplace inspection checklist and undertake the inspection at appropriate intervals.
- Responsibilities for supervisors or production managers need to be clearly defined and include the supervision of trainees.
- Emergency procedures should be reviewed regularly to ensure they are appropriate. Consider conducting an emergency drill to ensure the emergency response will go to plan.
