# FATAL CRANE INCIDENT 22<sup>nd</sup> October 2007

Germano Construction Site Brazil

## LESSONS LEARNED

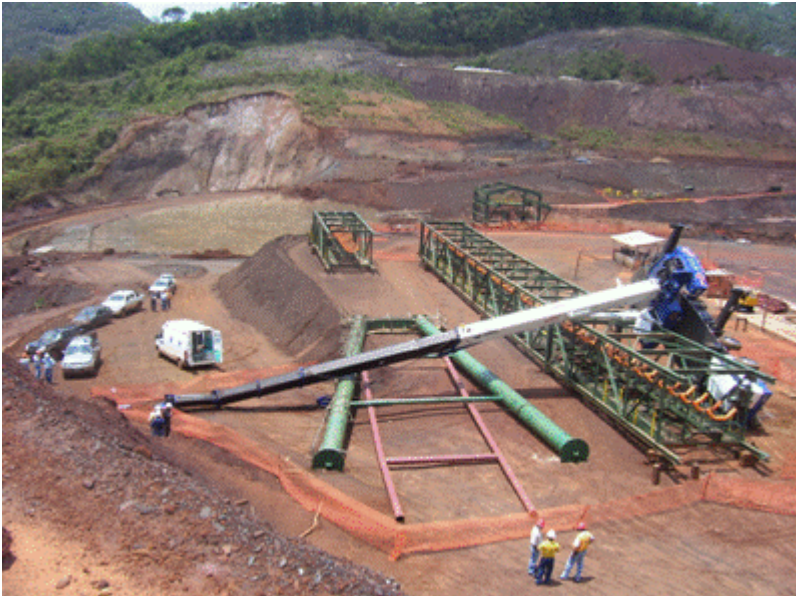
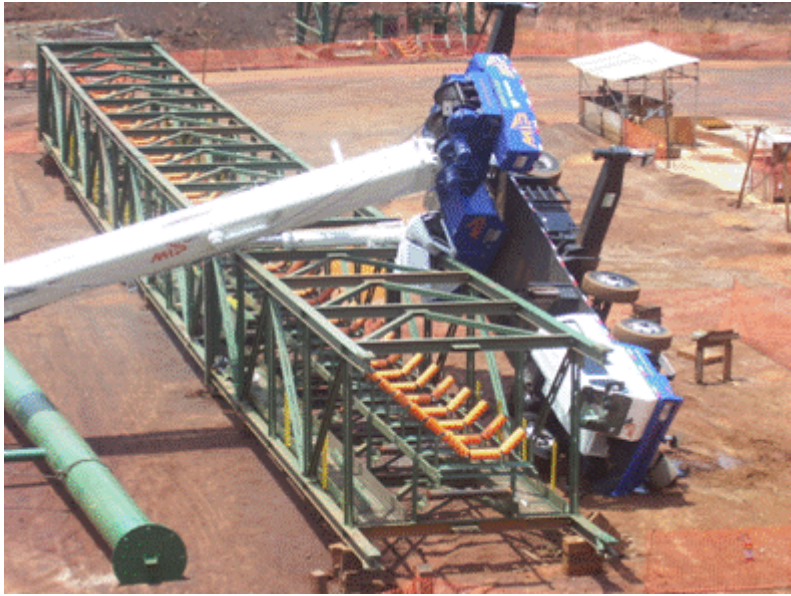
**Crane falls over onto its side with the head of the boom resting on the ground, the middle of the boom resting on the conveyor gallery and the cab crushed against the conveyor gallery.**

- **The crane was out of radius for its set up and the weight of the load;**
- **The automatic safety interlocks for the crane operation were immobilised at the key outside of the operators cab and the crane operator deliberately overrode the crane limits from the manual switch in the cabin.**
- **There was no Rigging Plan in place for the lift;**
- **Wrong crane used for the lifting task;**

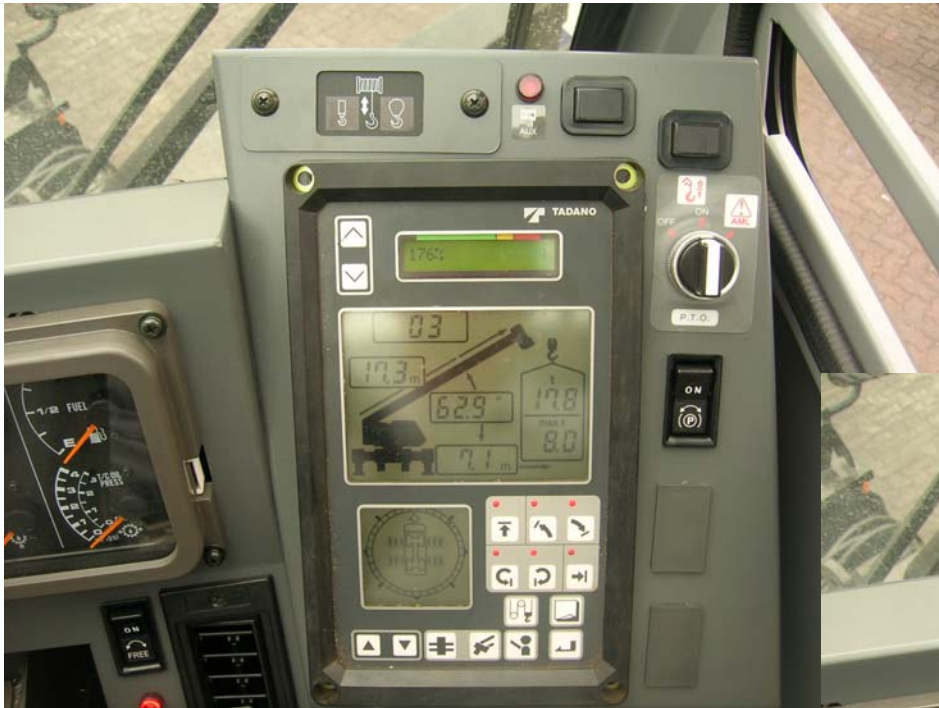
The crane operator had a history of overriding the crane limits and overloading the crane. Shown by computer records from the crane over 40 overloading incidents during October 2007

1. The computers in all site cranes (where fitted) have their data downloaded to investigate if the overloading of cranes is a general violation or restricted to this crane operator.
2. Emergency bypass controls are to be locked in the off position at all times.
3. Crane operators are to ensure that the all emergency bypass controls are locked in the off position at the Start of each shift.
4. Supervision is to inspect all emergency bypass controls during each shift to ensure they are locked in the off position.
5. Crane operational data from the onboard computer is to be downloaded each month to review the safe use and operation of the crane for the month.
