REPORT OF INVESTIGATION

Fatal Underground Coal Burst Accidents  
August 6 and 16, 2007

Crandall Canyon Mine  
Genwal Resources Inc  
Huntington, Emery County, Utah  
ID No. 42-01715

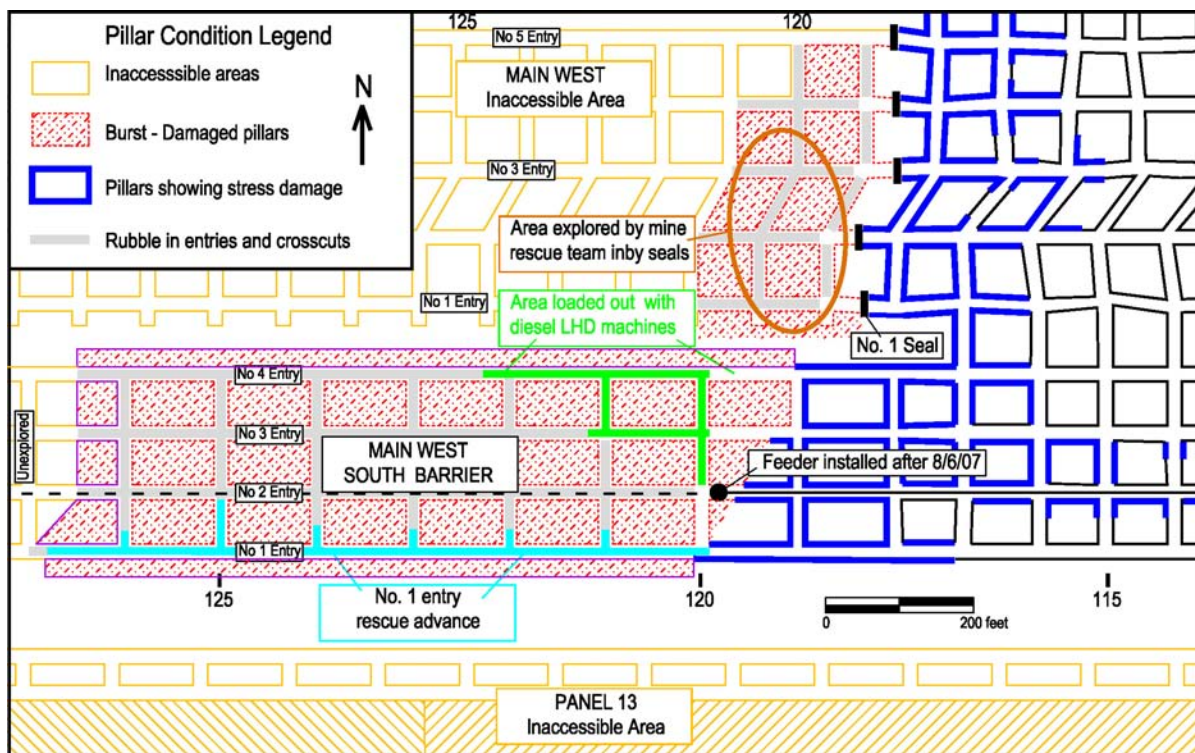
After 8:00 a.m., mine rescue team members from Energy West Mining Company also entered the mine. Grosely, Randy Gunderson (MSHA coal mine inspector), and a group of miners, including mine rescue team members, explored approaches to the South Barrier section by traveling back and forth between the Nos. 1 and 4 entries in an attempt to find a route to the entrapped miners. Entries and crosscuts were largely filled with debris, while intersections were less filled. They advanced to crosscut 126 where they encountered debris within inches of the roof and oxygen below 16%. A decision was made to retreat.

**Figure 3 - South Barrier Section Rescue Area  
Showing Ground Conditions and Rescue Attempts.**

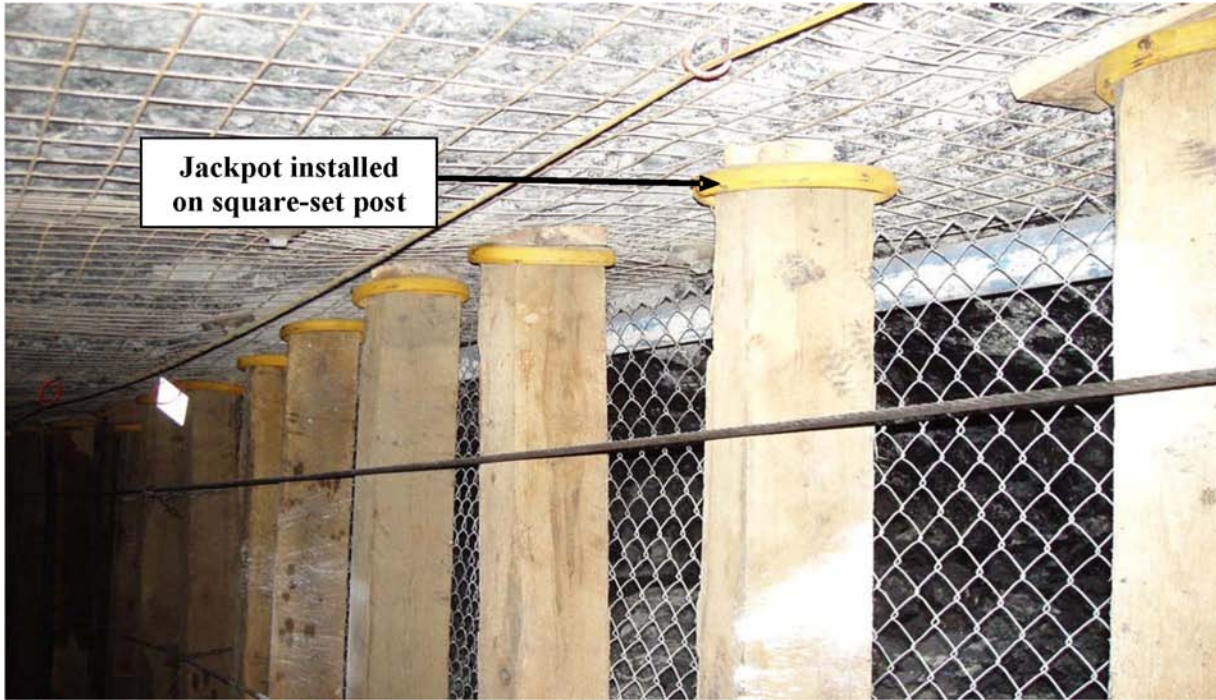
Figure 5 - Hardwood Posts Installed with Jackpots in No. 1 Entry

As specified in the plan, pressurized roof-to-floor standing supports were installed along pillar ribs for protection from pillar bursts. On August 8, 6 x 8-inch hardwood wood posts were installed on both sides of the No. 1 entry beginning at crosscut 118, narrowing the roadway to 14 feet. These posts were capped with Jackpots to actively preload each support between the roof and floor (see Figure 5). The wood posts were installed in the No. 1 entry to midway

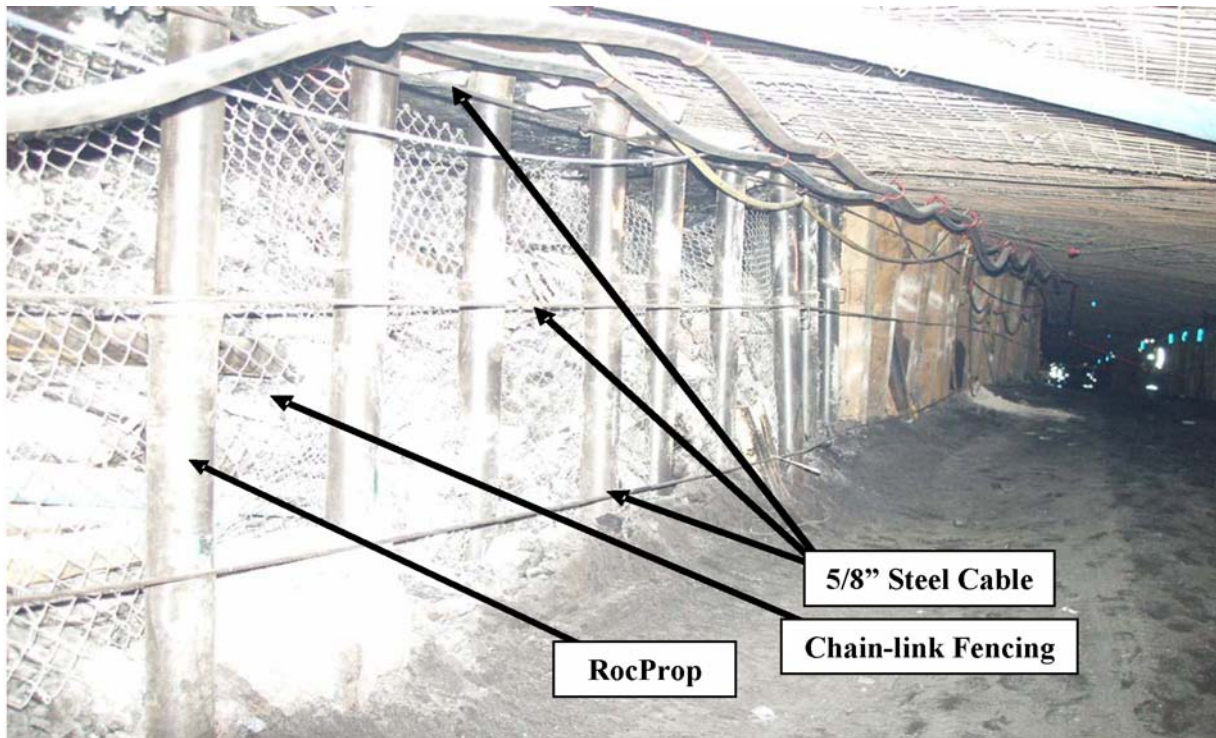
Figure 6 - RocProps, Cables, and Chain-link Fencing Installed in the No. 1 Entry

between crosscut 119 and 120 until RocProps (telescoping steel supports expanded with high pressure water) were available. Thereafter, RocProps were used exclusively as roof-to-floor support (see Figure 6). After the supports were installed, chain-link fence was installed between the rib and the row of supports to confine dislodged coal and to protect miners and the roadway. Additionally, 5/8-inch steel cables were wrapped around the RocProps to secure them from being dislodged.

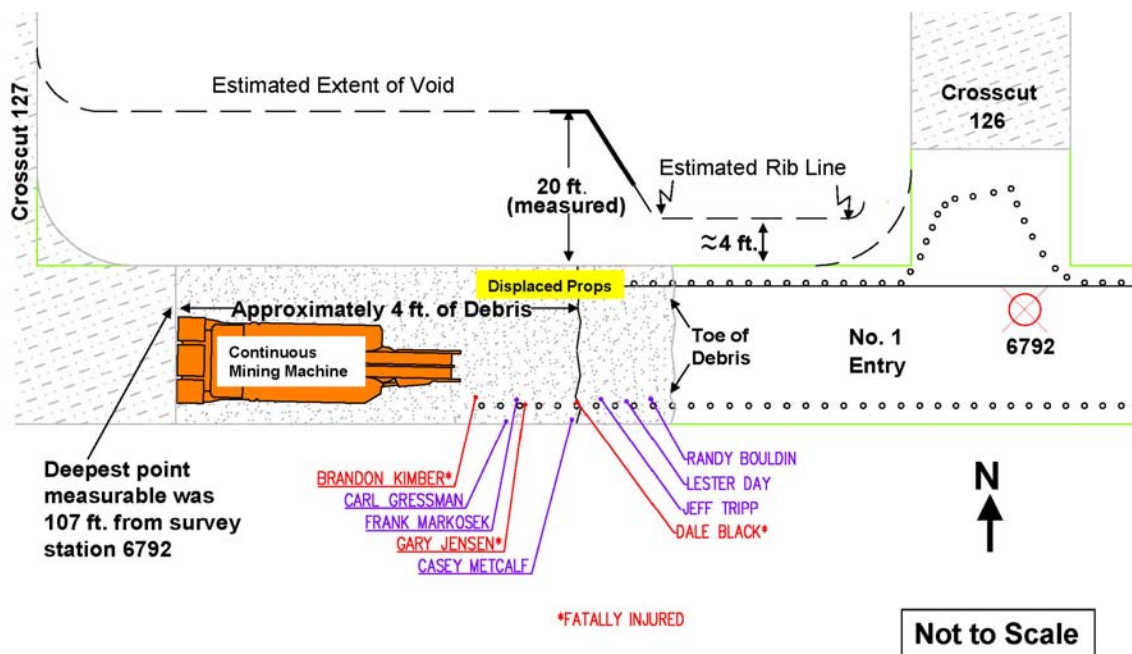
Figure 14 - August 16, 2007, Coal Burst Effects and Location of Injured Miners

At 6:38 p.m., as the crew completed installing ground support in the clean-up area, the coal pillar between the No. 1 and No. 2 entries burst. Coal was thrown violently across the No. 1 entry during the magnitude 1.9 seismic event. The burst created a void up to 20 feet deep into the pillar at the roof line (see Figure 12 and Figure 13, view indicated by arrow). The dislodged coal threw eight RocProps, steel cables, chain-link fence, and a steel channel toward the left side of the entry, striking the rescue workers and filling the entry with approximately four feet of debris (see Figure 14). Heavy dust filled the clean-up area, reduced visibility, and impaired breathing. Oxygen deficient air from the inby area migrated over the miners. The dust and oxygen deficiency were slow to clear due to damaged ventilation controls.

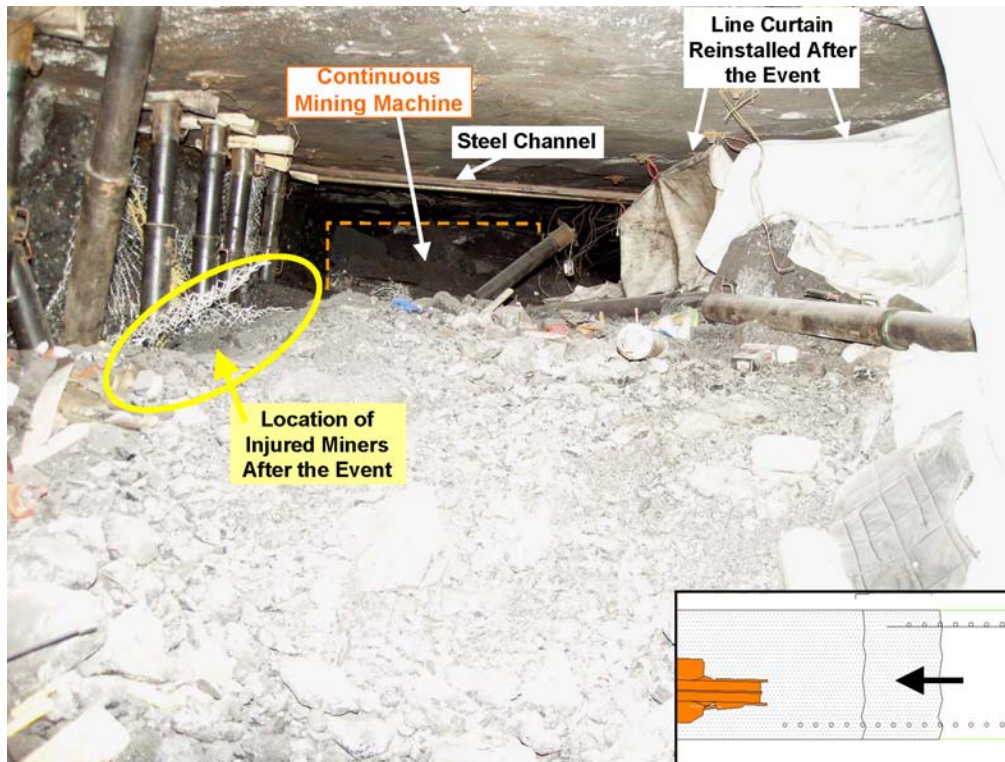
Harper rejoined Mann and Ward. Harper helped Day get a ride outside while Mann and Ward continued inby to assist other victims. As the miners were working to free the injured miners, several factors were slowing their efforts. Not only were rescuers dealing with the quantity of burst material, the roof and rib support that had been installed to protect the workers was now part of the rubble. The electrical cable and water line used to operate the continuous mining machine, along with the line curtain used for ventilation of the clean-up area, were also hindering the recovery of the injured miners (refer to Figure 15).

**Figure 15 – Clean-up Area Following the Fatal August 16, 2007, Accident**  
**The direction and location of camera view is denoted by black arrow in the insert.**

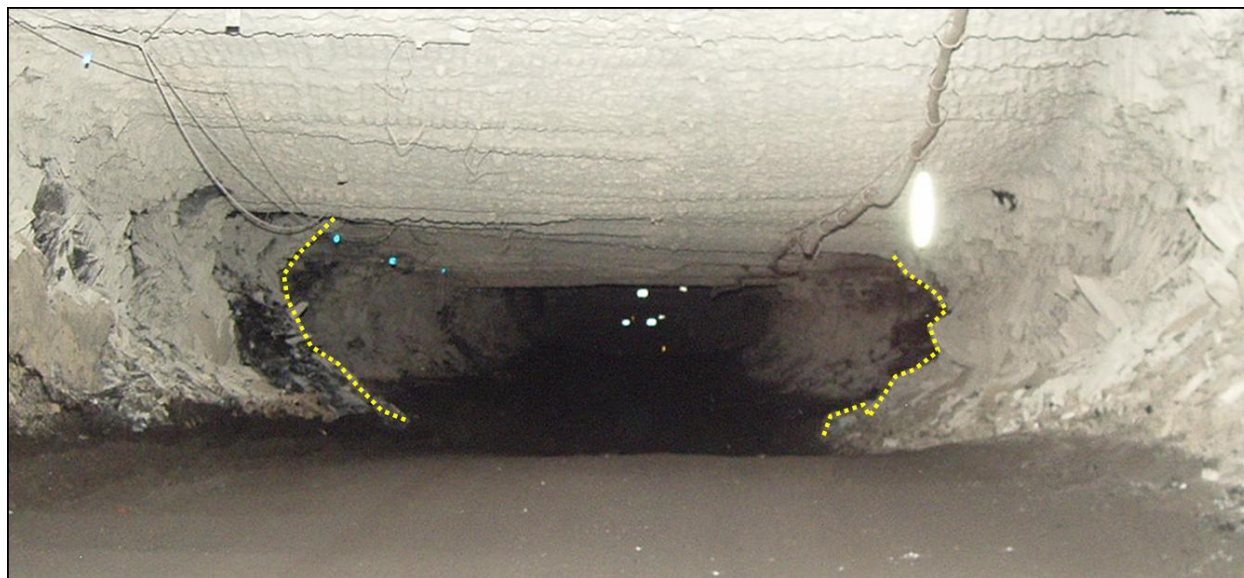
Areas of Main West developed with continuous haulage were mined an average of approximately 20 to 21 feet wide (based on measurements from 1991 era mining east of crosscut 107). In the newer development, entries and crosscuts were mined 18 feet wide, although the approved roof control plan permitted a maximum mining width of 20 feet. Throughout the mine, pillars showed an hour glass rib profile (see Figure 24). Consequently, mining widths measured at mid pillar often were wider than the original excavated width. The hour glass rib profile was evident when overburden exceeded approximately 1,100 feet and was more pronounced as the depth increased. For example, measurements made during the accident investigation beneath 1,500 feet of cover indicated that older entries, which averaged 20.6 feet on development, had hour glassed to 24.7 feet. Similarly, recently mined 18.5-foot wide openings had hour glassed to an average of 22.4 feet.

**Figure 24 - Hour Glass Shape of Stressed Pillars**

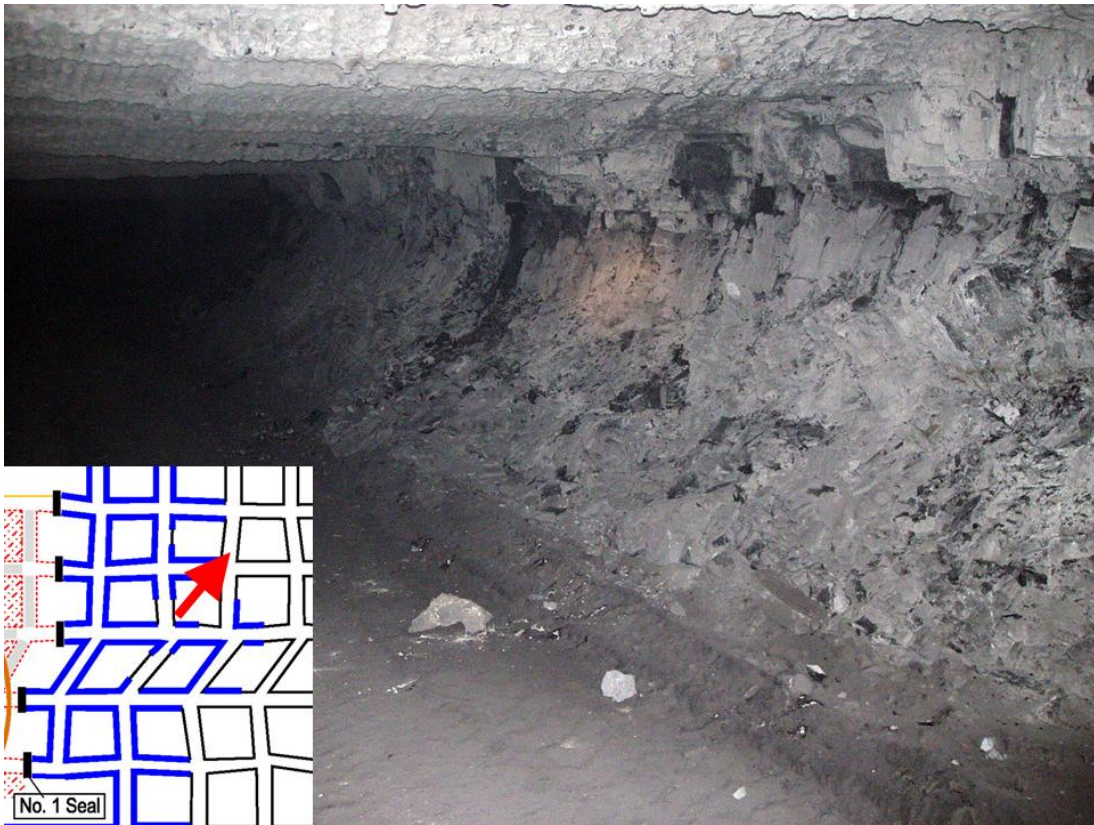
Figure 27 - Normal Main West Pillar Rib Conditions

On August 11, 2007, ground conditions were mapped in the Main West entries and the North and South Barrier workings outby crosscut 119. Pillar damage was noted up to three crosscuts outby the seals (see Figure 26). The damaged ribs did not appear to be the result of bursting. Rather, the damage appeared to be associated with abutment stress transferred from inby the seals. Figure 27 and Figure 28 illustrate the difference between damaged and undamaged pillar rib conditions. Figure 27 shows normal Main West pillar rib conditions and Figure 28 shows recent pillar rib sloughage from abutment stress.

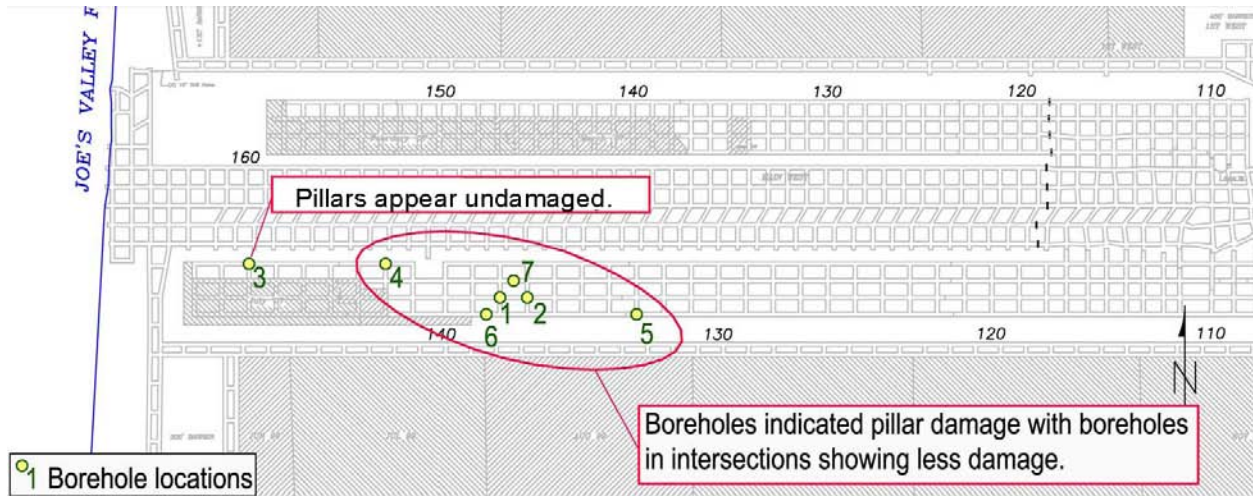
Conditions determined by the boreholes and visual observations from borehole cameras set the western boundary of the collapse between Borehole Nos. 3 and 4. Borehole No. 4 and others to the east of that location indicated that the mine openings contained rubble. Boreholes in the entries were filled or nearly filled with rubble while boreholes in the intersections contained less rubble. Figure 29 depicts the borehole locations.

**Figure 29 - Borehole Locations and Conditions Observed**

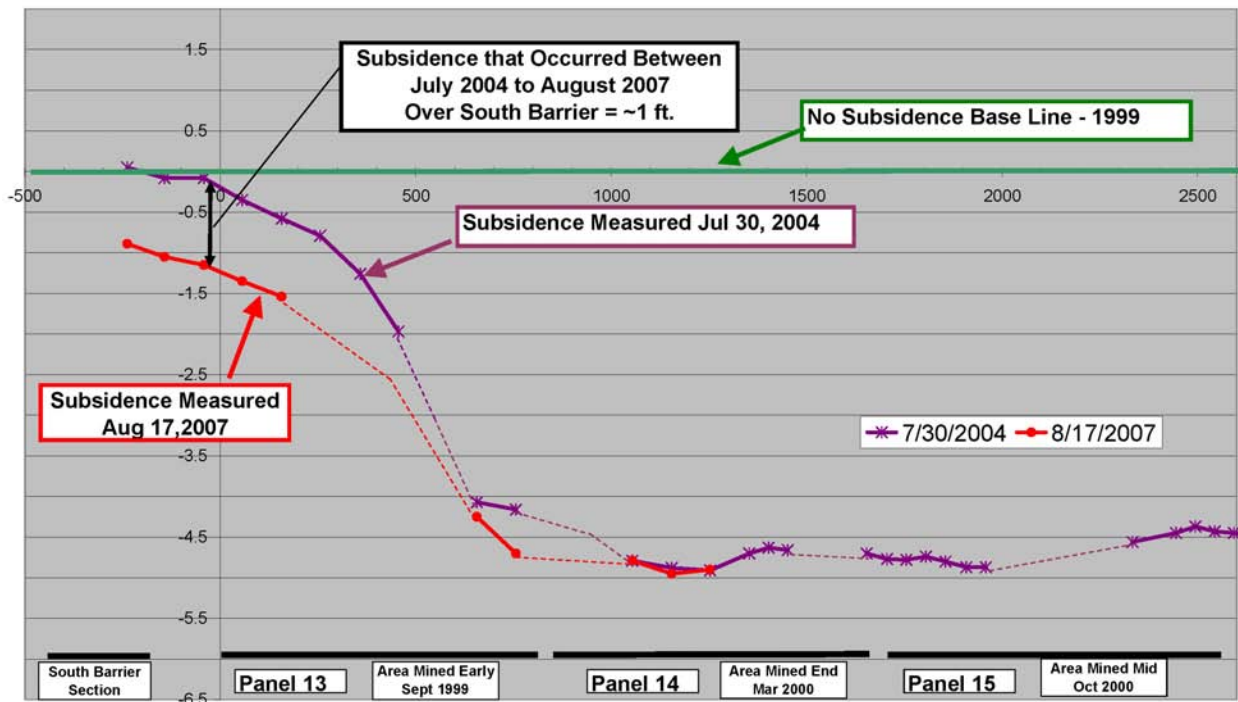
Figure 30 - Subsidence Profiles over Panels 13 to 15  
Measurements from 2004 and 2007, vertical scale exaggerated

The longwall subsidence behavior observed in Figure 30 is somewhat typical of the Wasatch Plateau. In this region, strong, thick strata in the overburden control caving characteristics and are responsible for the high abutment stresses and long abutment stress transfer distances discussed in the ground control analysis portion of this report. Subsidence data collected elsewhere in the region indicates that the amount or extent of cantilevered strata at panel boundaries varies. Data presented in Figure 30 indicate that subsidence adjacent to the South Barrier section was incomplete over more than half the width of Panel 13. The figure also demonstrates that additional subsidence over the panel and the adjacent barrier was observed between 2004 and 2007. To determine how much of the recorded movement during the 3-year period was associated with the August accidents, Interferometric Synthetic Aperture Radar (InSAR) analyses were conducted.

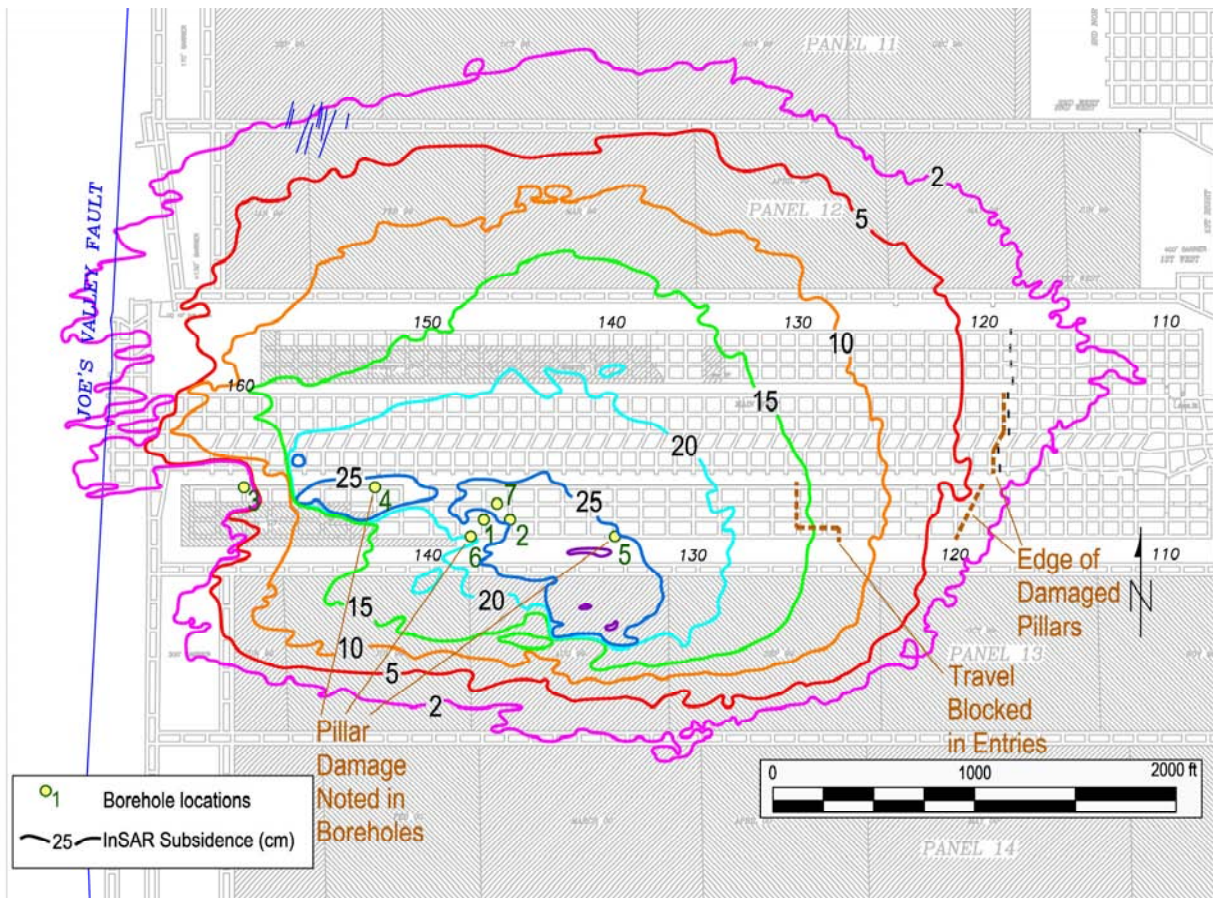
**Figure 31 - Surface Deformation from Neva Ridge InSAR Analyses (June to Sept. 2007)**

Neva Ridge Technologies (Neva Ridge) in Boulder, Colorado, subsequently was contracted to provide an independent InSAR analysis. The Neva Ridge report (see Appendix M) confirmed the lateral extent and vertical displacements determined by USGS. Maximum vertical displacement at the center of the depression was 12 inches (30 centimeters). Vertical subsidence from the Neva Ridge study is shown on Figure 31. Calculations, based on coal density (in situ and post mining) and mining geometry (pillar and entry volumes) demonstrate that surface subsidence of this magnitude is consistent with extensive coal pillar bursts and substantial filling of entries. A discussion of the two studies is included in Appendix L.

The InSAR analysis generally confirms the magnitude of subsidence determined in the GPS survey and further constrains the time in which the subsidence occurred. The analysis also provides insight to the lateral extent of the collapse zone. As illustrated in Figure 31, the surface area affected by the collapse extends approximately 1 mile east-to-west and  $\frac{3}{4}$  miles north-to-south. At seam level, subsidence principles suggest that the extent of the collapse would be less laterally but greater vertically than the surface expression implies.

The depth of burst coal in the No. 1 entry of the South Barrier section increased from crosscut 120 until it blocked access to all entries at approximately crosscut 126. Above crosscut 119, the InSAR analysis indicates there was almost 2 inches (5 cm) of vertical subsidence; above crosscut 126, the subsidence was approximately 6 inches (15 cm). The 15 cm subsidence contour encompasses all of the area above the South Barrier section from crosscuts 126 to 142. If the 15 cm contour is used as an indication of pillar damage severe enough to block all travel, then the surface subsidence indicates that the entire working section was severely damaged. The region of Main West between the longwall panels that subsided vertically 6 inches (15 cm) or more was approximately 69 acres in area, centered near crosscut 135.

The area of greatest subsidence, and therefore the greatest damage at seam level, was centered on the 121-foot wide barrier between the South Barrier section and longwall Panel 13. A maximum displacement of nearly 12 inches was observed over the barrier pillar about 500 feet outby the last known location of the entrapped miners. Borehole No. 5 penetrated the mine workings near the point of maximum displacement and confirmed that the damage was severe there as demonstrated by the observation that the void space in that intersection was only 0.5 feet.

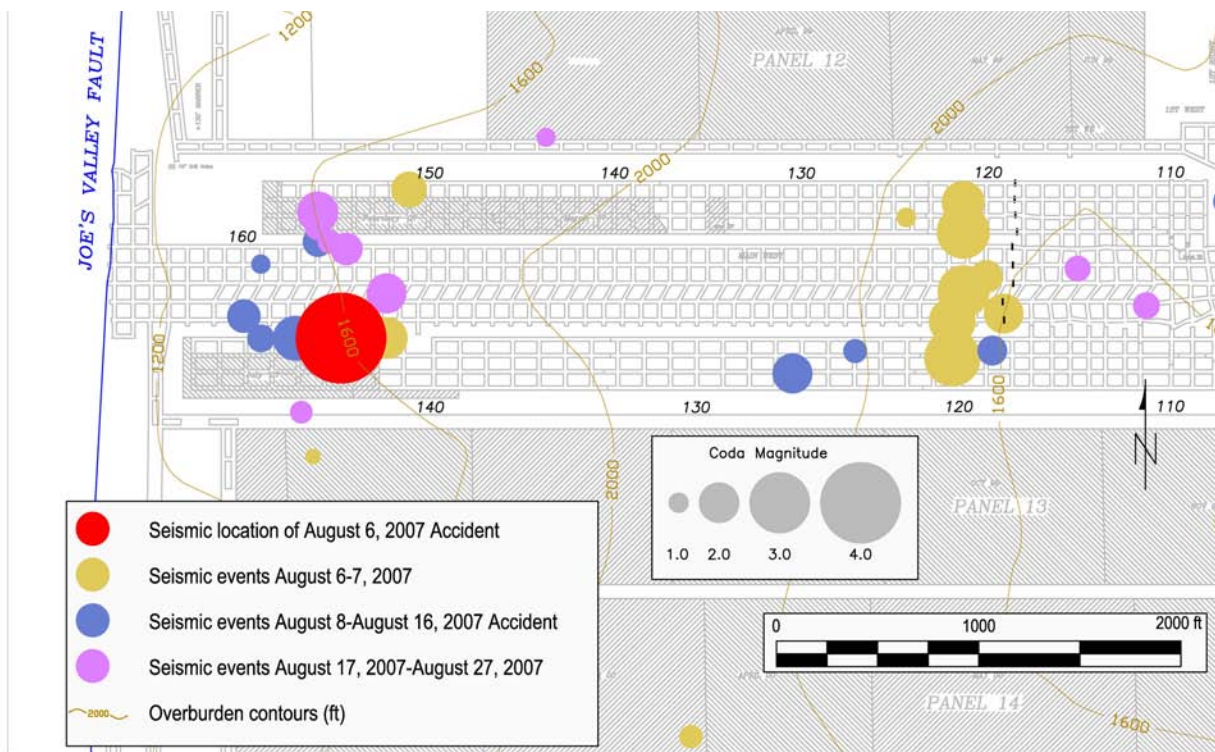
Figure 32 – Double Difference Locations of Seismic Events, August 6-27, 2007

Refined double difference locations of seismic events for the period of August 6 to August 27, 2007, are shown in Figure 32. These refined locations were unavailable until three months after all rescue efforts had been suspended. The August 6 event is indicated by the red circle and the twelve events that occurred within 37 hours afterward are represented as tan circles; the radius of each circle corresponds to the relative magnitude of the events. Activity during the first 37 hours after the accident was predominantly located on the outby side of the collapse area. Conversely, seismic activity for the time period August 8-27 (shown as blue and magenta circles) was concentrated on the inby side of the collapse area. Very few events were located near the north and south boundaries of the collapse area.

Seismologic analyses indicated that the August 6, 2007, event was dominantly a collapse mechanism but the waveforms also included a smaller shear component. A likely explanation was shear displacement along a vertical plane with movement downward on the east side. The plane would have a strike of approximately 150 degrees azimuth. This conclusion is substantiated by InSAR analyses which show a more abrupt displacement on the western side of the collapse area than on the eastern side. Steeper subsidence in this region could be consistent with movement on a steeply dipping, north-south oriented plane between the North and South

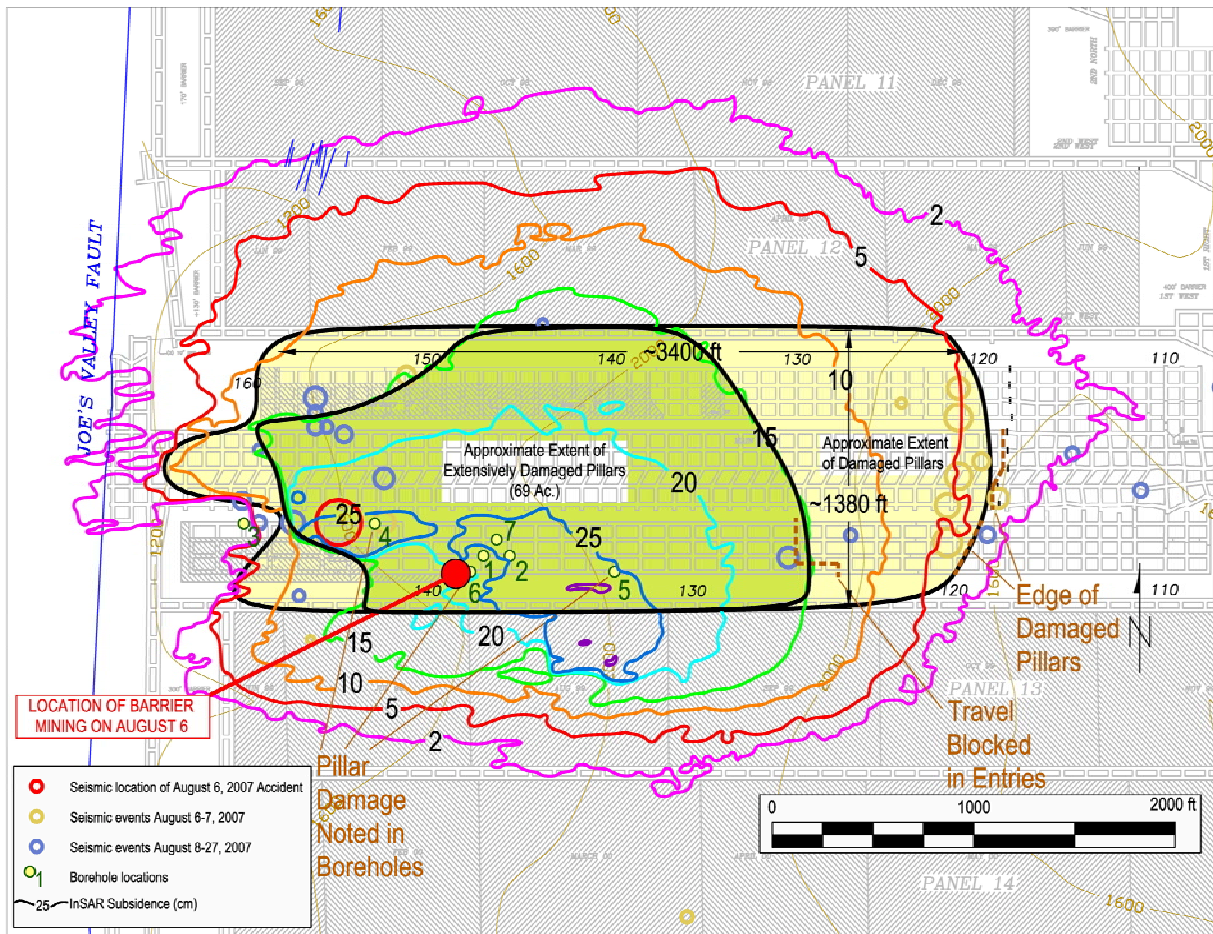
**Figure 33 - Combined Data and Likely Extent of Collapse**

Figure 33 superimposes a variety of data used to determine the extent of the collapse, including: the seismic data from the time of the August 6 accident to August 27, 2007, the borehole locations, the InSAR subsidence contours, and the likely extent of damaged pillars. The eastern boundary of the pillar failures was based on the underground observations and InSAR subsidence data and is consistent with residual seismic activity. The western edge of the pillar failures was based on the borehole observations and InSAR subsidence data and is consistent with the seismic location of the accident and the additional seismicity later in August 2007.

The extent coincides approximately with the 5 cm vertical subsidence line. The 5 cm line falls between Borehole Nos. 3 and 4. The area indicating extensively damaged pillars was based on conditions observed near crosscut 126 where the damage was more severe and the entries were impassable. The boundary of the area follows the 15 cm subsidence contour and encompasses Boreholes Nos. 1, 2, 4, 5, 6, and 7, all of which showed damage.

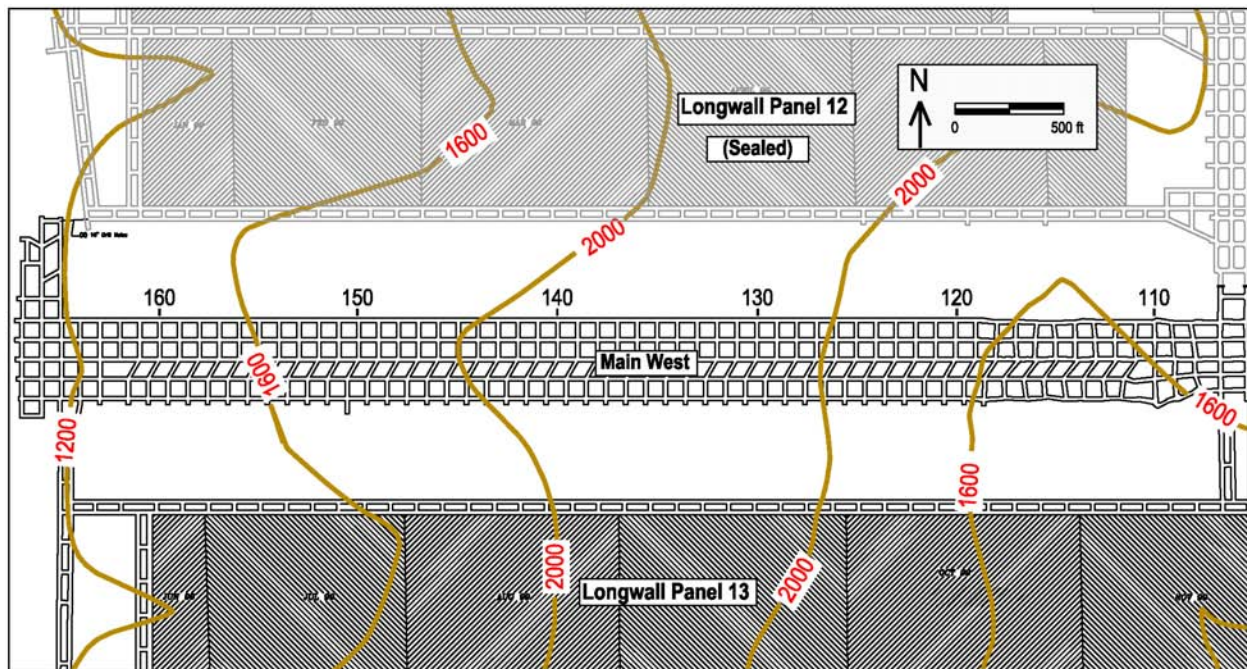
**Figure 34 – Initial Main West Barrier Pillars after Panel 13 Mining showing Overburden**

Longwall panels were mined parallel to the Main West entries between 1997 and 2003. Six panels were mined north of Main West (Panels 7 to 12) and six were mined to the south (Panels 13 to 18). Barrier pillars measuring approximately 450 feet wide were established between Main West and the adjacent longwall Panels 12 and 13 (see Figure 34).

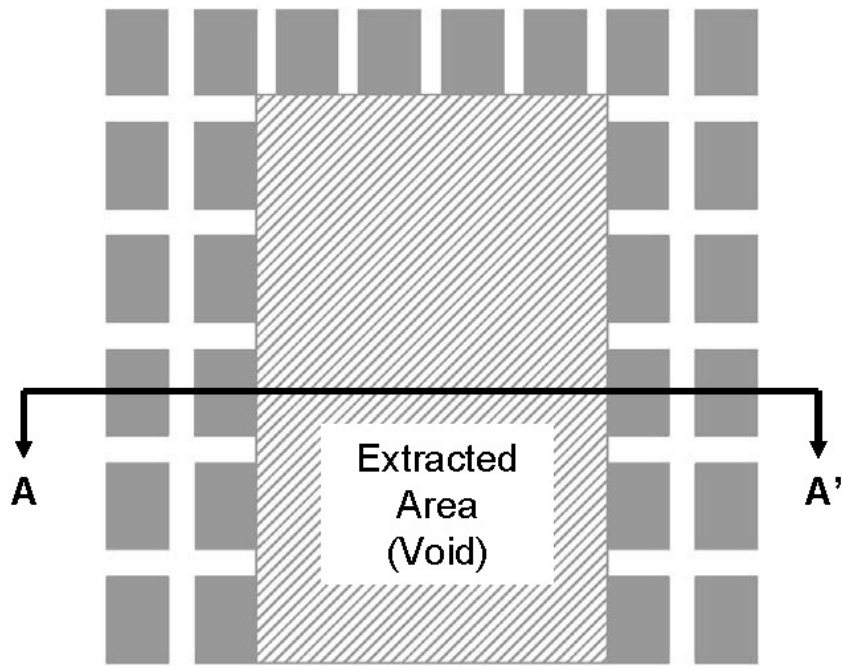
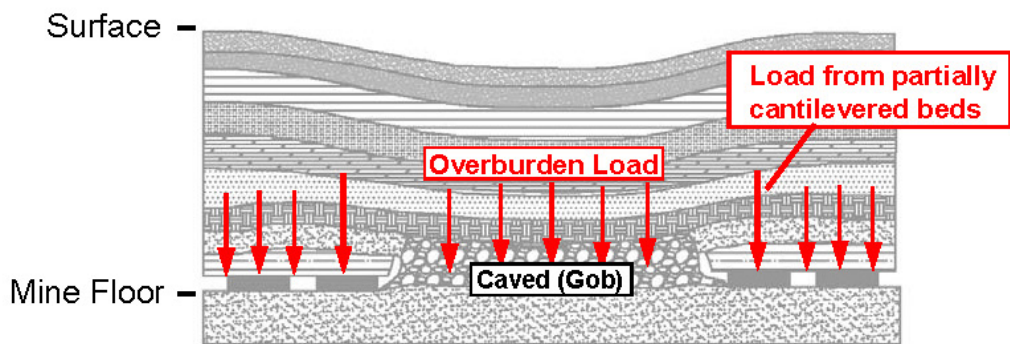
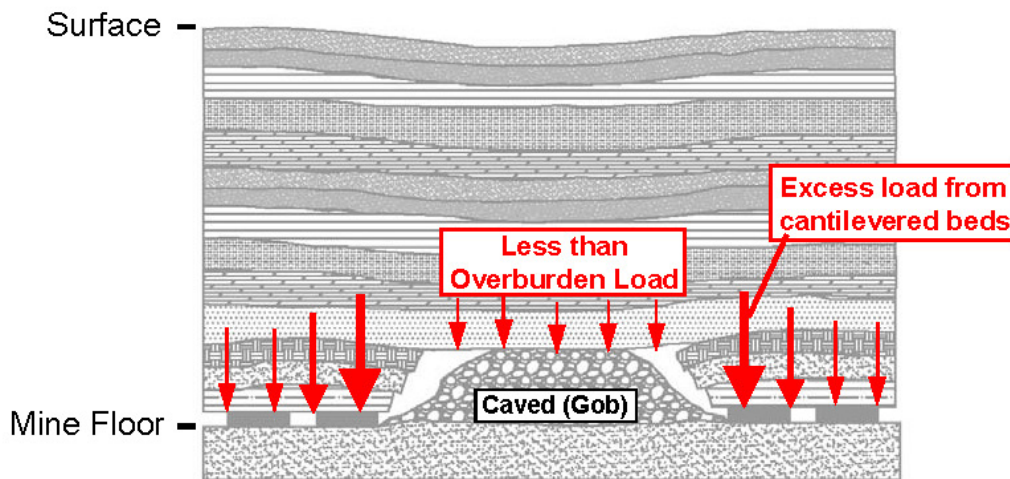
Figure 35 - Abutment Stress due to Cantilevered Strata from Mining

In deep overburden and/or in narrow extraction areas, failure may not propagate to the surface. Instead, strata near the excavation can fail and fall into the void while higher strata may simply sag onto the fallen lower layers. The strength and stiffness of rock layers in the mine roof generally dictate the degree to which the uncaved layers sag and transfer load into the broken material (gob). If the rock layers are strong and thick, load can be transferred across the void created by mining in much the same way that an arch bridge rests on abutments at either of its ends. This abutment stress is usually highest near the excavation and lessens with distance away from the caved area.

Abutment stresses are transferred from extracted areas to adjacent workings (see Figure 35). The stresses are highest near pillared areas (referred to as "gob") and diminish with distance. Rules of thumb used to estimate abutment stress transfer distance are discussed in Appendix T. However, longer transfer distances have been observed in some mines in the Wasatch Plateau. In a paper titled *"Long load transfer distances at the Deer Creek Mine,"* Goodrich et al.<sup>9</sup> wrote:

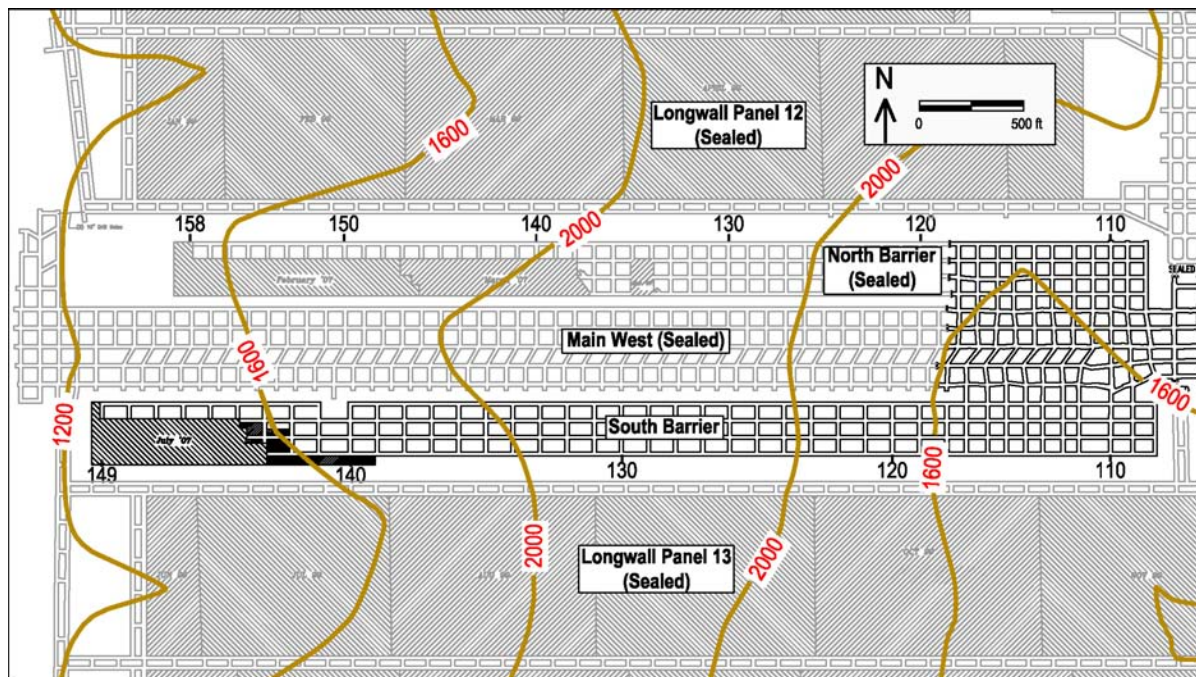
**Figure 37 - North Barrier Section Mining showing Overburden**

In contrast to the sequential development and recovery plan used in the South Mains, four entries were driven on 80 x 92-foot centers through the Main West North Barrier prior to retreat. The original 448-foot barrier width was reduced during development to 135 feet between the section and Panel 12 to the north and to 53 feet between the section and the sealed Main West to the south (see Figure 37). One implication of this approach was that the load bearing capacity of these barriers (i.e., their ability to support front and side abutment loading during pillar recovery) was reduced. Another was that entries used to access the working faces were subjected to abutment loading during development.

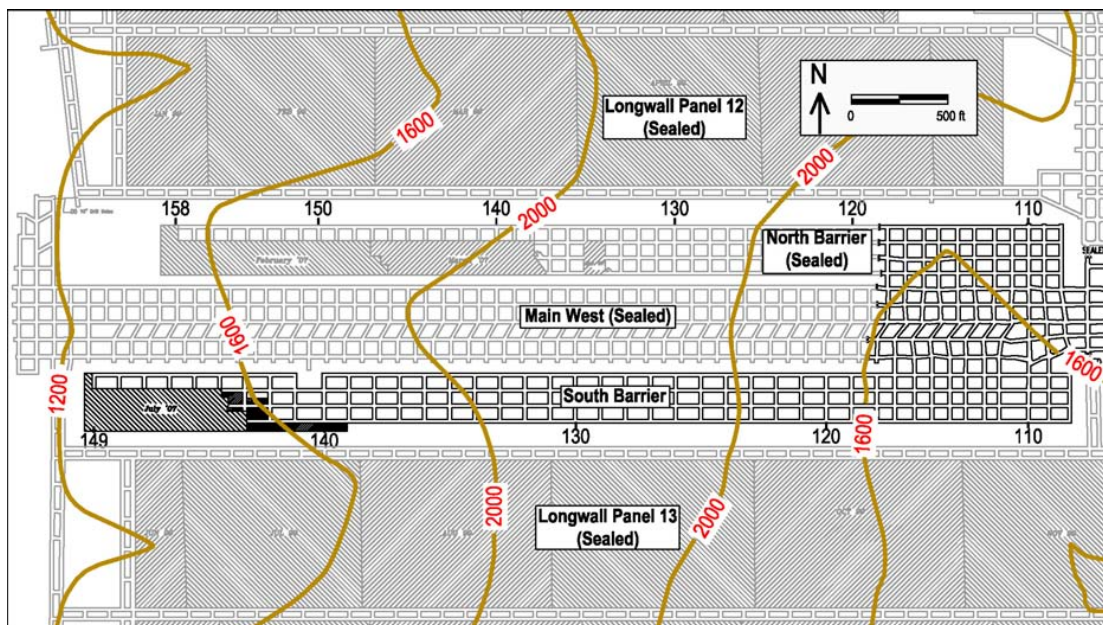
**Figure 40 - South Barrier Section Mining showing Overburden**

In the South Barrier section, pillar length was increased by 38 feet (from 92 to 130-foot center-to-center – see Figure 40). AAI indicated that this change “*increases the size and strength of the pillars’ confined cores, which helps to isolate bumps to the face and reduce the risk of larger bumps overrunning crews in outby locations.*”

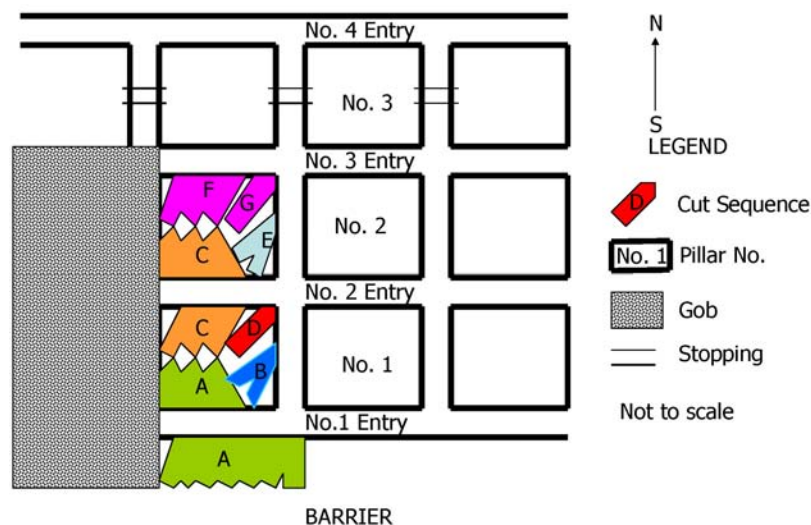
**Figure 41 - South Barrier Section Pillar Recovery Cut Sequence**

The cut sequence when mining a row of pillars is shown in Figure 41. Half of the No. 1 pillar and the barrier to the south were mined simultaneously, right and left, from the No. 1 entry (Sequence A). The remainder of the No. 1 pillar and the No. 2 pillar were then mined as they had been in the North Barrier section (Sequences B, C, D, E, F, and G).

Coal production resumed at 10:35 a.m., as the day shift crew mined the remaining cuts from either side of the No. 2 entry inby crosscut 142. Adverse ground conditions in the No. 3 entry prevented mining the north half of the damaged pillar (cut F and G as shown on Figure 41). Crew members (including the section foreman) discussed the possibility that management would decide to pull out of the South Barrier section due to similarities between the outburst accident that morning and the events in the North Barrier. The section was visited by mine management, who discussed the conditions with the section foreman. After this discussion, the section foreman informed the crew that they were to begin mining the barrier and skip some pillar rows. The crew moved the continuous mining machine outby crosscut 142 in the No. 1 entry and mined a lift from the barrier pillar. Six cuts were mined from the barrier during the night shift, retreating to near crosscut 141. Mining in the barrier between crosscuts 139 and 142 was prohibited by the approved roof control plan.

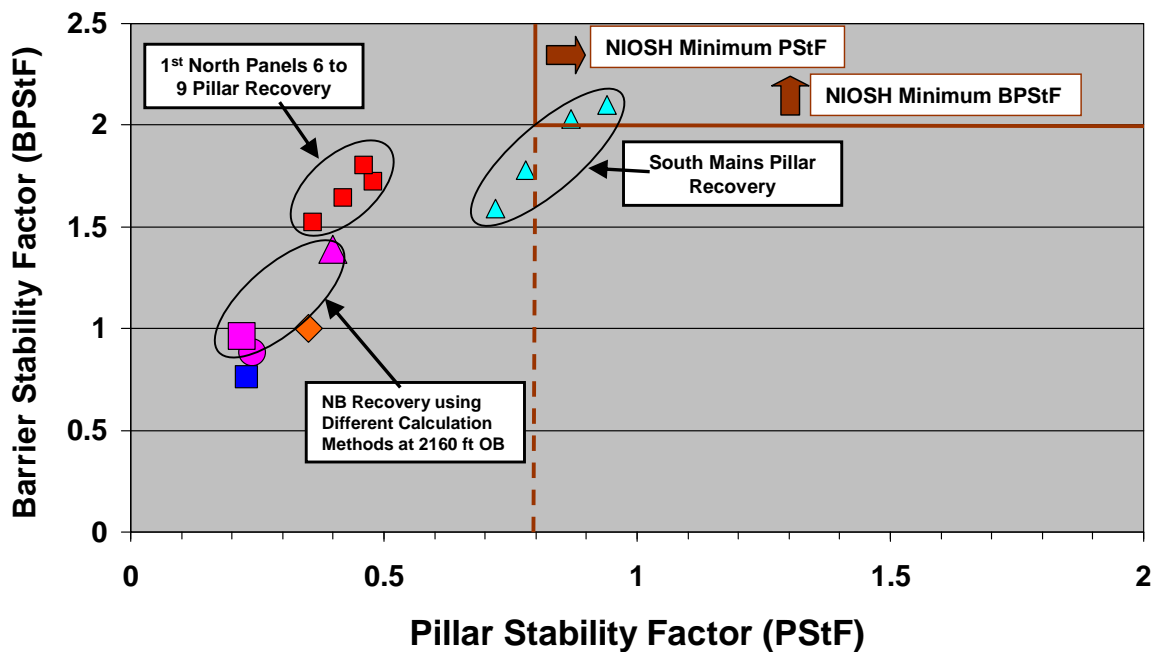
Figure 45 - ARMPS Stability Factors at Crandall Canyon Mine

The four red squares in Figure 45 represent ARMPs stability factors associated with the 1<sup>st</sup> North continuous haulage system panels. Although no catastrophic failures were reported, pillar recovery was not trouble-free. Accident records indicate that two injuries resulted from bounces (one of which was a coal burst) during pillar recovery in late 1993 and early 1994 in the 7<sup>th</sup> Left continuous haulage panel. Also, pillars were abandoned in each panel to alleviate some form of difficult ground condition. Roof coal had been left during development of these panels and this practice may have contributed to the difficulties. Regardless of the reason for leaving the pillars, these unmined zones indicate that pillar recovery was not entirely successful.

The light blue triangles in Figure 45 represent stability factors associated with pillar recovery in the South Mains. Two of the cases satisfied the NIOSH criteria for minimum stability factors. Although no catastrophic failures were reported, miners described “heavy” conditions on the pillar line indicative of high stress and pillar bounces were reported. These conditions led the operator to adopt a pillar recovery sequence in which pillars were extracted exclusively in one direction rather than alternating the direction between successive rows. Reportedly, less “thumping” was experienced on the pillar line when the pillars were extracted exclusively from west-to-east. Also, interview statements and documents indicate pillar “bouncing” occurred during pillar extraction in the South Mains. Two rows of pillars beneath a ridge near the center of South Mains (1520 feet of overburden) were not extracted.

The magenta colored shapes in Figure 45 represent ARMPS stability factors for the North Barrier section determined using the three methodologies discussed earlier. They are grouped together in an oval to signify that all three correspond to the same mining scenario. Regardless of the methodology used, both the pillar stability factor and barrier pillar stability factor fall below the NIOSH recommended values for bump-prone and non-bump-prone ground. The low stability factors indicate that poor ground conditions and/or section failure would be anticipated during pillar recovery.

The blue square and orange diamond in Figure 45 correspond to these two pillar recovery scenarios. Since the bleeder pillar in this section was not adjacent to the barrier along the Panel 13 gob, the ARMPS software could consider the South Barrier width directly (i.e., without making adjustments like those for the North Barrier). Had the pillar line retreated to a point beneath the deepest cover, the PStF and BPStF would have been nearly the same or less than those associated with the March burst in the North Barrier (substantially lower than values determined using the method with the highest risk, Method 1, and lower than the NIOSH recommended values). Although longer pillars were employed in the South Barrier section, the thinner barrier towards Panel 13 and the slab cut into the barrier during pillar recovery result in larger calculated abutment loads and lower StF's. As before, the low stability factors indicate that poor ground conditions and/or failure would be anticipated.

*Summary.* ARMPS stability factors for Crandall Canyon Mine pillar recovery scenarios are illustrated in Figure 45. In this figure the vertical and horizontal solid color lines represent NIOSH recommended minimum stability factors (0.8 PStF and 2.0 BPSStF). The recommended NIOSH values (0.8 PStF and 2.0 BPSStF) are for overburden deeper than 1,250 feet with strong roof and bump prone ground. ARMPS stability factors that are above or below NIOSH recommended values do not ensure success or failure. However, when stability factors are maintained above the thresholds for both production and barrier pillars, experience (reflected in case studies in the NIOSH database) has demonstrated likelihood for success.

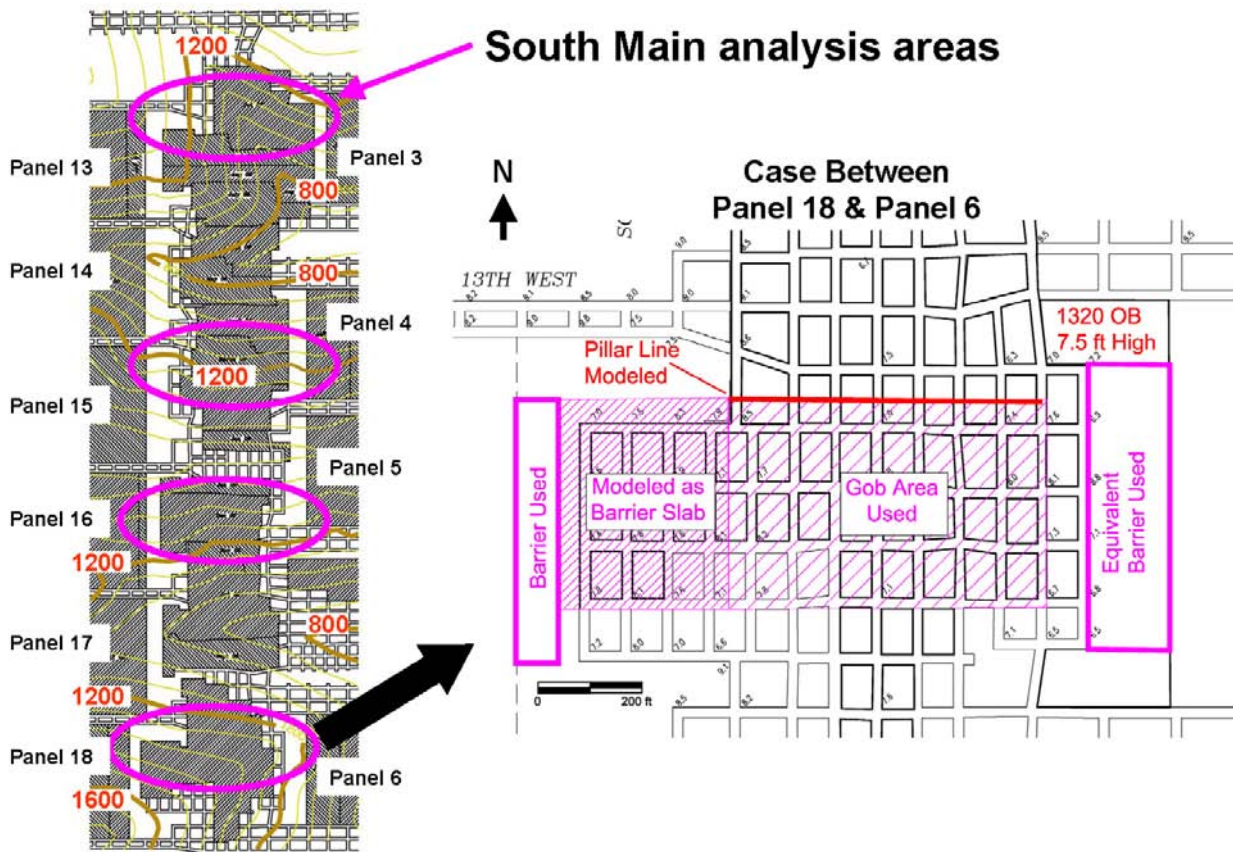
Figure 46 - South Mains ARMPs Calculation Areas

Four areas with relatively high overburden and minimal barrier width to the longwall gobs were selected for back-analysis using ARMPS. The areas were between longwall Panels 6 and 18, Panels 5 and 16, Panels 4 and 15, and Panels 3 and 13 (see Figure 46). At each of these locations, the maximum extraction area and minimum barrier widths were applied in the analysis to subject pillars and barriers surrounding the developing gob to the highest degree of loading. This approach was used to define the lower limit of the historical pillar stability factors associated with pillar recovery in the South Mains. Results of the ARMPS analyses are included in Table 6.
