REPORT OF INVESTIGATION

Fatal Underground Coal Burst Accidents  
August 6 and 16, 2007

Crandall Canyon Mine  
Genwal Resources Inc  
Huntington, Emery County, Utah  
ID No. 42-01715

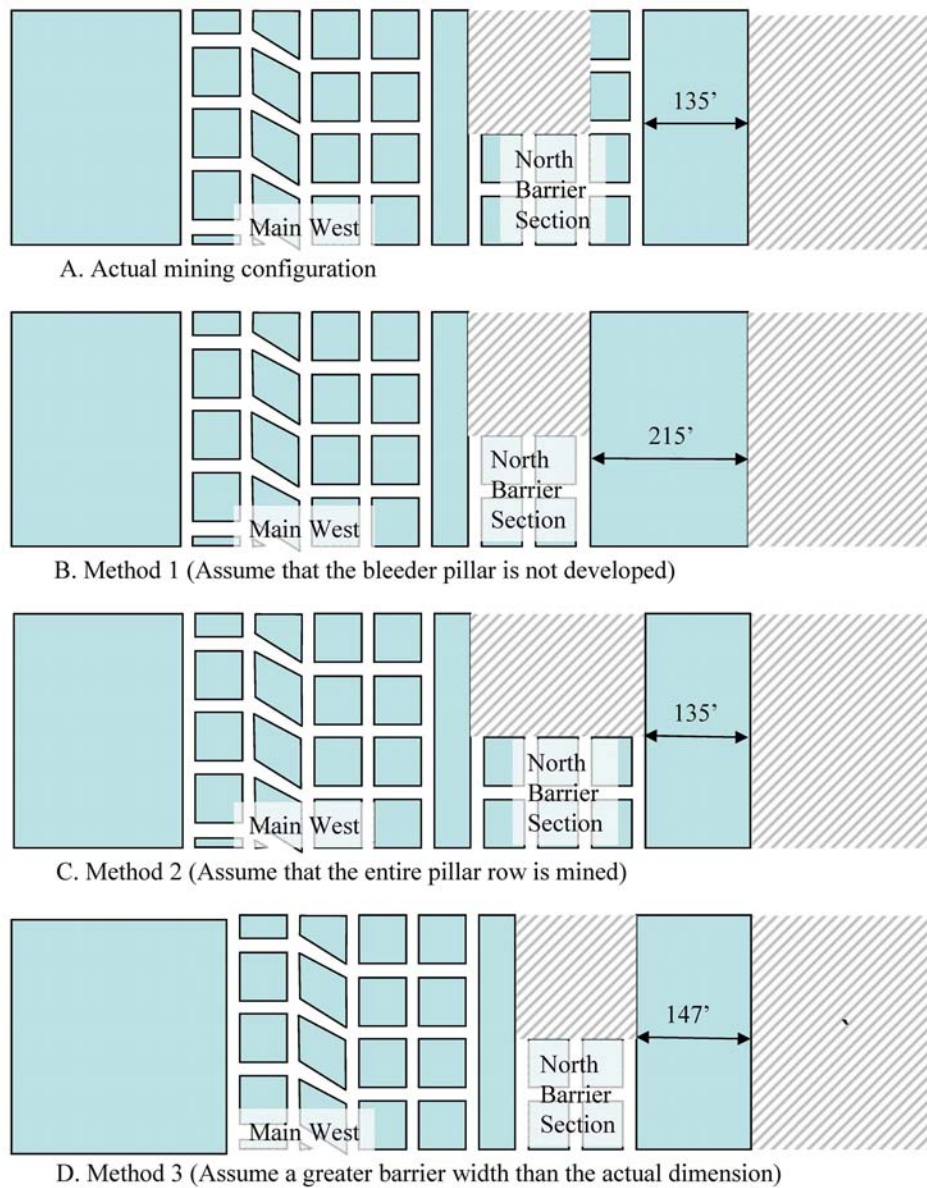
**Figure 47 - Methods of Incorporating a Bleeder Pillar in ARMPS Analyses**

Each of these approaches uses a different assumed geometry (Figure 47) and provides a different result. The first method generates the highest PStF and the second and third methods generate lower and similar PStF values. Consequently, when compared to NIOSH pillar design criteria from the NIOSH database or pillar design from mine site back-analysis, the first method is more likely to overstate stability than the second or third method. The inappropriateness of Method 1 is evident in the fact that StF's calculated for a retreating section using this method are actually greater than StF's calculated for development using actual pillar and barrier dimensions (see Table 7). When comparing the design to NIOSH or mine site specific design criteria, the second and third methods offer the safest approach.

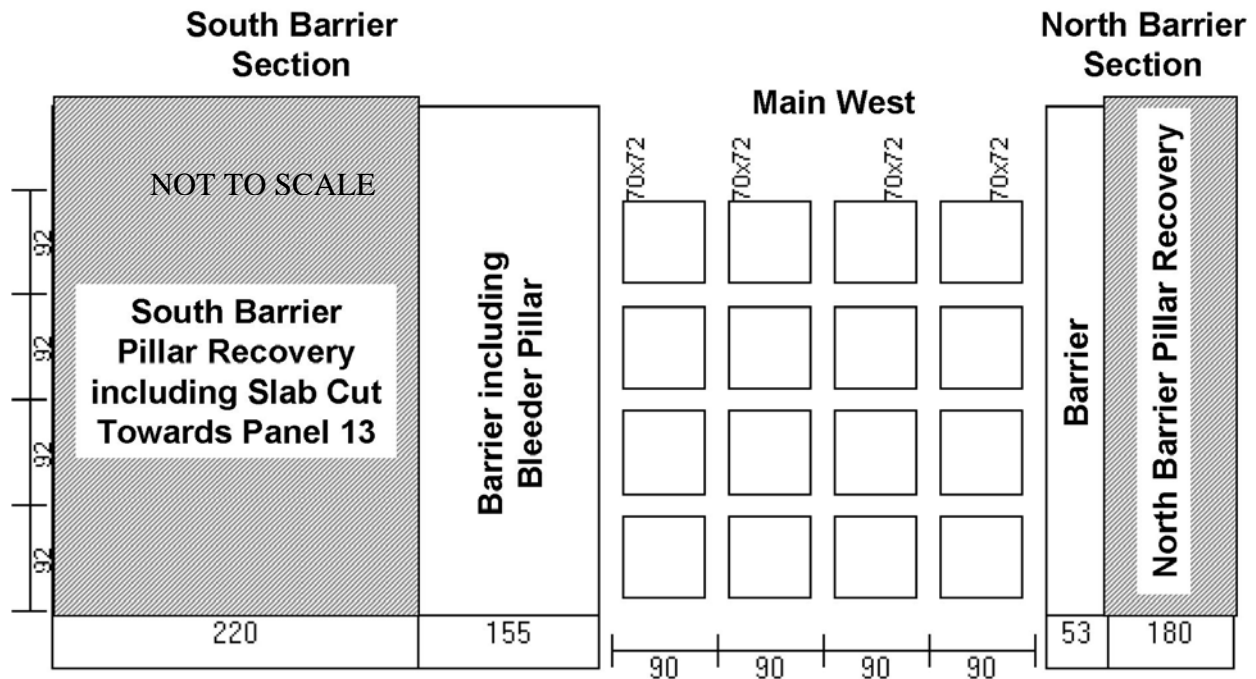
Figure 48 - ARMPS Layout for Simplified Main West Analysis

The Main West can be represented as a developed section (no pillar recovery) bounded on either side by the North and South Barrier Section workings, as illustrated in Figure 48. On development, the Main West PStF is 0.86 (near borderline with respect to NIOSH recommendations) for the maximum Main West overburden of 2,160 feet. As the North Barrier is recovered, the PStF drops to 0.70, below the recommended level, and even further to 0.66 with extraction in the South Barrier. In fact, the actual StF's are likely much lower given the age of the workings (i.e., pillar degradation over time) and the influence of the adjacent longwall workings.

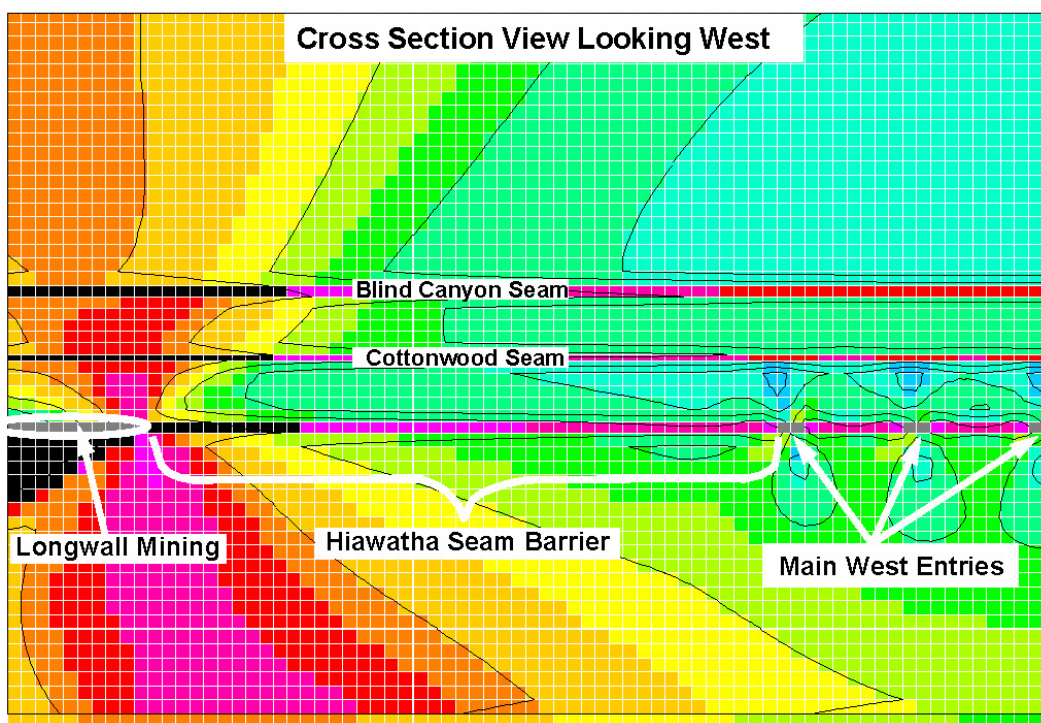
**Figure 49 - Element Safety Factors about a Barrier Pillar after Longwall Mining**

*Longwall Mining.* Model results in the second mining stage, longwall panel extraction, indicate that some areas have reached the elastic limit while others are well below (see Figure 49). For example, 25% of the barrier pillar separating the Main West from the longwall panels has yielded in this stage of mining. Although the remainder of the barrier adjacent to the Main West has not yielded, it is highly stressed. The gray elements in Figure 49 indicate mine openings in the Hiawatha seam and the black elements represent element safety factors less than 1.0.

Although yielding is isolated to the longwall side of the barrier opposite Main West, longwall mining has had a significant effect on stress levels in the Main West pillars. The highest SF in the Main West pillars is 1.34 which is substantially less than the values on development. Roof and floor SF’s are in the 4 to 5 range suggesting that they continue to be stable.

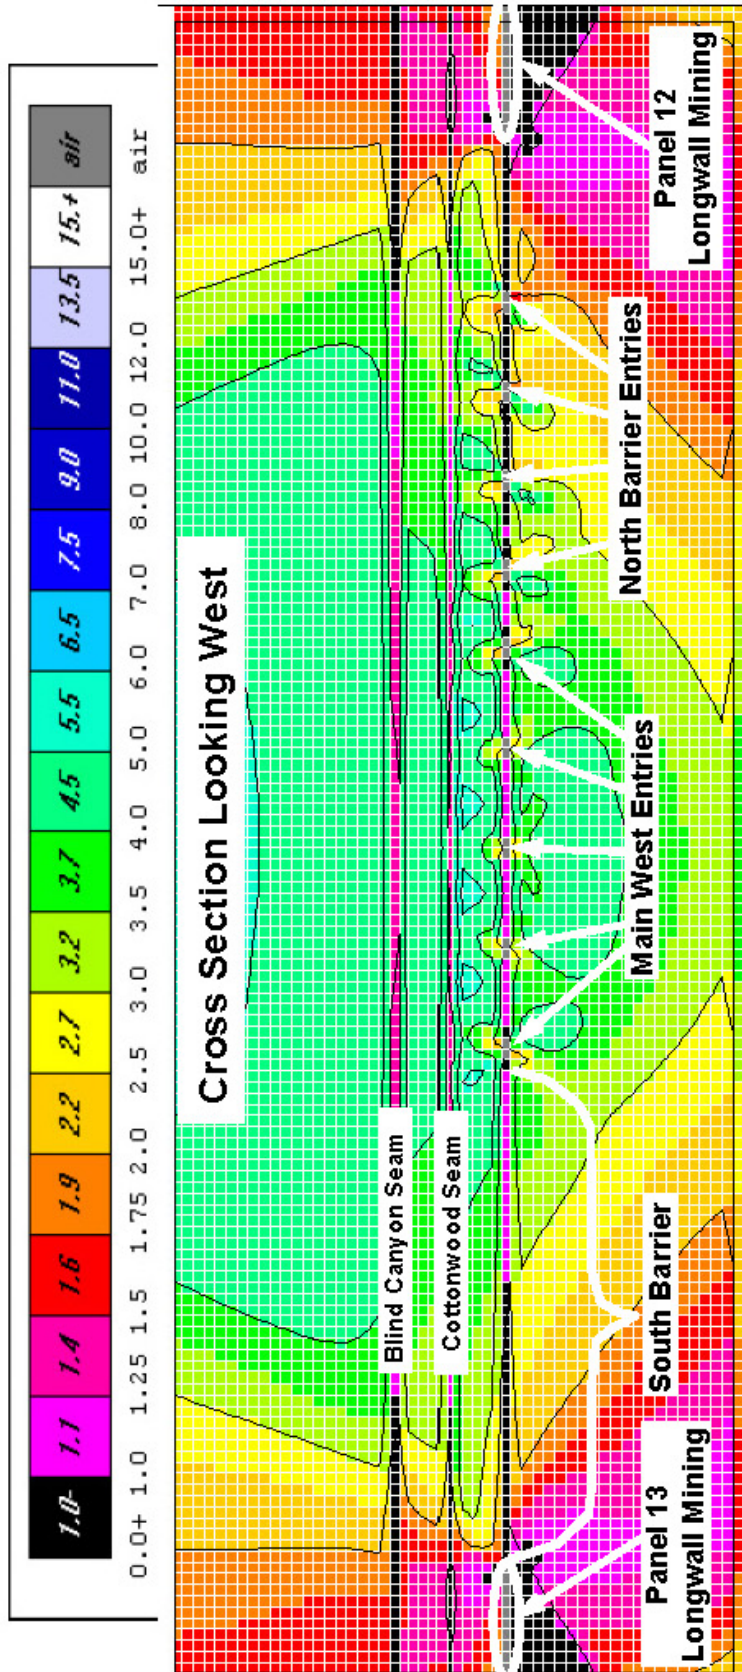
Figure 50 - Element Safety Factor Distribution after North Barrier Section Development

*North Barrier Section Development.* Model results from the third stage of excavation, development in the North Barrier, indicate that most elements in the north side barrier pillar are now at yield (note the black elements on the right side of Figure 50 at seam level). Rib elements in pillars adjacent to the Main West entries are also at yield. The outside entry of Main West shows ribs yielding in the pillar between it and the new north side barrier pillar entry. The south outside entry ribs show yielding extending 10 feet into the ribs and the highest safety factor in any pillar element in Figure 50 is 1.2.

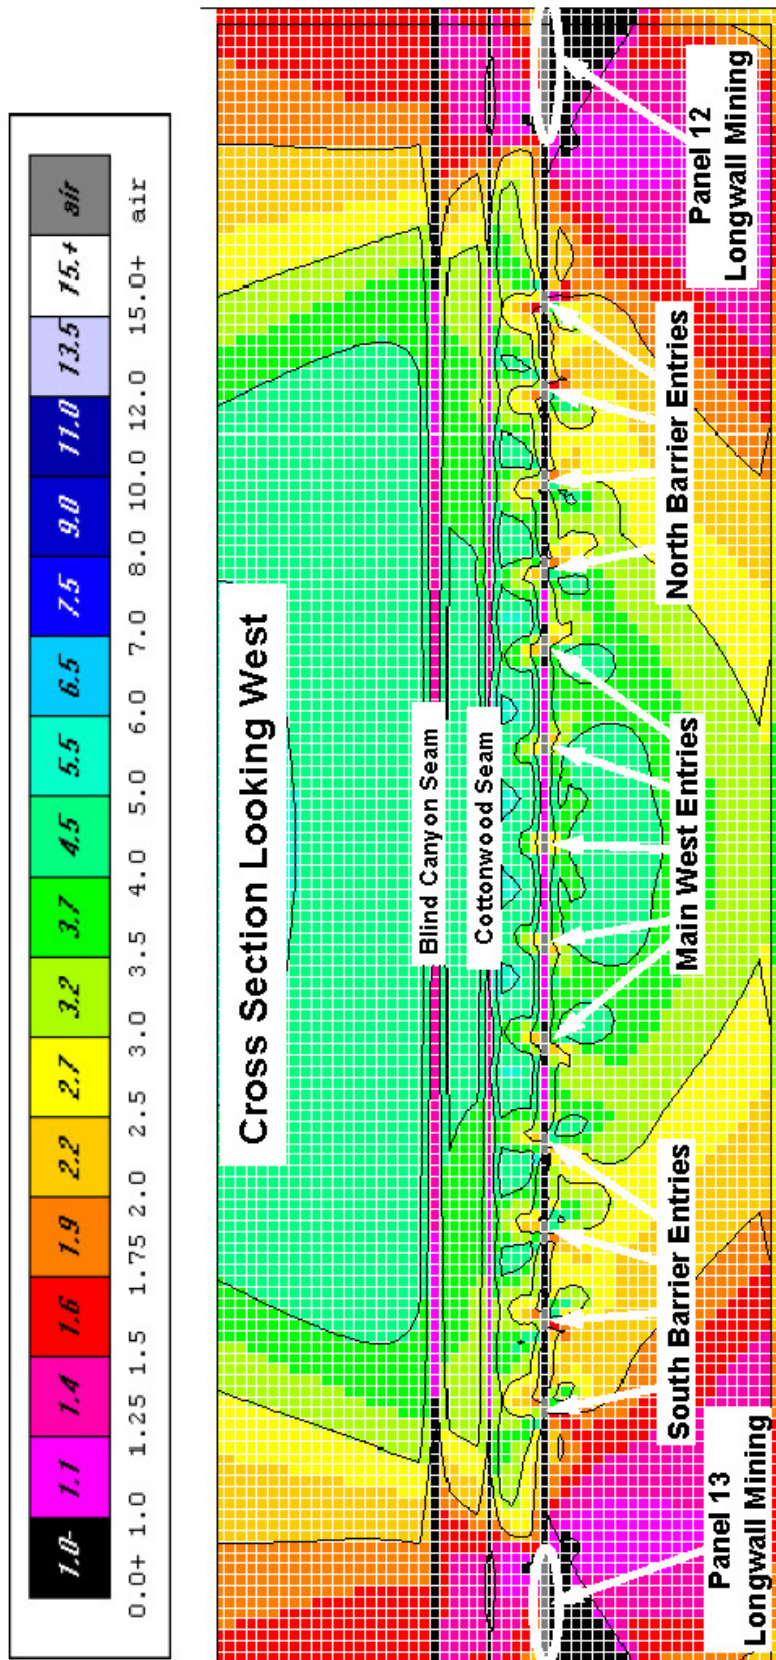
Figure 51 - Element Safety Factor Distribution after South Barrier Section Development

*South Barrier Section Development.* The fourth and last stage of analysis is entry development in the South Barrier. The distribution of element safety factors at this stage is shown in Figure 51. Almost all elements in the south side barrier pillar are now at yield and all pillar elements across the mining horizon are close to yield. Again, since purely elastic behavior leads to an underestimate of the extent of yielding, it is likely that yielding would spread further and affect portions of the pillars that have not yielded in the elastic model.

Peak vertical stress in the barrier pillars exceeds 38,400 psi, over 9 times the unconfined compressive strength of the coal. Horizontal stress exceeds 7,300 psi. Even so, this high confining pressure is insufficient to prevent yielding. The lowest vertical pillar stress is about 6,000 psi, almost half again greater than the unconfined compressive strength of the coal; the lowest horizontal pillar stress is about 1,500 psi. Any release of horizontal confinement would likely result in rapid destruction of pillars. Additionally, entries nearest to the mined panels are showing reduced roof and floor safety factors. Overlying coal seams are also yielding or are very close to yielding over portions of the barrier pillars, as seen in Figure 51. These model results are indicative of unstable conditions.

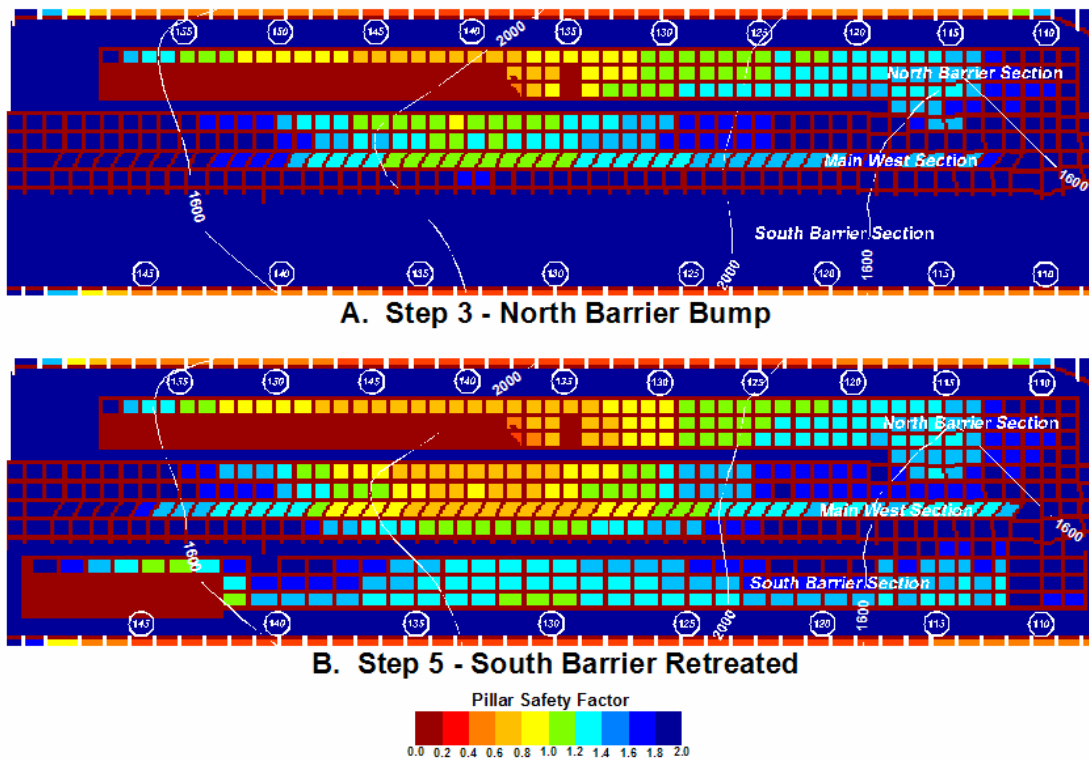
Figure 54 - Optimum Model Before and After South Barrier Section Mining

*LaModel Results.* The results from the optimum calibrated model for Crandall Canyon Mine are shown in Figure 54 and Figure 55. In these figures, “cooler” colors (green and blue) correspond to safety factors greater than 1.0. “Hotter” colors (yellow, orange, and red) correspond to safety factors less than 1.0 and, therefore, represent pillar failure. It is important to note that LaModel does not calculate any of the details of the coal or overburden failure mechanics. Since the program does not have any dynamic capabilities, it cannot distinguish between a gentle controlled pillar failure and a violent pillar burst. However, coal that bursts must be at, or very near, its ultimate strength at the time of the burst; therefore, it is reasonable in bump prone ground to associate the point of coal failure in LaModel simulations with coal bursts.

In Figure 54A, model results correlate reasonably well with conditions observed after the March 2007 bursts. For example, failure in the North Barrier section correlates well with observed damage. In this illustration, only one pillar appears to have failed in the Main West at the time of the burst. Figure 54B shows the development and retreat to crosscut 142 of the South Barrier section. In this illustration, safety factors for pillars in the South Barrier section remain above 1.0, although 42 pillars have failed in the Main West. Figure 55 demonstrates the catastrophic pillar failure propagation consistent with the August 6 collapse. In this simulation, 106 additional pillars fail in the Main West and 59 pillars fail in the South Barrier section. The failed area extends from crosscut 123 in the South Barrier section inby to crosscut 146 in the bleeder area. This optimum model simulates most of the critical observations of ground behavior at the Crandall Canyon Mine reasonably well.

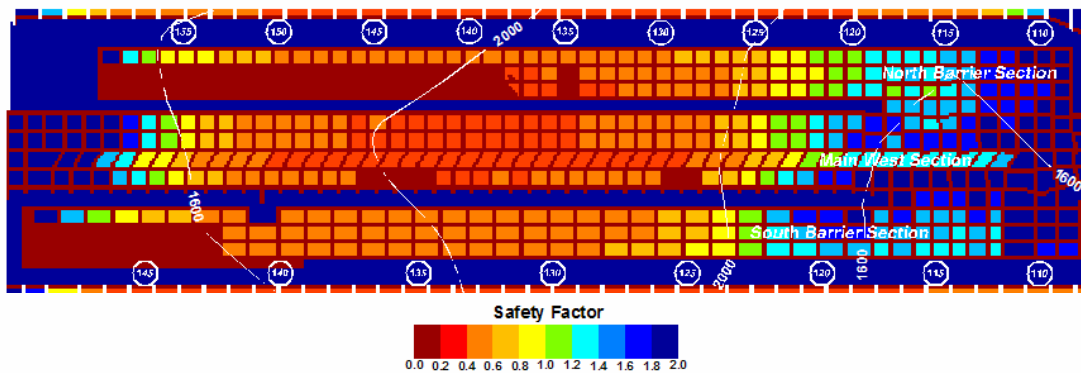
Figure 55 - Optimum Model after August 6 Failure

In all of these models, once the coal strength was calibrated to the March 10, 2007, North Barrier section outburst, results indicate that the pillars in the Main West were also close to failure. Once the South Barrier was subsequently developed, the model showed that it was very likely for the entire Main West and South Barrier entries to collapse upon the South Barrier development, or just a small perturbation was needed to initiate the collapse.

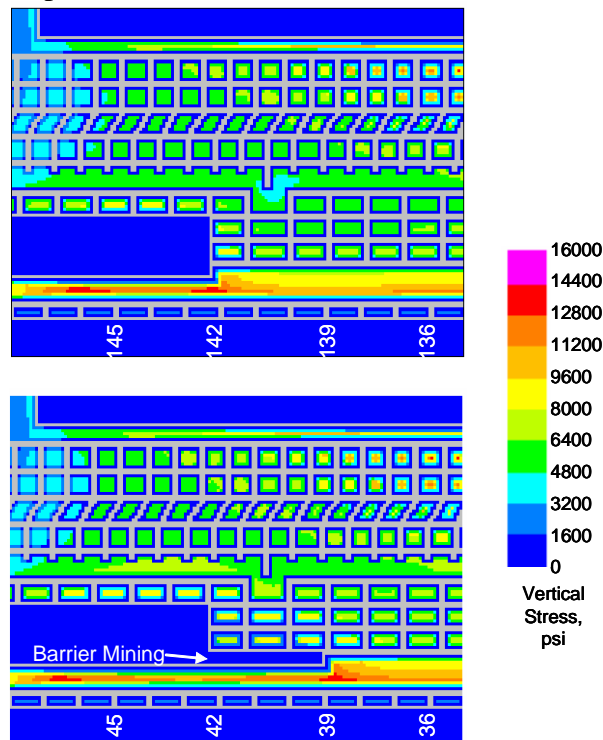
Figure 56 - Distribution of Vertical Stress in the South Barrier Section

The impact of barrier mining was evaluated by observing the distribution of vertical stress in the vicinity of the August 6 mining location. Vertical stresses were determined for the section before and after mining the barrier (see Figure 56). As discussed in the Main West Ground Control History section of this report, eight pillars and the adjacent barrier between crosscuts 139 and 142 were to remain unmined to protect the bleeder entry where it jogged around a sump in the Main West workings. The pillars were not mined but the barrier to the south was mined. Model results indicate that stress levels increased substantially in the pillars adjacent to the sump and were highest in the remnant barrier near the location where the South Barrier section crew was working at the time of the August 6 accident. These stress levels are similar in magnitude to those in the remnant barrier pillar inby crosscut 142 before barrier mining.

Stress redistribution associated with barrier mining occurred over a relatively broad area but diminished with distance from the extracted area. Vertical stress changes throughout the model can be determined by subtracting model results in the grid representing an intact barrier (Figure 56, top) from those in the grid that includes barrier mining (Figure 56, bottom). Negative values reflect stress decreases that result from either element removal (i.e., simulated mining) or yielding. Positive values represent stress increases.

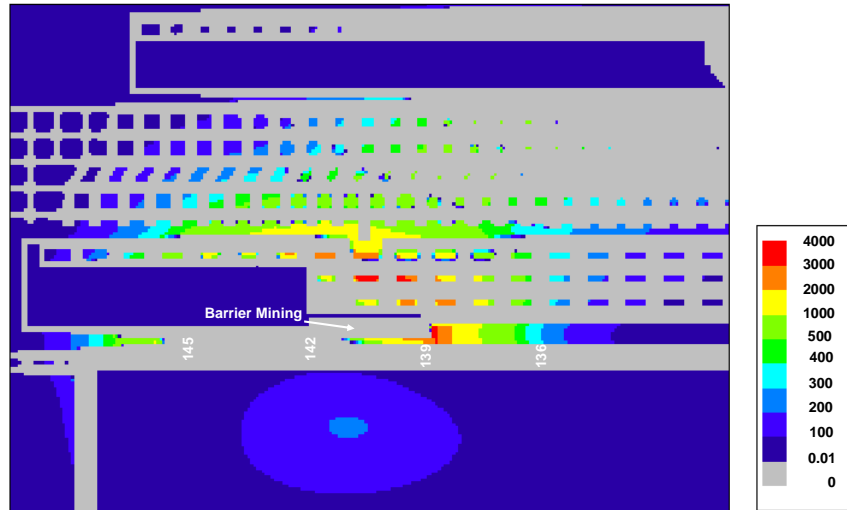
**Figure 57 - Vertical Stress Increases due to Barrier Mining**

The magnitude and distribution of increased vertical stress in the vicinity of the Main West sump are illustrated in Figure 57. Model results indicate that the highest increases (over 4,000 psi) occurred in the remnant barrier and adjacent pillars and decreased substantially within a relatively short distance. Stress increased in the Main West and outby in the South Barrier. However, it is important to note that the vertical stress scale in Figure 57 has been expanded in the interval from 0 to 500 psi to provide more detail in this range. Modeled stress increase was less than 200 psi within five crosscuts (~500 feet) of crosscut 139. Also, it should be noted that these values represent increases in individual elements rather than in average pillar stress.

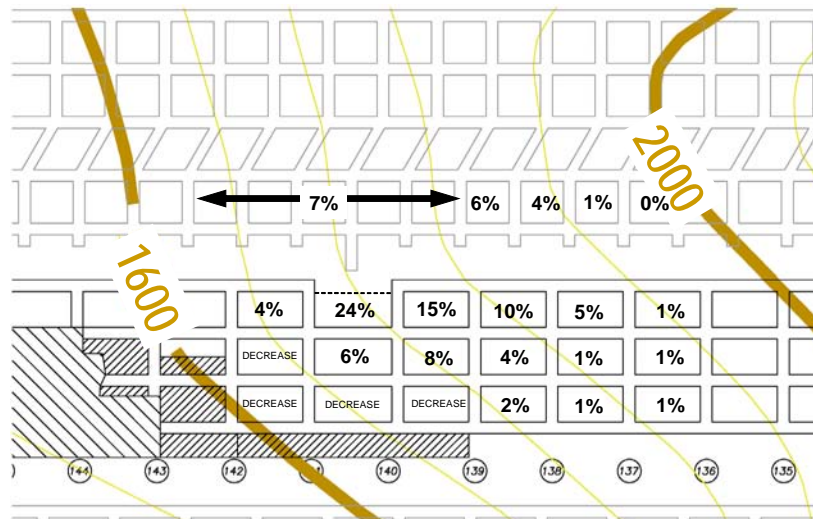
**Figure 58 - Effect of Barrier Mining on Average Pillar Stress**

As illustrated in Figure 58, average pillar stress decreased in the pillars immediately adjacent to the barrier mining. However, pillar yielding that caused these decreases contributed to load transfer and increased stress levels in adjacent pillars. Stress increases were largest in the vicinity of the bleeder entry. For example, model results indicate that vertical stress increased by 24% in a portion of the barrier adjacent to the Main West sump. The approved roof control plan excluded mining the barrier between crosscut 139 and 142 explicitly to protect the bleeder entry in this area. Model results indicate that mining in this area likely jeopardized the stability of the bleeder system inby crosscut 139. This activity also increased stress levels in the remnant barrier and pillars near the location where the South Barrier section crew was working at the time of the August 6 accident.

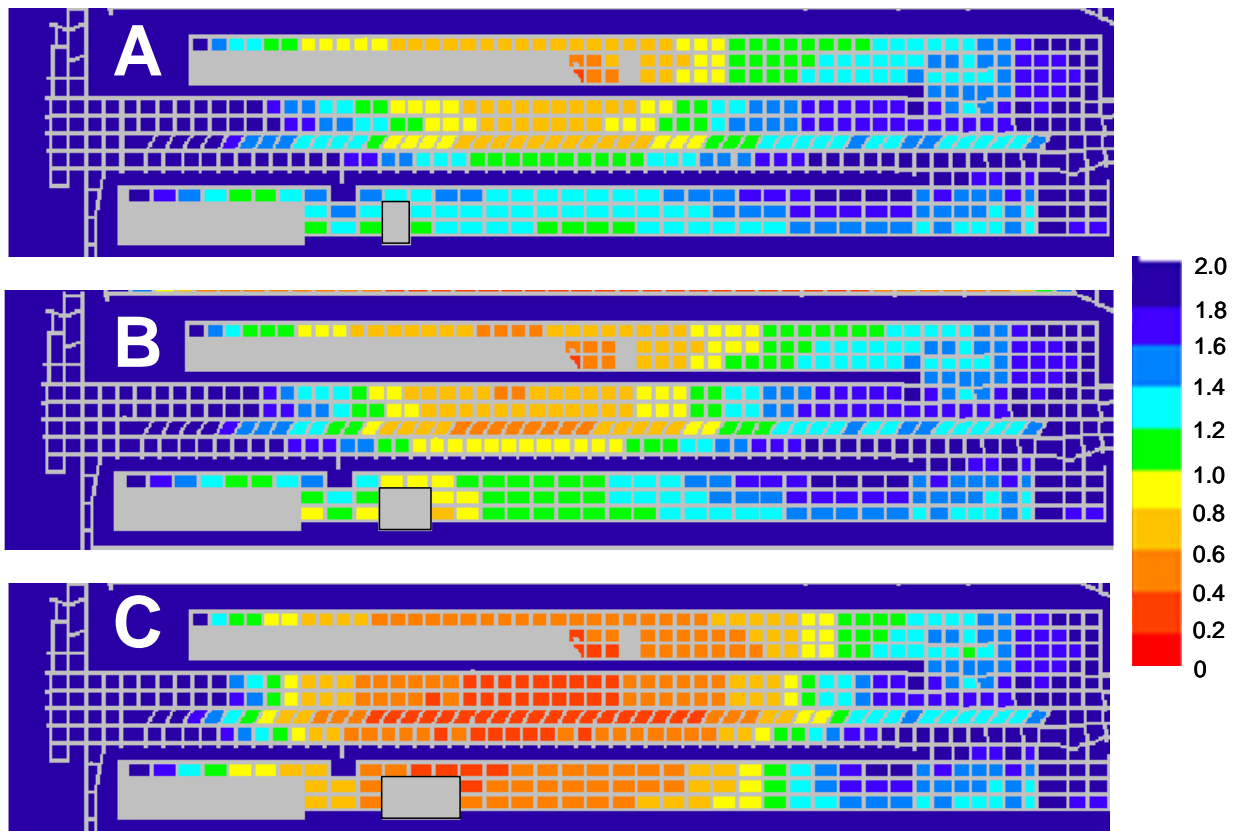
**Figure 59 - Pillar Safety Factors for Pillar Recovery Outby Crosscut 139**

Steps were added to Dr. Heasley’s model to simulate the planned pillar recovery outby crosscut 139 (with the barrier intact between crosscuts 139 and 142). Pillar safety factors associated with pillar extraction in the rows between crosscuts 139 and 136 are shown in Figure 59. These results indicate that even if the barrier had not been mined between crosscuts 139 and 142, pillars in the South Barrier section likely would have failed if pillar mining continued in the next several pillar rows. After one row of pillars is recovered, pillar SF’s are still above 1.0 as indicated by the blue and green colors in Figure 59A. When the next row of pillars is recovered (Figure 59B), failure occurs near the pillar line (yellow and orange) and with recovery of the third row, failure propagates outby over a broad area as indicated by the red and orange colors in Figure 59C.

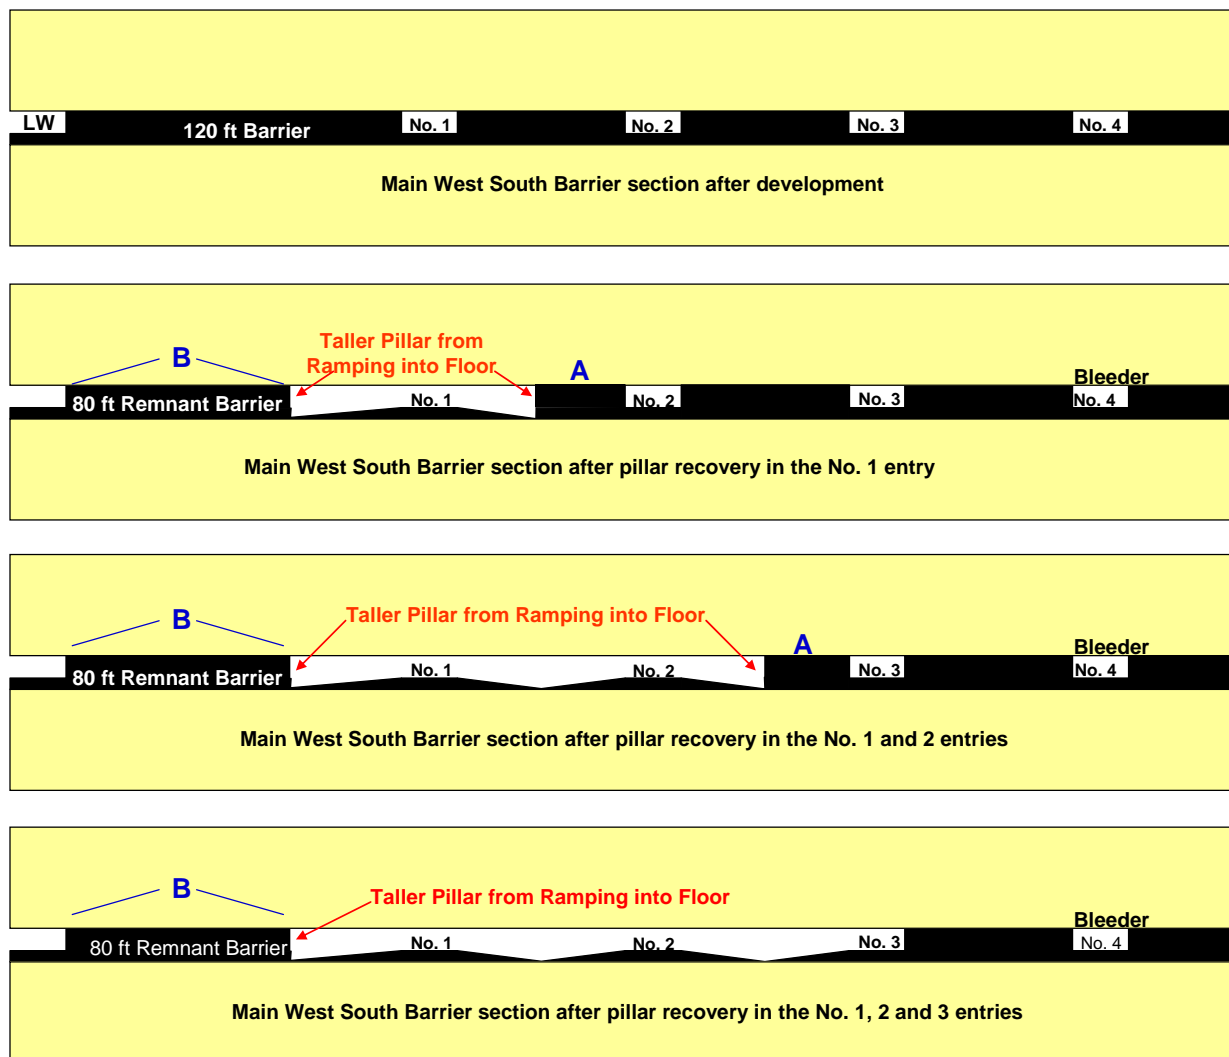
**Figure 60 - Cross-Section through South Barrier Section during Pillar Recovery**

Bottom mining creates taller pillars, which are generally weaker than shorter pillars of the same length and width. In the South Barrier section, the affected areas were the remnant pillars and the 80-foot wide remnant barrier labeled A and B, respectively, in Figure 60. Bottom mining in the pillars affected pillar stability as mining proceeded within each row. However, once a row

was completed, this effect was negated as the roof was intended to collapse after mining was completed.

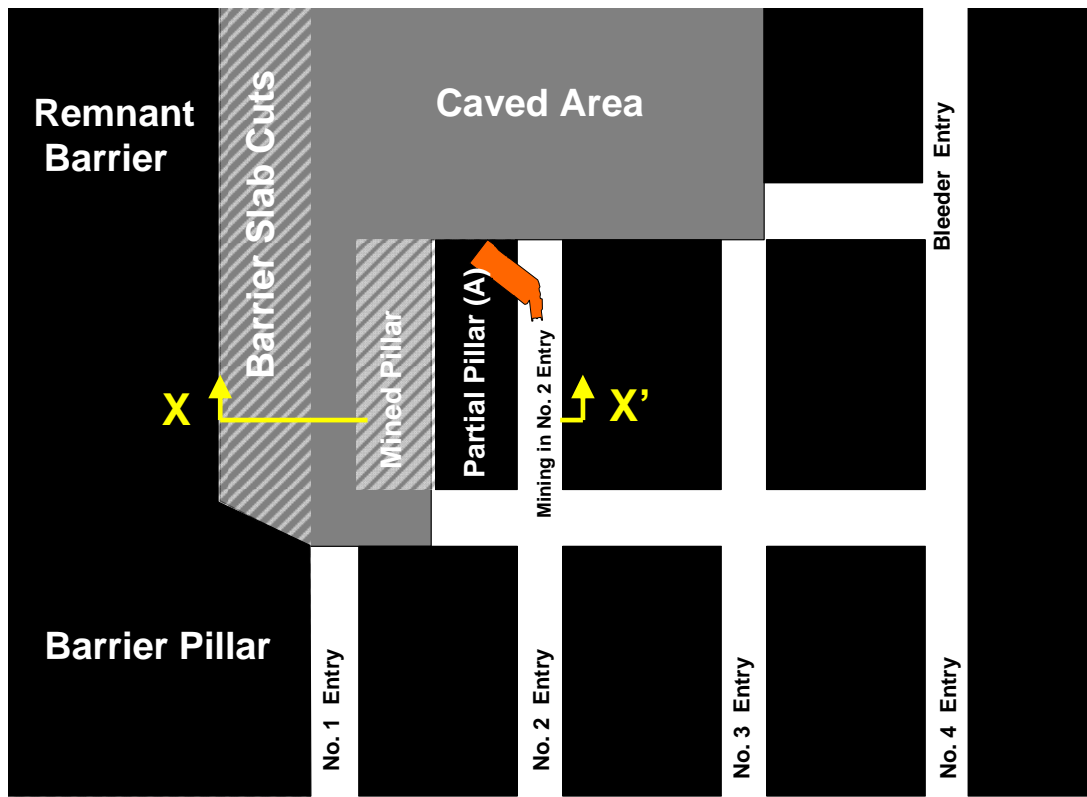
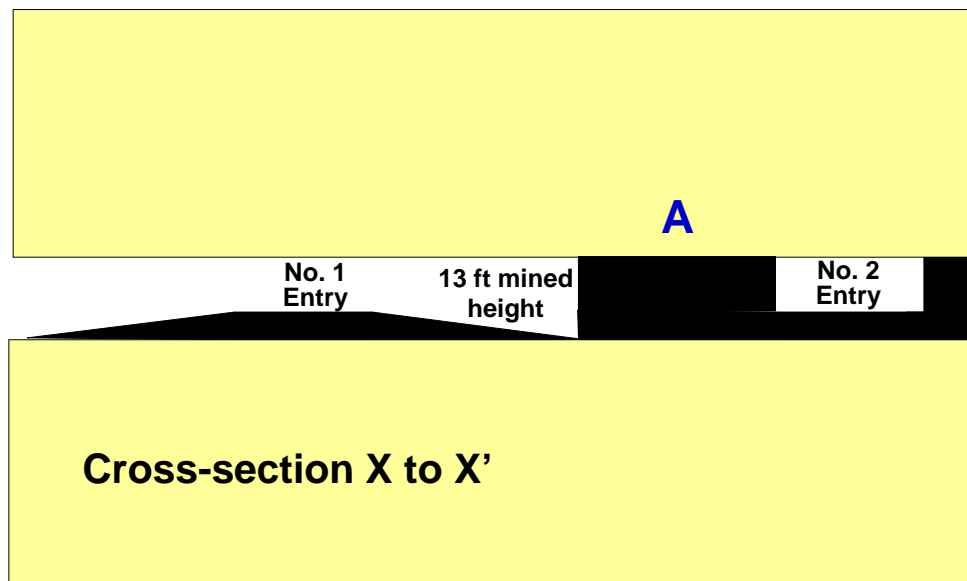
Figure 61 - Effect of Bottom Mining on Pillar Geometry  
(e.g. inby crosscut 142)

As illustrated in Figure 61, the partial pillar between No. 1 and No. 2 entry separates the mining crew from the caved area. The stability of the work area relies largely on the stability of the partial pillar, particularly as mining progresses outby to the intersection. Bottom mining on the gob side of this pillar increases the pillar height and effectively reduces its strength. A similar situation occurs when mining moves to the No. 3 entry. Thus, bottom mining can impact local stability even though the pillars are intentionally being reduced in size and the roof is expected to collapse. Also, bottom mining adjacent to the remnant barrier weakened the remnant barrier in the pillar line and contributed to overall instability of the section as it retreated.

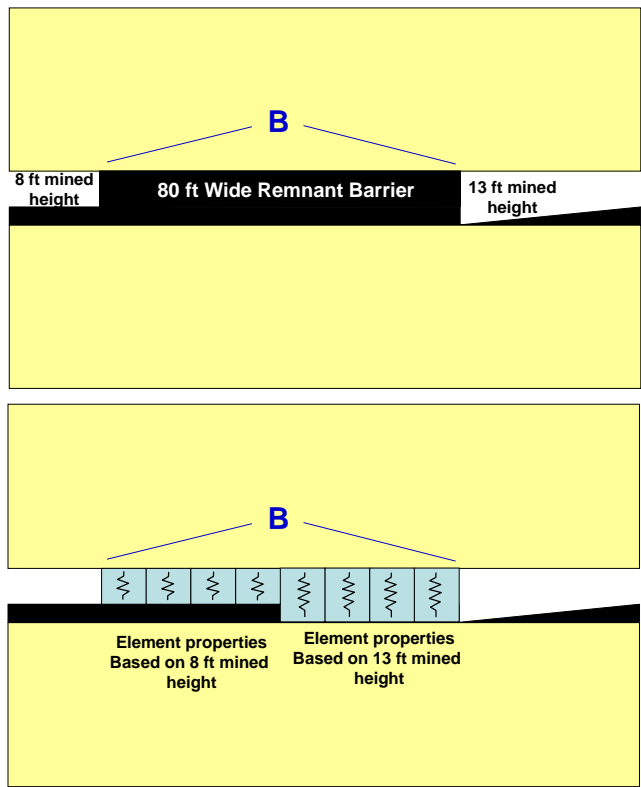
Figure 62 - Model Representation of Bottom Mining in the Remnant Barrier

Dr. Heasley's model was modified to evaluate the impact of bottom mining. As illustrated in Figure 62, one half of the remnant barrier was modeled using coal properties developed for a mining height of 8 feet, while the other half used a weaker coal strength and lower stiffness based on a mining height of 13 feet. Simulations with and without bottom mining were compared to measure the relative impact of the activity.

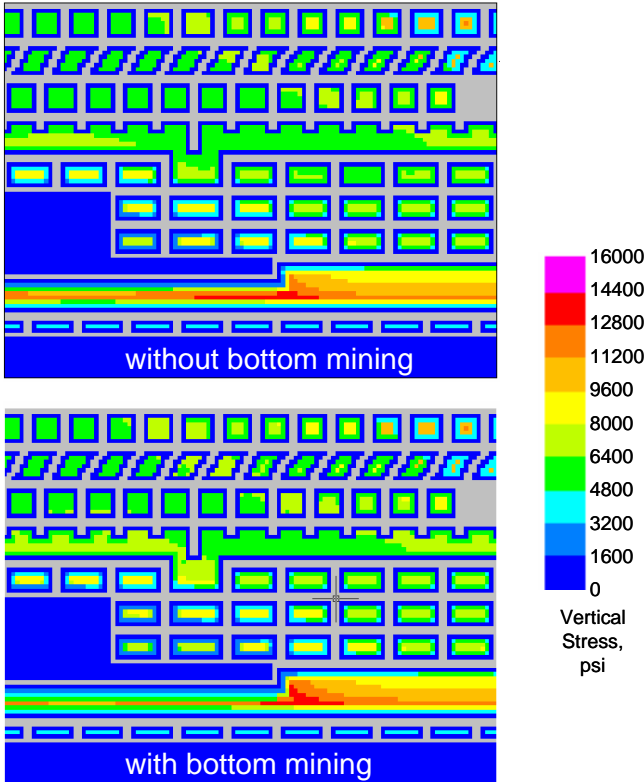
Figure 63 - Distribution of Vertical Stress in the South Barrier Section

The impact of bottom mining in the barrier was evaluated by assessing vertical stress levels and element safety factors in the vicinity of the August 6 mining location. The distributions of vertical stress with and without bottom mining are presented in Figure 63.

Although there are subtle differences over a broad area, the primary impact of bottom mining is seen in the remnant barrier. The core of the 80-foot wide remnant barrier has a higher peak and residual strength (Figure 63 top) when bottom mining is not conducted. With bottom mining, load that otherwise may have been supported by the barrier is redistributed to other elements. Stress redistribution was examined by subtracting model results in the two model grids shown in Figure 63. Negative values reflect stress decreases that result from lower element strength and/or yielding. Positive values represent stress increases. Since no additional mining was simulated, decreases between the models demonstrate the stress redistribution between elements. In effect, Figure 64 shows where stress increased and decreased as a result of bottom mining.

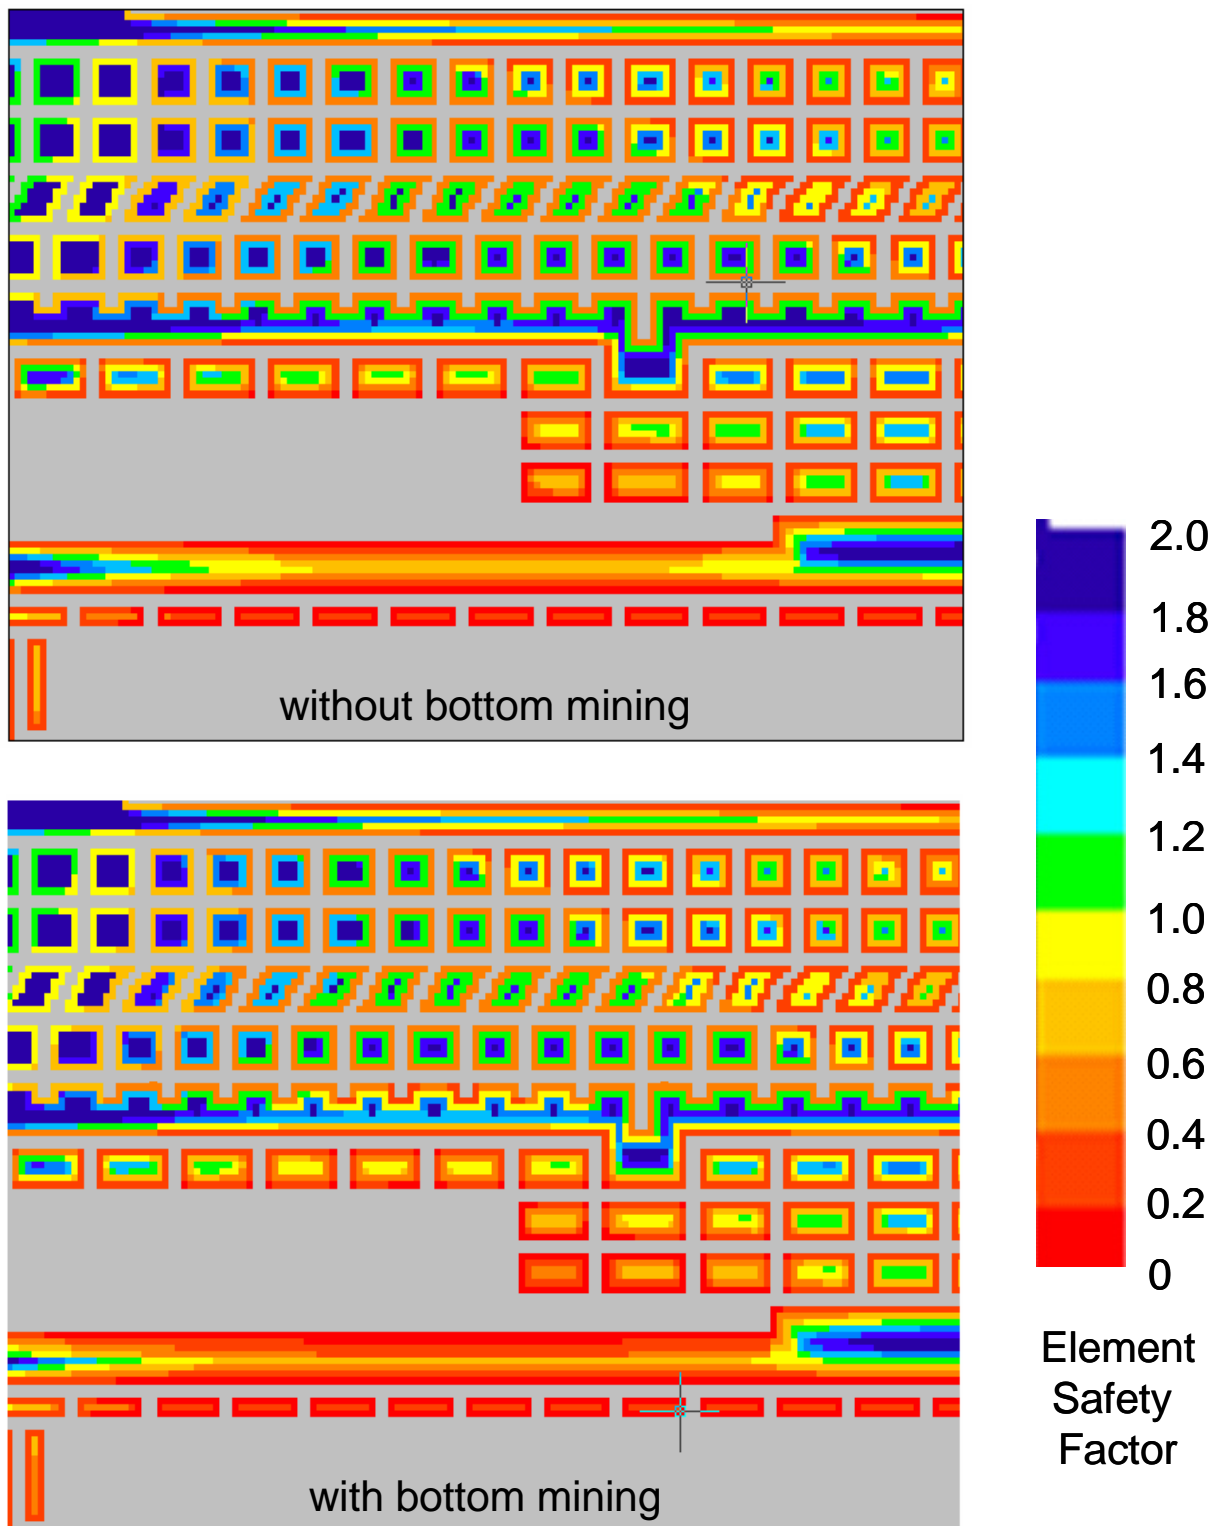
Figure 65 - Element Safety Factors

The element safety factors from the model results indicate that the remnant barrier would have failed even if the bottom coal had not been mined (Figure 65). Element stability factors below 1.0 in Figure 65 indicate that the peak strength of elements was exceeded across the entire width of the barrier even though the modeled mining height was 8 feet. The primary effect of bottom mining in by the pillar line was to weaken an already undersized remnant barrier. Bottom mining in the barrier cuts between crosscuts 139 and 142 weakened the barrier near the last known location of the miners and, consequently, contributed to increased stress levels.

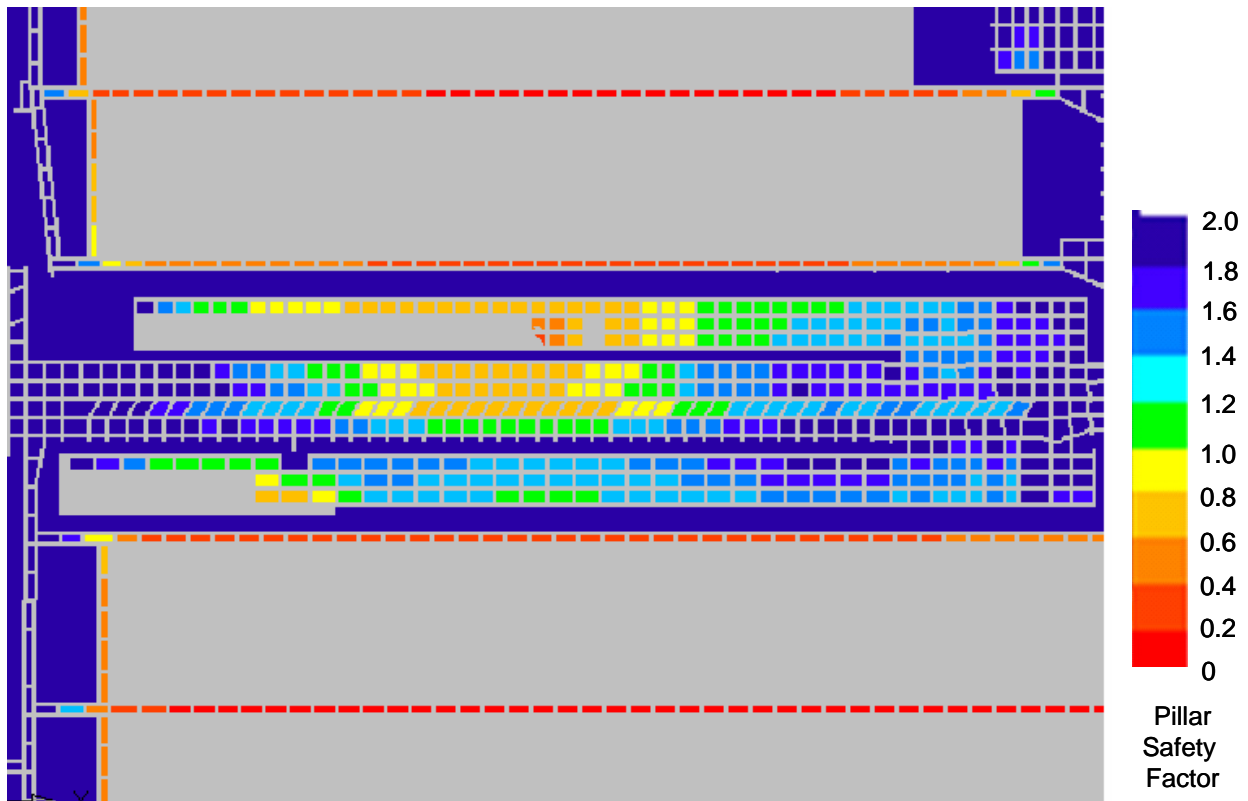
**Figure 66 – Pillar Safety Factors Modeled with a 120-foot Southern Barrier**

Figure 66 illustrates pillar safety factors calculated for the Main West region as it was actually developed and recovered prior to the August 6 accident. These model results are consistent with Dr. Heasley's results that show some pillar failure in the sealed portion of Main West but stable pillars in the section after development and after the pillar recovery prior to the August 6 accident. Although broad pillar failure can be triggered by one of several mechanisms, the model demonstrates a general reluctance for the Main West failure to propagate south past the

75-foot wide barrier pillar (modeled as 80 feet wide) and into the South Barrier Section. In contrast, when the north side barrier width is reduced to 55 feet (modeled as 60 feet), Main West pillar failure propagates southward into the section during development mining.

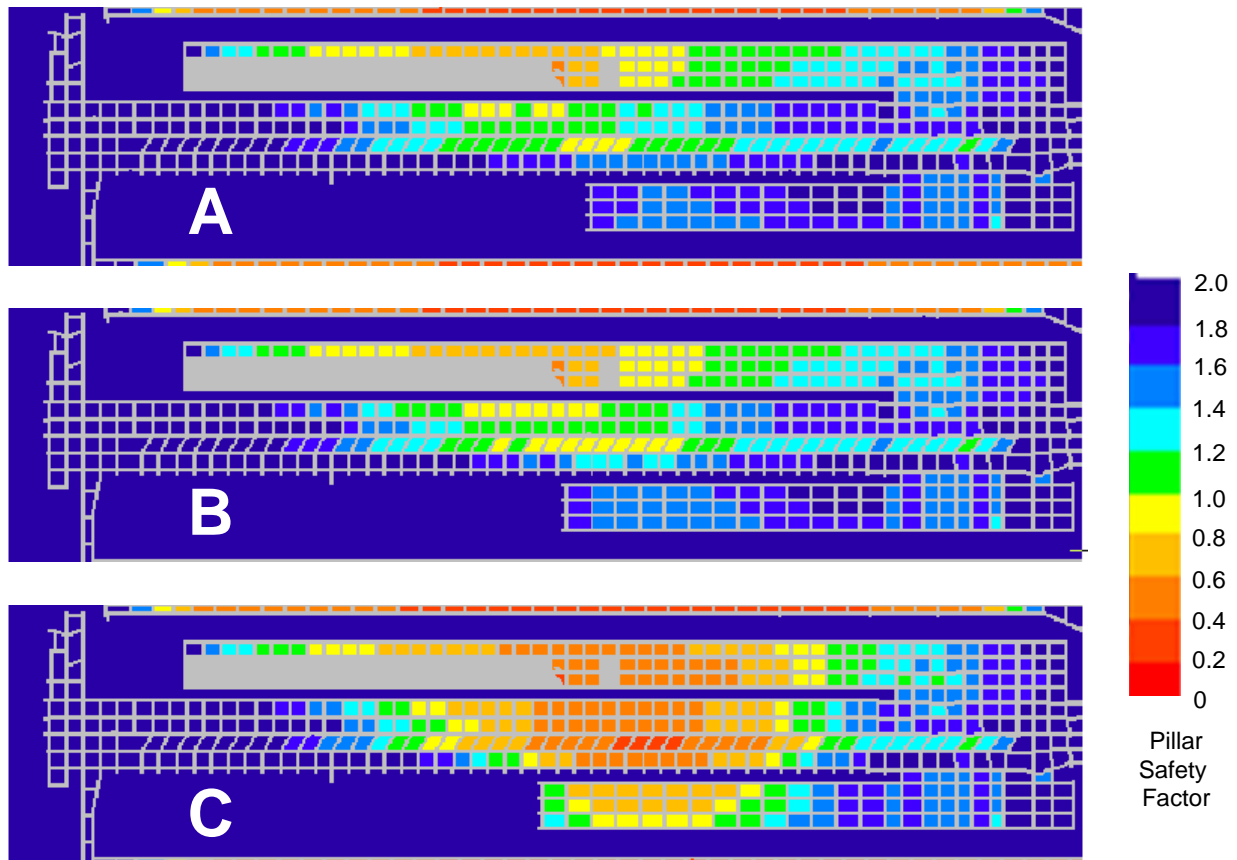
**Figure 67 – Pillar Safety Factors Modeled with a 140-foot Southern Barrier for Development Mining**

Figure 67 illustrates pillar safety factors for three model steps that represent development mining in the South Barrier section modeled with a 60-foot north side and a 140-foot south side barrier. In Figure 67A, pillars in the South Barrier section are stable as indicated by the blue colors. In Figure 67B, one additional crosscut has been developed. The South Barrier section remains stable but several additional pillar failures are noted in the Main West. In Figure 67C, another crosscut has been developed and failure is widespread throughout the South Barrier section as noted by the yellow and orange colors. A wider barrier south of the section (137-foot versus the 121-foot actually mined) may have decreased the likelihood of failure from Panel 13 longwall extraction abutment stress. However, model results suggest that pillar failure may have occurred in the section during development as a result of the corresponding reduction of barrier width to the north (55 feet initially planned versus 75 feet as mined measured outside the Main West notches).

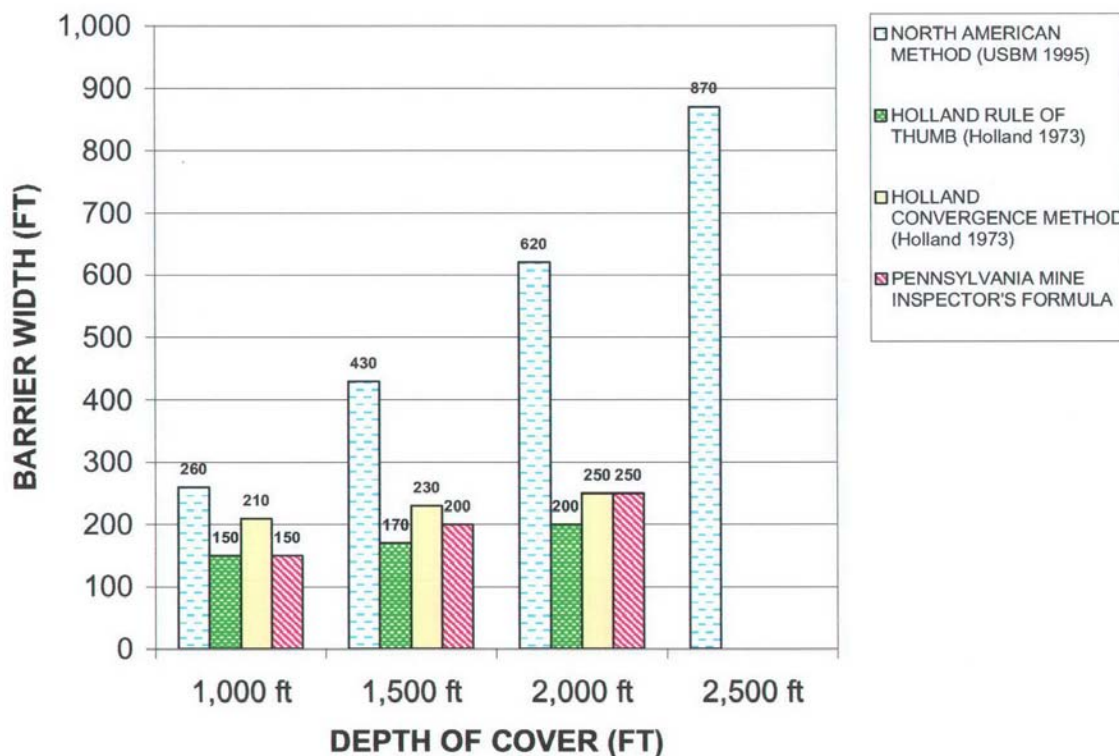
**Figure 68 - Barrier Pillar Sizes from Empirical Methods**  
**Figure 4 in AAI's May 5, 2000, Report**

AAI had considered four of these equations in a 2000 project which evaluated the effects of barrier pillar widths on future bleeder entry stability for Panel 15, south of Main West (see Appendix E). Results of AAI's analyses in that study are illustrated in Figure 68<sup>‡</sup>. AAI stated that this figure “*gives a summary of recommended barrier pillar widths by various empirical*

As indicated in Figure 68, AAI had previously used the North American method to determine barrier width in overburden depths up to 2,500 feet. This method is the only one of the four that accounts for the width of the adjacent panel in determining the barrier width. AAI's results in Figure 68 were based on using two longwall panel widths (~1,560 feet) and, even at lower depths of cover, this method recommends wider barrier widths than the other three methods. This is a reasonable assumption, given the caving characteristics of strata in the Wasatch Plateau (i.e., maximum subsidence may not be achieved with the extraction of a single panel – see Appendix L). However, if one panel width is used (~800 feet), the calculated barrier widths are much more consistent with the other methods (i.e., 130 feet wide at 1,000 feet of overburden, 210 feet wide at 1,500 feet of overburden, 310 feet wide at 2,000 feet of overburden, and 430 feet wide at 2,500 feet of overburden). As indicated in Table 9, the recommended barrier width using this approach is 357 feet for 2,160 feet of overburden (the depth at which pillar recovery was abandoned in the North Barrier section). Although this approach generates a narrower barrier width than what AAI had calculated in 2000, the recommended width is still nearly three times larger than the 130-foot width determined through numerical modeling in AAI's 2006 studies.

Also, the 130-foot dimension is approximately half the width that the barrier design equations would recommend for a depth of 2,000 feet. This is significant since about 25% of the Main West North and South Barriers have overburden exceeding 2,000 feet. Whereas the numerical model results for barrier design in the May 2000 study were consistent with empirical design equations, the 2006 results were not.
