REPORT OF INVESTIGATION

Fatal Underground Coal Burst Accidents  
August 6 and 16, 2007

Crandall Canyon Mine  
Genwal Resources Inc  
Huntington, Emery County, Utah  
ID No. 42-01715

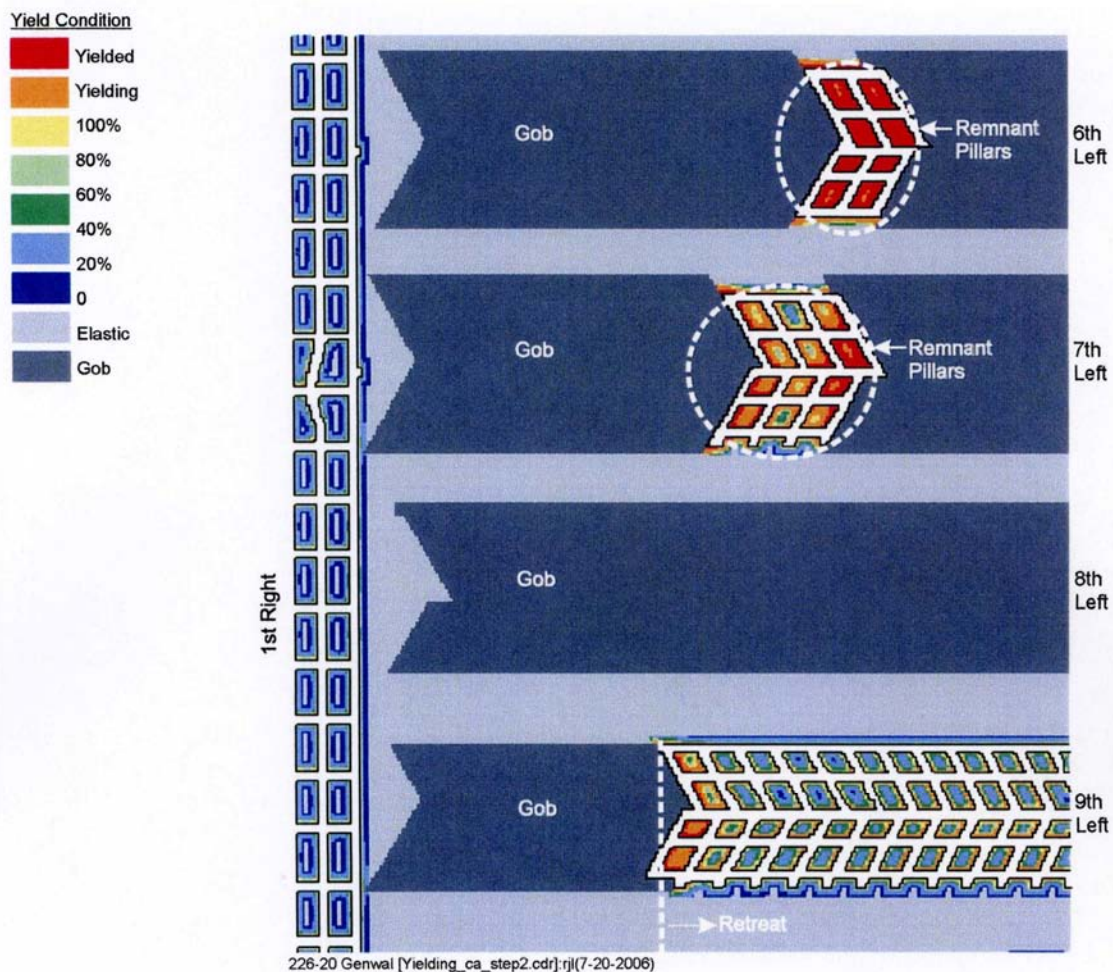
**Figure 71 - Modeled Yield Condition - Partial Retreat in 9th Left Panel**

AAI claimed that they calibrated the LaModel program using three criteria: vertical stress, convergence, and yielding condition. Lamination thicknesses and coal strength were varied to gauge the sensitivity of model results, reportedly to calibrate to all three input criteria. In their written response to the accident investigation team, AAI indicated that this activity resulted in a calibrated model that simultaneously fit all three criteria. However, interview statements of the AAI engineer that did the modeling reveal that the calibration process relied exclusively on an evaluation of pillar yield condition. Coal strength was adjusted until pillars in the first pillar row of the 1<sup>st</sup> North, 9<sup>th</sup> Left Panel (immediately north of Main West crosscut 99) yielded during panel retreat while the outby rows did not (Figure 71).

While mining the 9<sup>th</sup> Left panel, difficult roof conditions were encountered (i.e., “peeling top coal”) on the pillar line. AAI noted that 2.0 inches or more of convergence was associated with the yielded pillar row in their “calibrated” model. Thus, 2.0 inches of convergence was considered a site-specific indicator of potential roof and rib instability for subsequent predictive models.

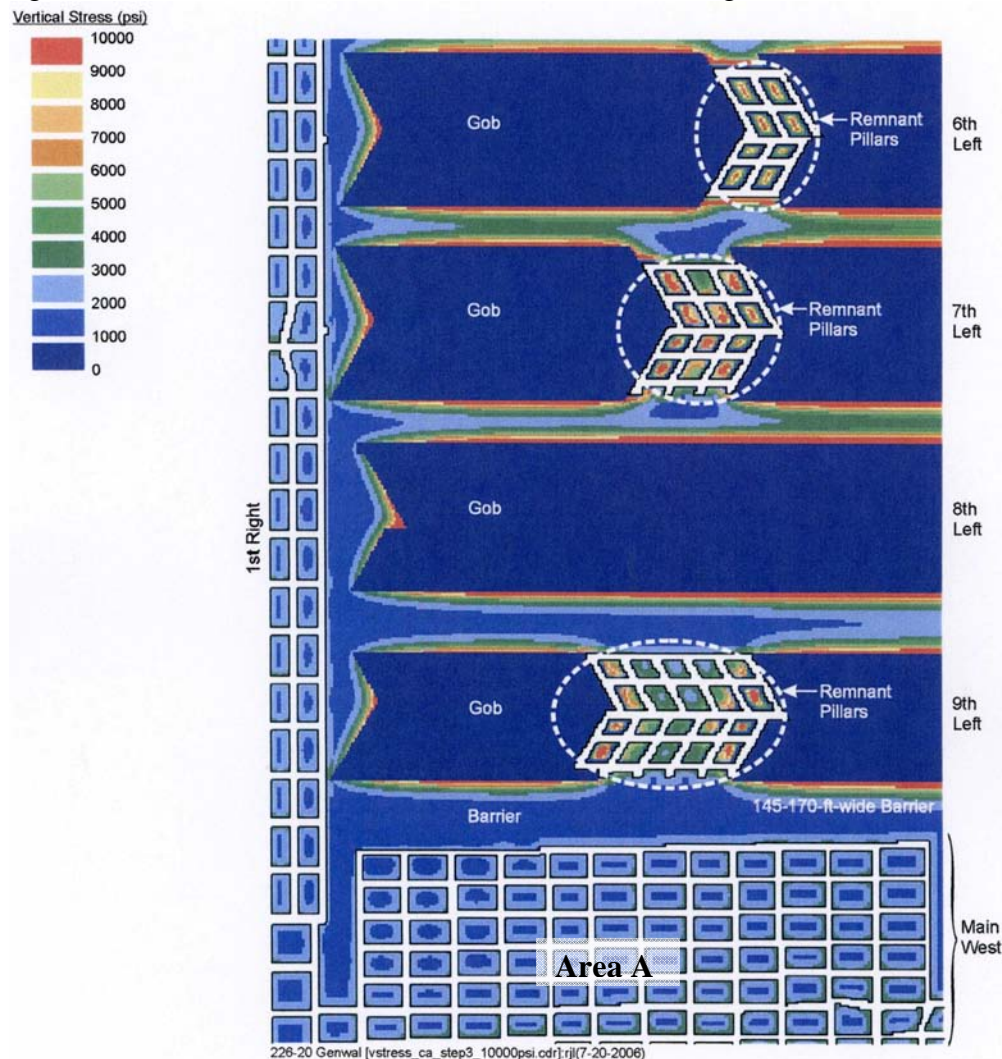
Figure 72 - Modeled Vertical Stress – Retreat Completed in 9<sup>th</sup> Left Panel

AAI also interpreted abutment stress transfer from their model of the completed 9<sup>th</sup> Left Panel. As illustrated in Figure 72, AAI's model included mining that was done north of the Main West entries. This northward extension of Main West (labeled "Area A" in Figure 72) was developed intermittently between 2003 and 2005 and approached to within about 145 feet of the 9<sup>th</sup> Left Panel. AAI interpreted model results to show "no significant side abutment stress override across the barrier on the main pillars, consistent with actual conditions." Since this interpretation appears in a report section titled "1<sup>st</sup> North Left Panels Back-Analysis," it appears to be intended to support the validity of AAI's model. However, the interpretation actually does little to verify that abutment stress transfer in AAI's model is reasonable.

Underground observations made by the accident investigation team (in Area A, Figure 72) confirmed that there were no significant effects of abutment stress transfer from the adjacent 9<sup>th</sup> Left Panel. However, this observation does not validate AAI's model results. Given the geometry, substantial abutment stress effects would not be anticipated to occur in Area A. The center of this area is bounded by unrecovered pillars in the 9<sup>th</sup> Left Panel. One end of the area is bounded by solid coal and the other by a barrier and unmined pillars of the 1<sup>st</sup> Right Mains. A more appropriate method of validating model behavior is to correlate model results with stress damage (e.g., roof or rib deterioration) rather than a lack of damage.

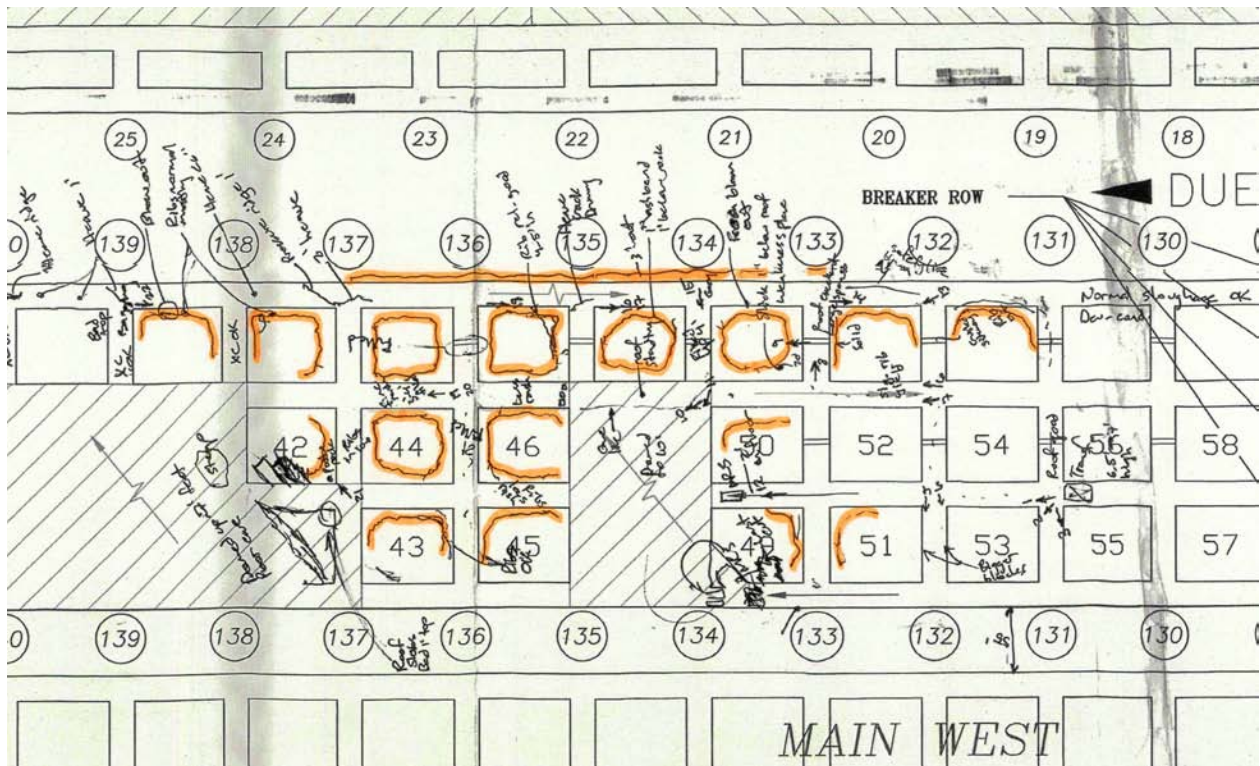
**Figure 73 - Notes Made by AAI on March 16, 2007  
(orange lines added for emphasis)**

Photographs, sketches, and interview statements of others indicate that the area affected by the burst was not limited to six or seven pillars and did extend outby. BLM’s Falk noted, for example, that “*Entry ways outby two breaks from the face had extensive rib coal thrown into the entry way. Stress overrides outby the face were very concerning.*” AAI’s field notes also suggest that the damage was more widespread (see Figure 73). The remnants of damaged pillars are sketched inside the original pillar boundaries as indicated by the orange lines in the figure. Photographs taken in this area during AAI’s March 16 visit are included in Appendix O.

AAI attributed the March burst to a lagging cave inby crosscut 138 and the start-up cave between crosscuts 134 and 135 based on their onsite observations. The model grid was changed to reflect this condition. Open entries (as opposed to gob material) were used to represent the areas between crosscuts 134 to 135 and 138 to 139. However, this change had a negligible effect on the model results. Since the gob modulus used in both models was very low, the amount of load transmitted to the gob (rather than transferred to adjacent pillars) was small in either case. Models run by the accident investigation team indicated that peak stress in the gob only increased by approximately 7 psi when the lagging cave was replaced with AAI's low gob modulus.

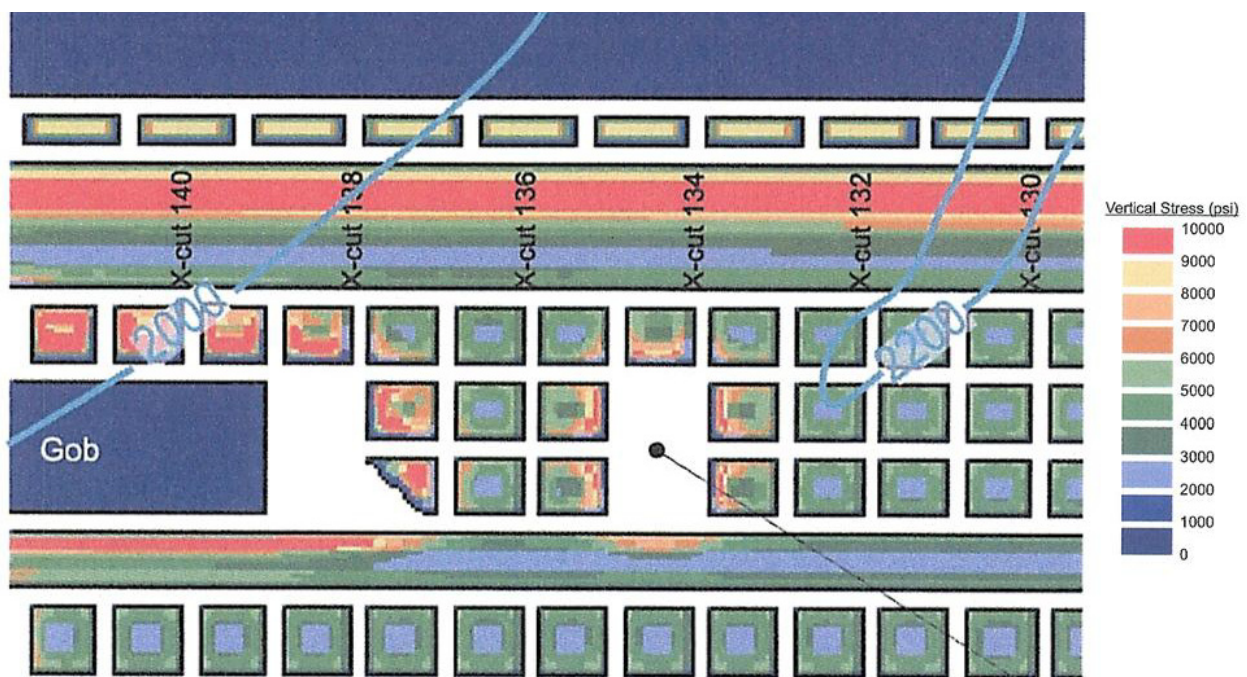
Figure 74 - AAI Model Results of Vertical Stress in March 2007 Burst Area

Models that AAI developed after the March bursts indicated that high stresses were concentrated in the area between these two partially caved or un-caved gobs (see Figure 74). A comparison of Figure 73 and Figure 74 indicates that, even with the lagging cave incorporated into the model, high vertical stresses do not coincide with the extent of damage observed in the mine. Modeled vertical stresses in pillars between crosscuts 136 and 137 appear to be quite similar to stress levels in pillars outby crosscut 133. Furthermore, the pillars outby 133 appear to be largely unaffected by stress transfer from either the longwall gob to the north or the un-caved pillared area between crosscuts 135 and 134. AAI postulated that a dynamic failure (a localized burst) of these pillars could have propagated to pillars over a much wider area.

The changes that AAI made to their numerical model after the March bursts did not constitute a recalibration of the model to the observed ground conditions. Had the disparity between field conditions and model results prompted a careful examination of model input and model recalibration, a properly constructed model would have shown that the South Barrier section mine design was destined to fail. The following section illustrates the output that can be derived by a properly constructed model using AAI's reported parameters.

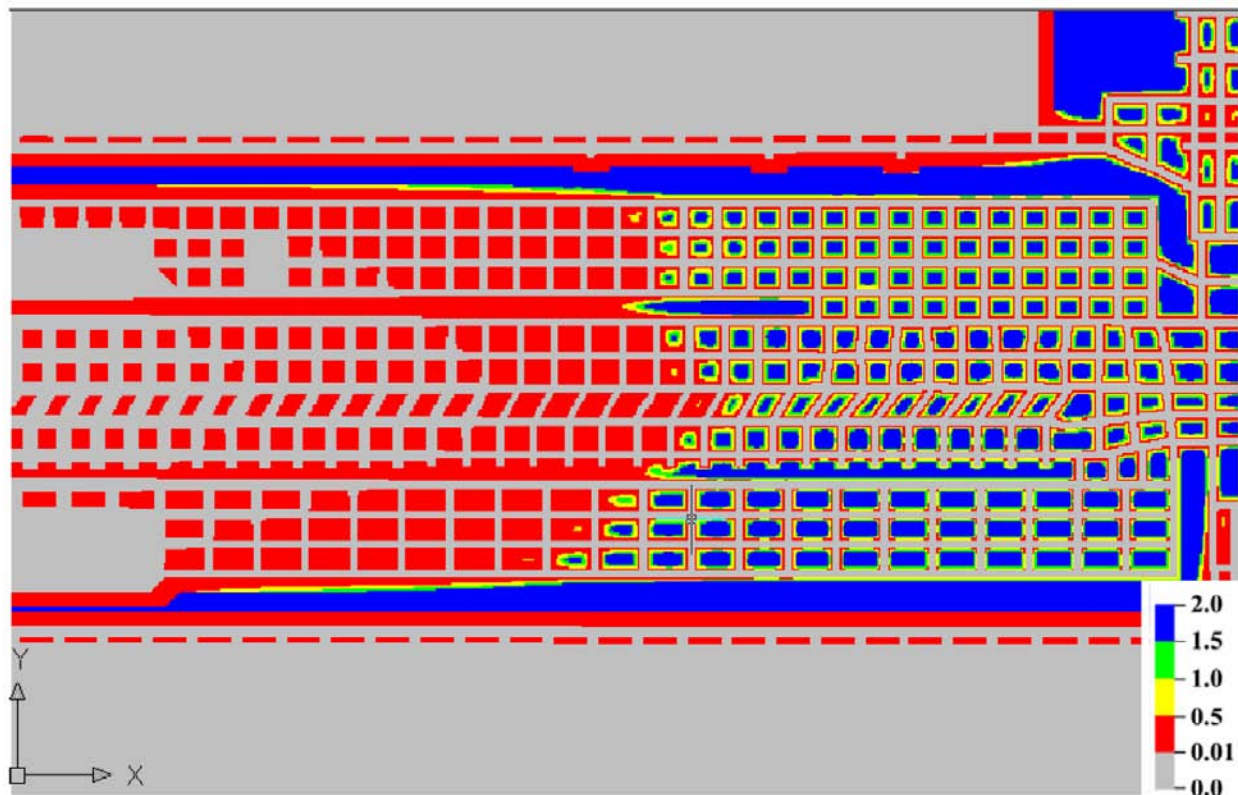
**Figure 75 - Element Safety Factors with Coal Properties Distributed as Indicated in AAI Report**

*BEM Using AAI Model Constructed as Reported.* LaModel analyses were conducted with coal properties distributed as outlined in the text of AAI's July 20 report (Appendix F). Results indicate that pillars in the North and South Barrier sections would have failed over a relatively

broad area (Figure 75). In this figure, red and yellow represent elements with a safety factor less than 1 (i.e., the element is considered to have failed).

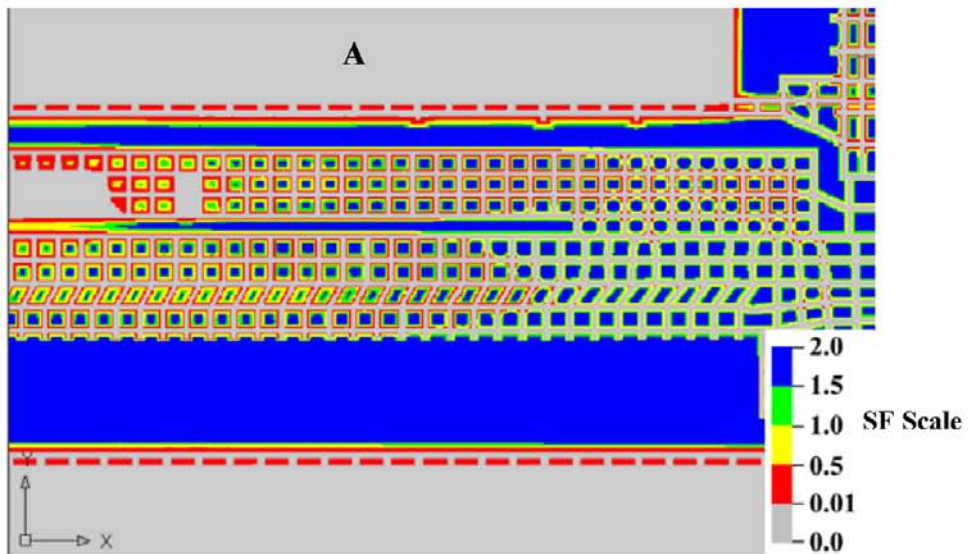
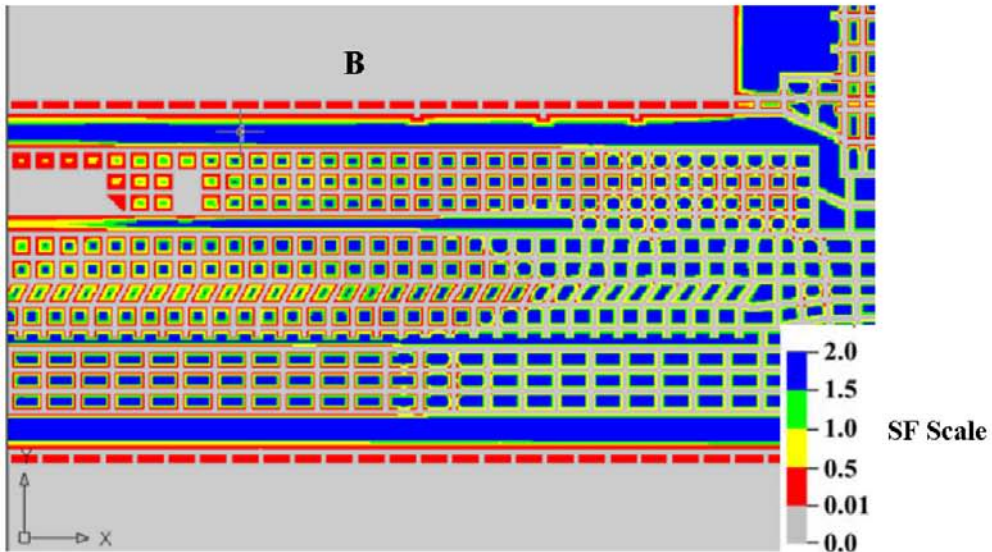
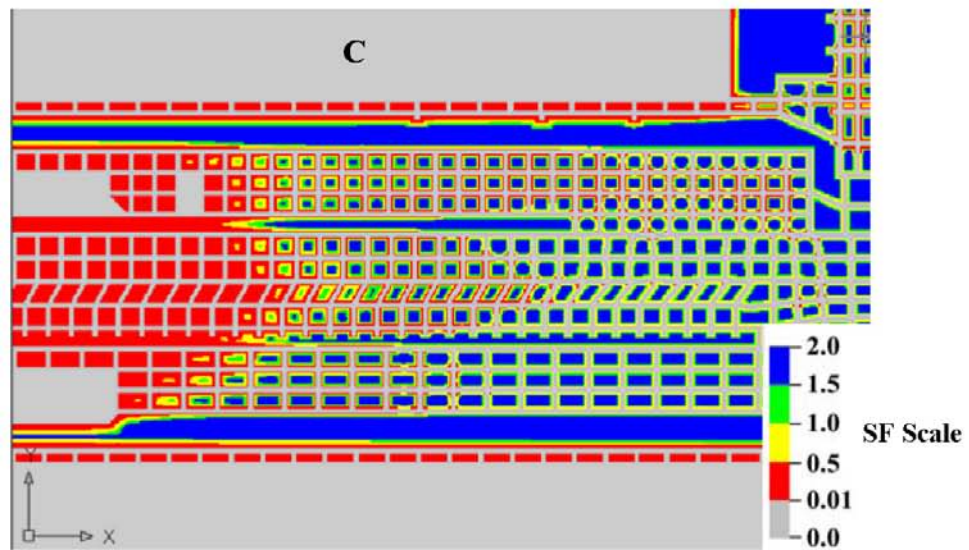
Figure 76 - Element Safety Factors using Modified Coal Strength Property Distribution, Gob Properties, and Lamination Thickness

Figure 76 illustrates element safety factors from a simulation in which AAI's model was further modified to reflect gob properties and lamination thicknesses more consistent with their calibrated EXPAREA model. In this case, a bilinear gob model was used rather than strain hardening and lamination thickness was increased to 115 feet rather than 25 feet. The greater thickness was established using an equation provided by Heasley<sup>5</sup>. Also, rather than modeling a single scenario as AAI had, mining in the North and South Barriers was modeled as three steps: (A) North Barrier pillar recovery to crosscut 133, (B) South Barrier development and (C) South Barrier pillar recovery to about crosscut 131. Results of these model steps are illustrated in Figure 76. Both models (Figure 75 and Figure 76) show widespread pillar failure.

Element safety factors based on the modified model show pillar failure near the site of the March 10 outburst accident (Figure 76 A). Pillar rib elements fail under the deepest cover but pillars remain stable as the South Barrier is developed (Figure 76 B). However, as pillars are recovered in the South Barrier, failure propagates outby the face and extends into the Main West and North Barrier section workings. Although the model does not match the observed damage as well as Dr. Heasley's model, it is generally consistent with the failures that occurred in March and August 2007 at Crandall Canyon Mine. The modeling results illustrate that a properly constructed and calibrated model will depict that the South Barrier section pillar design is unstable and destined to wide spread failure.

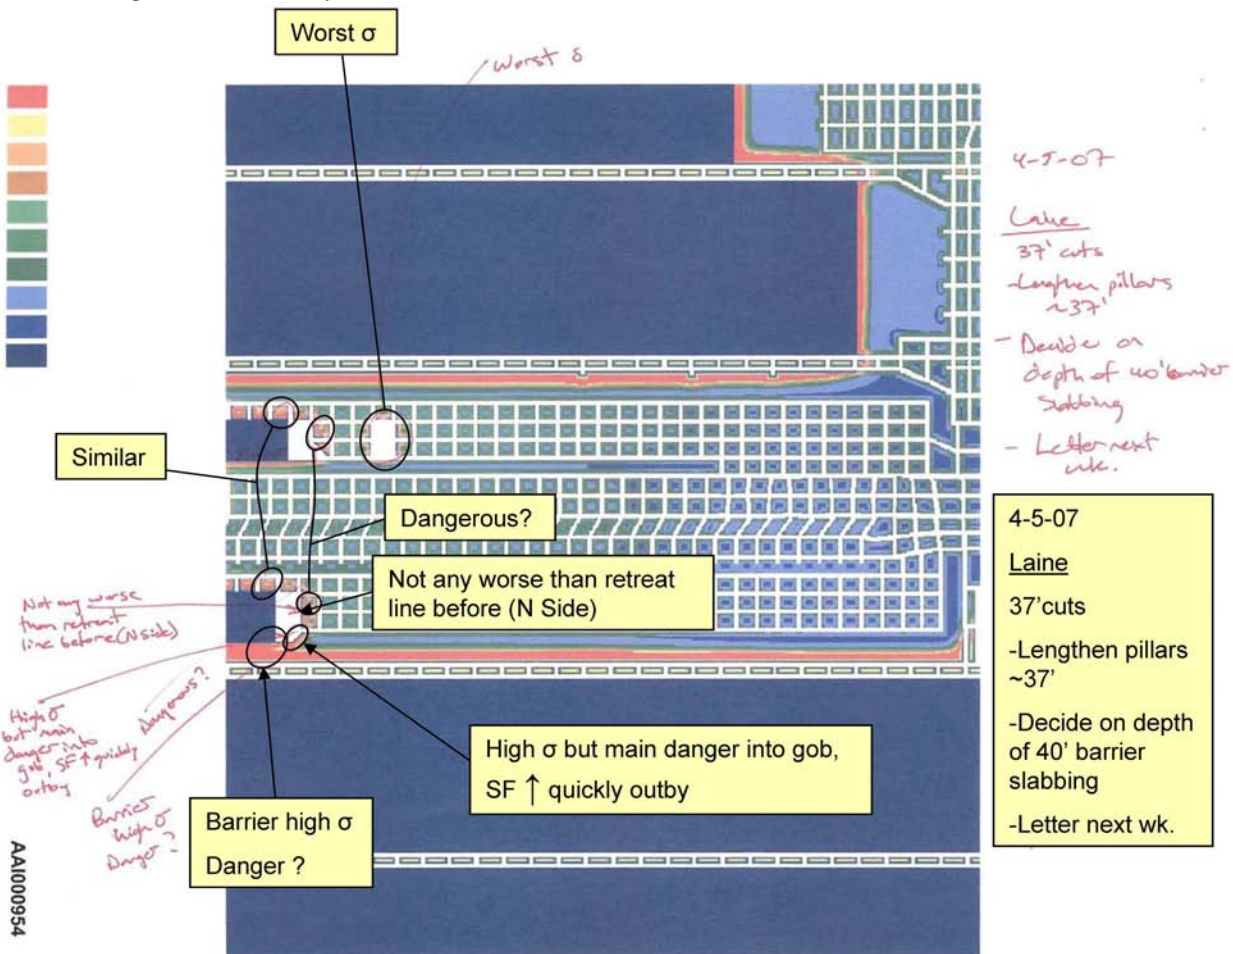
**Figure 77 - AAI Notation on Plot of Model Results**  
**Text boxes reflect handwritten notes and were added for clarity.**

*South Barrier Design.* After the March burst, AAI changed their model to reflect a lagging cave but this change had very little impact on model results. The model used to evaluate designs for the South Barrier section was essentially the same as the model used to design the North Barrier section. Proposed design changes including longer crosscut spacing were evaluated. AAI had modeled the effects of longer crosscut spacing early in the Main West Barrier Mining project. Their earlier conclusion was that “*increasing crosscut spacing does not significantly improve conditions.*” Increased pillar length (reported as a 20-foot increase, but modeled as a 10-foot increase from 70 to 80 feet) “*only incrementally reduces rib yielding, corresponding to a modest decrease in entry convergence.*” In the South Barrier section models, however, pillar length was increased by 37 feet (72 to 109 feet). AAI noted that modeled stresses in the projected South Barrier workings were similar to those experienced at the March burst site when crosscuts of similar length were used (see handwritten notes, Figure 77). However, AAI concluded that the longer crosscut spacing “*increases the size and strength of the pillars’ confined cores, which helps to isolate bumps to the face and reduce the risk of larger bumps overrunning crews in outby locations.*”

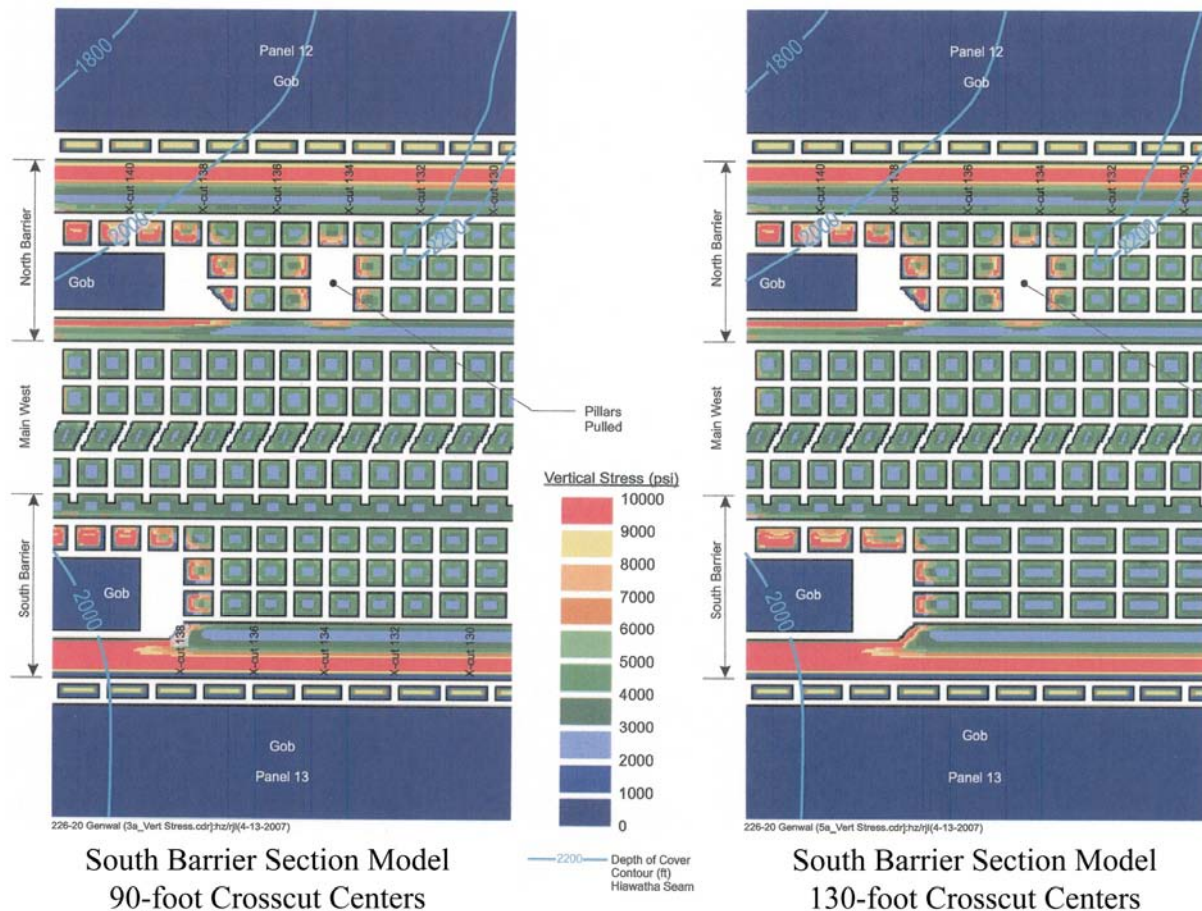
**Figure 78 – AAI Modeled Vertical Stress Results Comparing Effects of Crosscut Spacing**

AAI’s model results with two different crosscut spacing distances are shown in Figure 78. The images are similar in the sense that high stresses are concentrated in pillar ribs adjacent to the expanding gob area. With longer pillars, the concentration appears to be reduced in the vicinity of the outby intersection. It is important to note, however, that the models did not evaluate pillar recovery on a cut-by-cut basis. When pillar cuts remove coal from the inby ends, the pillars in

the active mining area are reduced in size. Consequently, some of the benefit of longer pillars in the active mining area is diminished as pillar recovery proceeds. The stress concentration will migrate towards the outby intersection as the pillar in the active mining area is reduced. Although the larger (i.e., longer) pillars used in the South Barrier were stronger than those used in the North Barrier, they were not sufficient to ensure the stability of these workings during pillar recovery. Given the aforementioned deficiencies, the models provided no insight into the “risk of larger bumps overrunning crews in outby locations.”

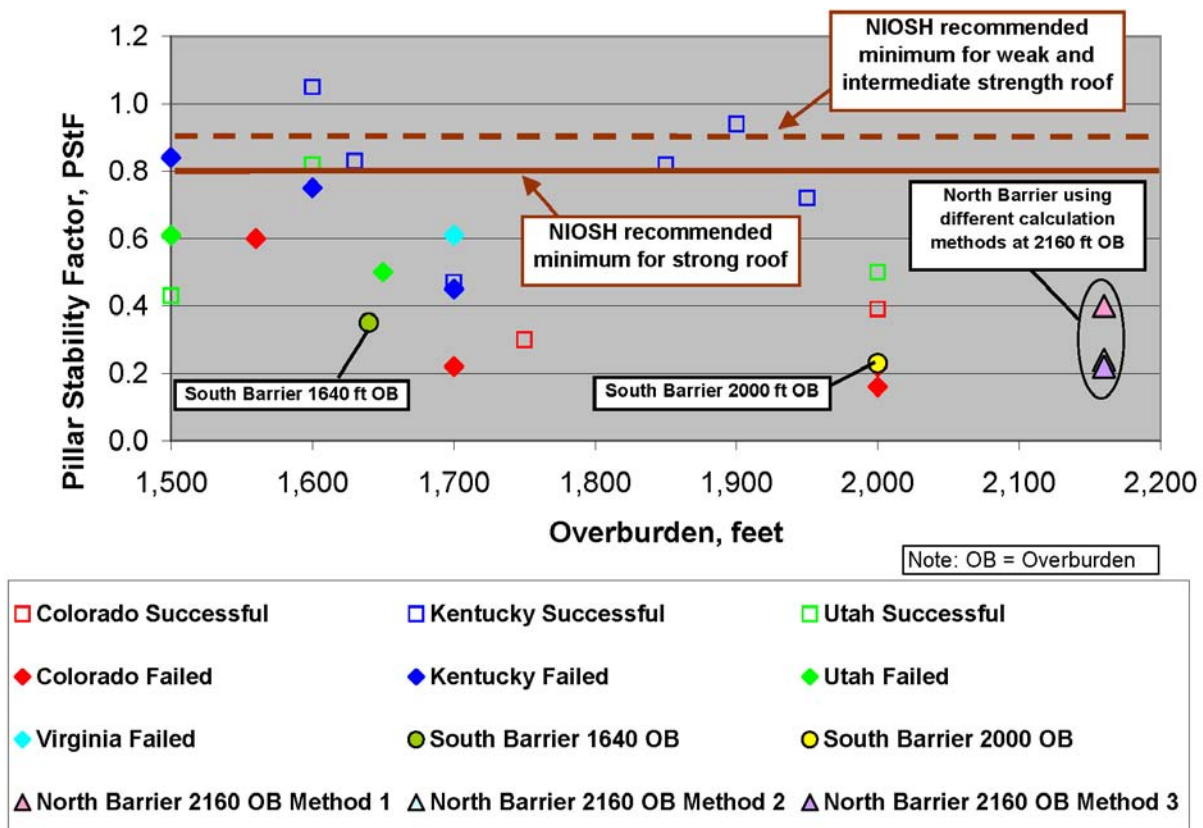
Figure 80 - Pillar Stability Factors from NIOSH ARMPS Database for Depths Over 1,500’  
NOTE: NIOSH ARMPS Database only contains case histories at or below 2,000’ overburden.

This observation is accurate. Eleven of 21 cases at depths greater than 1500 feet were deemed to be satisfactory designs. Difficult ground conditions were attributed to the remaining ten. Similarly, five of ten cases with PStF’s less than 0.53 (i.e., the PStF value they determined for the proposed North Barrier section) were satisfactory and the other five experienced difficulties (see Figure 80). It is noteworthy that in all of the “failed” cases, NIOSH indicated some degree of pillar “bumping” was involved.

AAI recognized that the North Barrier section pillar stability factors they had calculated were below the NIOSH recommended minimum. AAI reasoned that since the 1<sup>st</sup> North Left block panels had been mined successfully with a PStF of 0.37, the North Barrier section with a PStF of 0.53 should be acceptable:

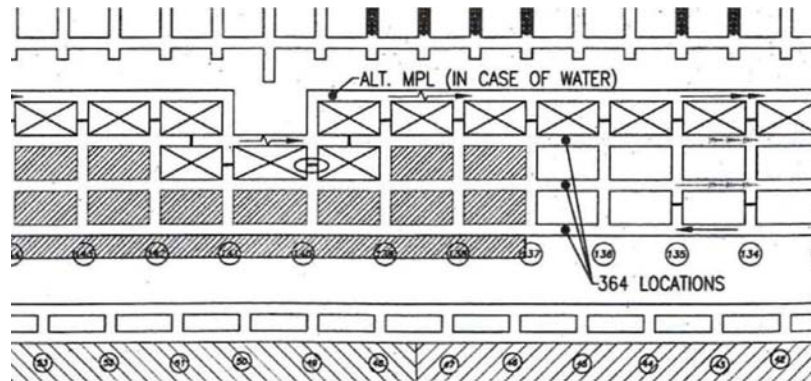
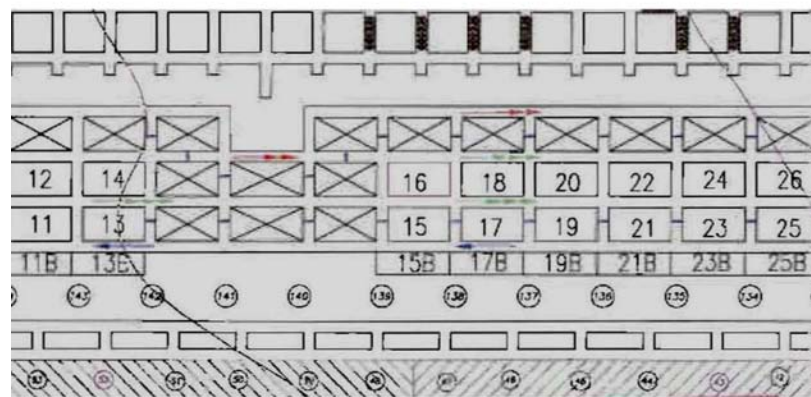
**Figure 82 - Comparison of South Barrier Roof Control and Ventilation Plans**

The revised roof control plan for pillar recovery of the South Barrier section was approved on June 15, 2007 (see Appendix J). Measurements from the scaled map included with this roof control plan addendum indicated that the pillars were to be mined on 80 x 130-foot centers. The plan also showed the sequence of removing pillars from west to east and specified where coal was to be left unmined. The rows of pillars were to be extracted from south to north. To protect the No. 4 bleeder entry, the northern-most pillars were not recovered.

A 55-foot barrier between the South Barrier section No. 4 entry and the sealed Main West notches was also required to be left unmined. The roof control plan permitted a maximum 40-foot cut from the last row of roof bolts into the barrier south of the No. 1 entry. A double row of roof-to-floor support (timbers) was also required to be installed at the entrance to crosscuts in the No. 4 entry for additional bleeder protection. These timbers were required to be set a maximum of four feet apart with a minimum of four per row.

Portion of mine map from ventilation plan approved June 1, 2007 showing pillar and barrier mining from crosscuts 139 to 142 allowed.

Portion of mine map from roof control plan approved June 15, 2007 showing pillar and barrier mining from crosscuts 139 to 142 not permitted.

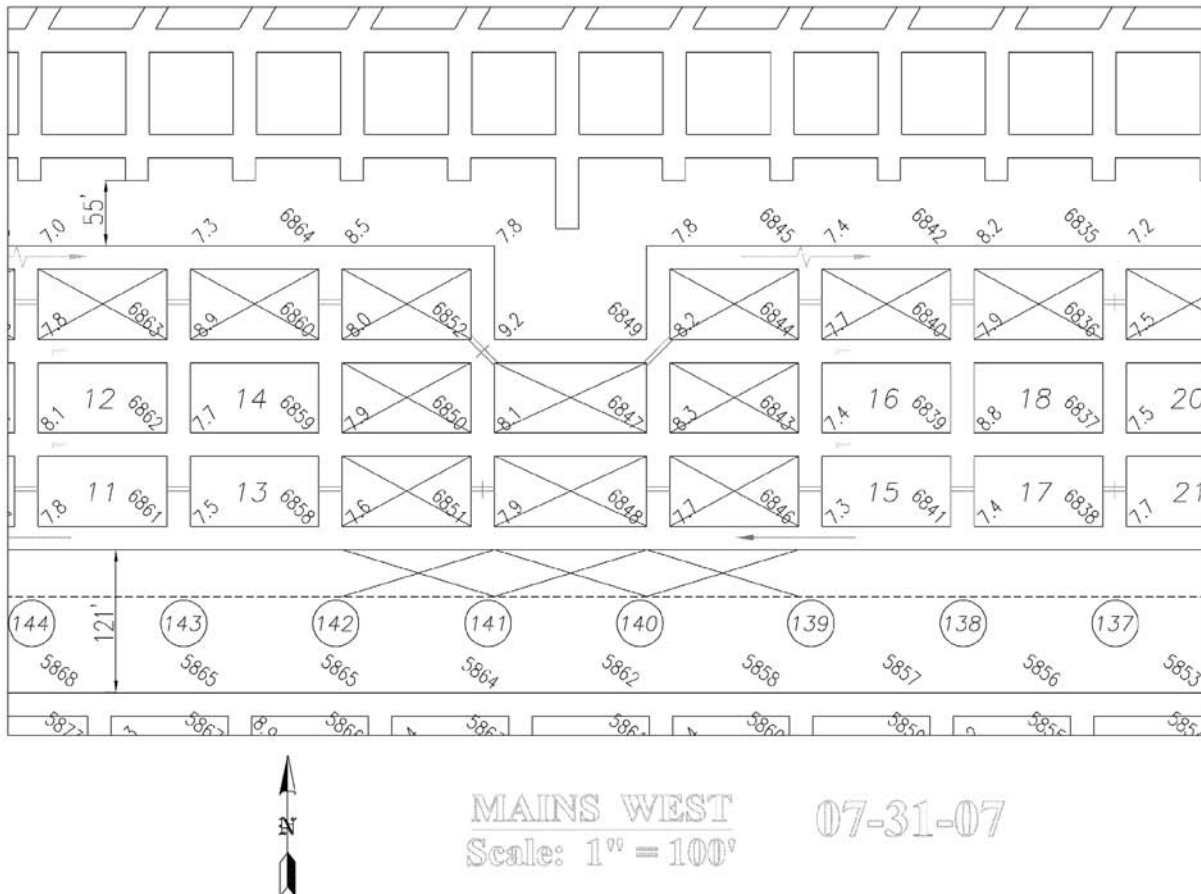
**Figure 83 - Mark Up Map Provided to Mine Management on July 31, 2007**

The initial South Barrier section mark up map showed the pillar recovery sequence from crosscut 149 to crosscut 142. On July 31, 2007, as pillar recovery approached crosscut 143, Gary Peacock emailed David Hibbs (manager of engineering), "We need an updated mark up map at Crandall showing the pillars that will be left in the area were there is only 3 entries." Hibbs replied, "Gary, I feel we need to leave all rows in the area of 3 entries and also delete the barrier. Do you have any thoughts?" Peacock answered, "I think we should take the barrier." Hibbs responded to Peacock: "Gary, This is the drawing in approved Roof Control Plan for that

area.” Hibbs attached a copy of the pillar extraction map from the approved roof control plan and included Shane Vasten (surveyor) in his email response to Peacock. Later that evening, Vasten emailed Peacock and Hibbs: “Gary, Here is a mark up map for you to look at based on the latest approvals forwarded to me from Dave. If you have any questions/concerns, get with Mr. Hibbs. Ace and I will be there tomorrow doing month end. I will check with you then to see if any changes need to be made. I will also plot more maps for you then. I just wanted to send you this one so you can be looking it over.” Between crosscuts 142 and 139, the attached mark up map (see Figure 83) correctly showed that no pillars were to be recovered and the barrier was to remain unmined south of the No. 1 entry (as indicated by the standard symbol X in the pillars) in accordance with the approved roof control plan. Interview statements, belt scale records, shift foremen’s reports, and production records revealed that the barrier south of the No. 1 entry between crosscuts 139 and 142 was, nonetheless, mined.

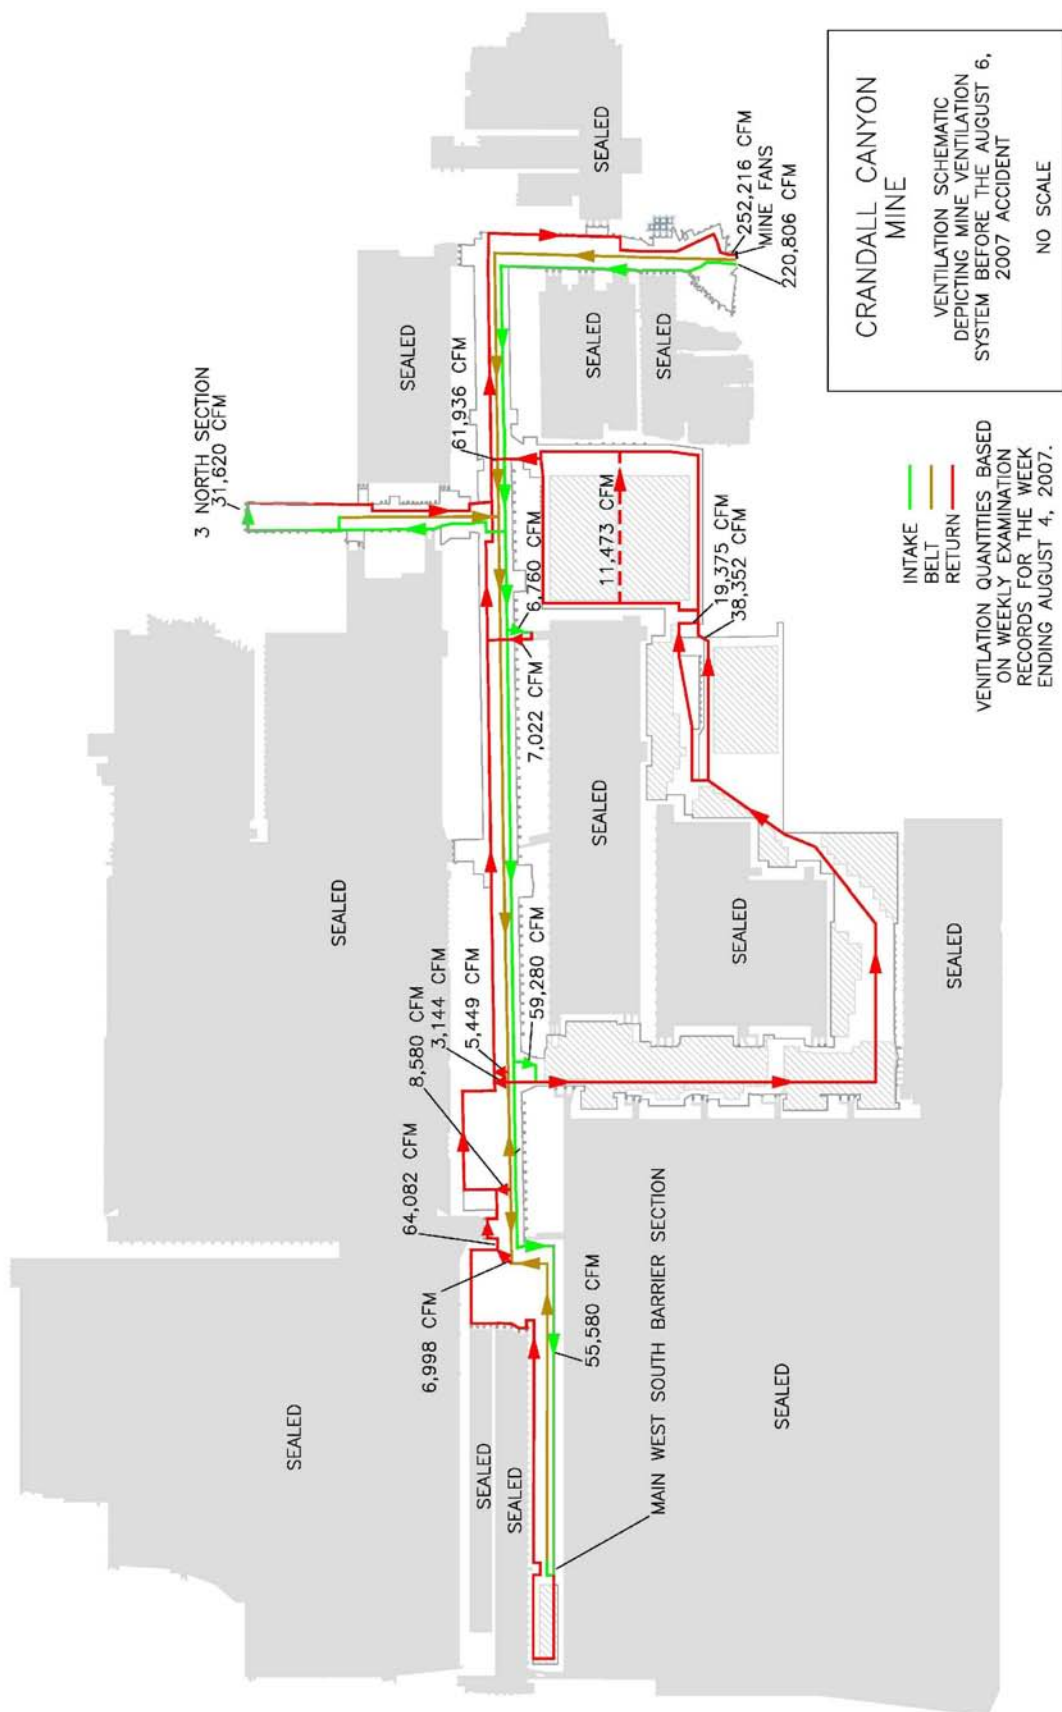
Figure 84 - Ventilation System before August 6 Accident

Figure 84 depicts a simplified schematic of the mine ventilation system based on air measurements recorded during the week prior to the accident. The mine was ventilated by exhausting fans. Mine openings consisted of five drift openings. From left to right, the first drift served as the entrance to an underground bath house and provided a small amount of intake air. The second drift served as the main intake and travelway. The third drift contained the belt conveyor. Return air exited the mine through the fourth drift. A stopping was erected in the fifth drift to separate the return air course from the surface.

According to the weekly examination record book, in the week preceding the August 6, 2007, accident, 220,806 cfm of air was entering the mine through the main intake. An air quantity of 252,216 cfm was exiting the mine through the return drift and main fans. The quantity entering the belt haulage entry and the bath house entrance were not recorded in the weekly examination book. A revised ventilation map received on July 2, 2007, indicated that 31,036 cfm of air entered the mine through the belt drift and 5,200 cfm entered through the bathhouse.

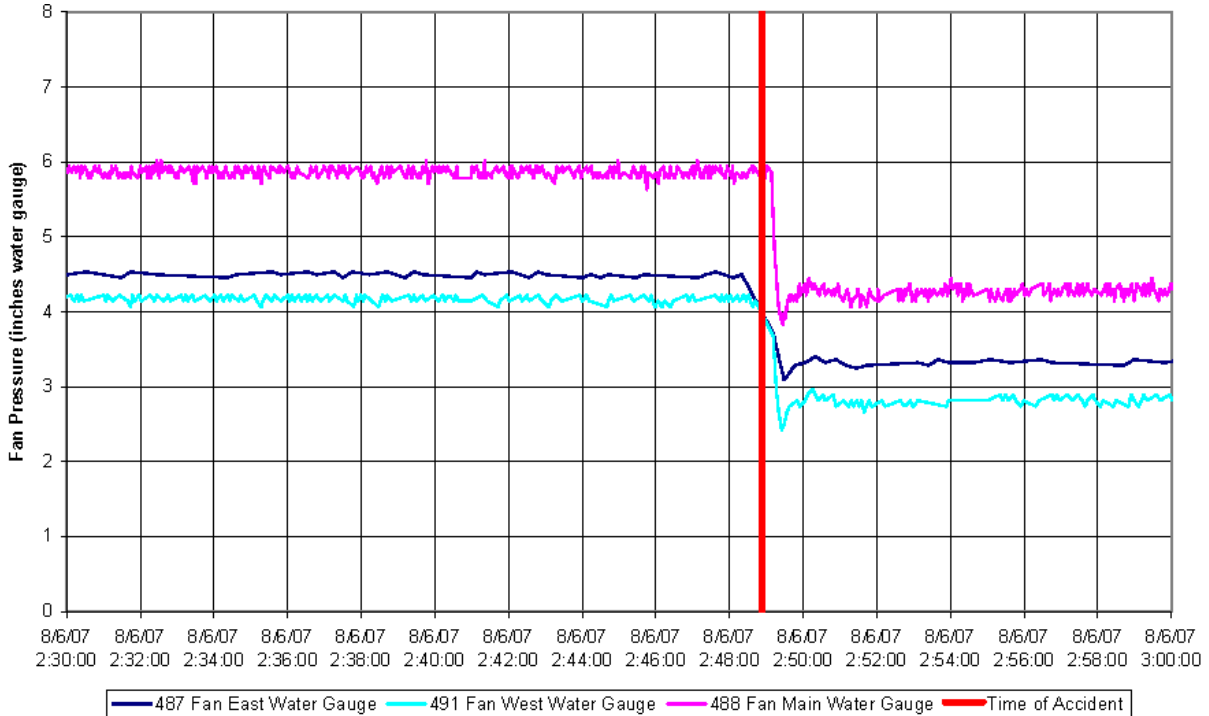
**Figure 85 - Fan Pressure at the Time of the August 6 Accident**

The effect of the August 6, 2007, accident on the mine ventilation system was significant. The initial air blast and burst coal pillars destroyed or damaged stoppings from the accident site outby to crosscut 93 and the overcasts at crosscut 90 and 91. The damage short-circuited ventilation inby that point.

The short circuiting of air affected the main fan pressure. Figure 85 shows the fan pressure recorded by the mine monitoring system for the time period immediately before and after the accident. Also, the daily fan examination record book indicated 6.5 inches of water gauge (w.g.) for fans 1 and 2 and 6.25 inches w.g. for fans 3 and 4 on the previous day. A pressure of 5.25 inches w.g. for fans 1 and 2 and 5.5 inches w.g. for fans 3 and 4 was recorded after the accident. This was an average decrease of 1.0 inches w.g. after the accident.

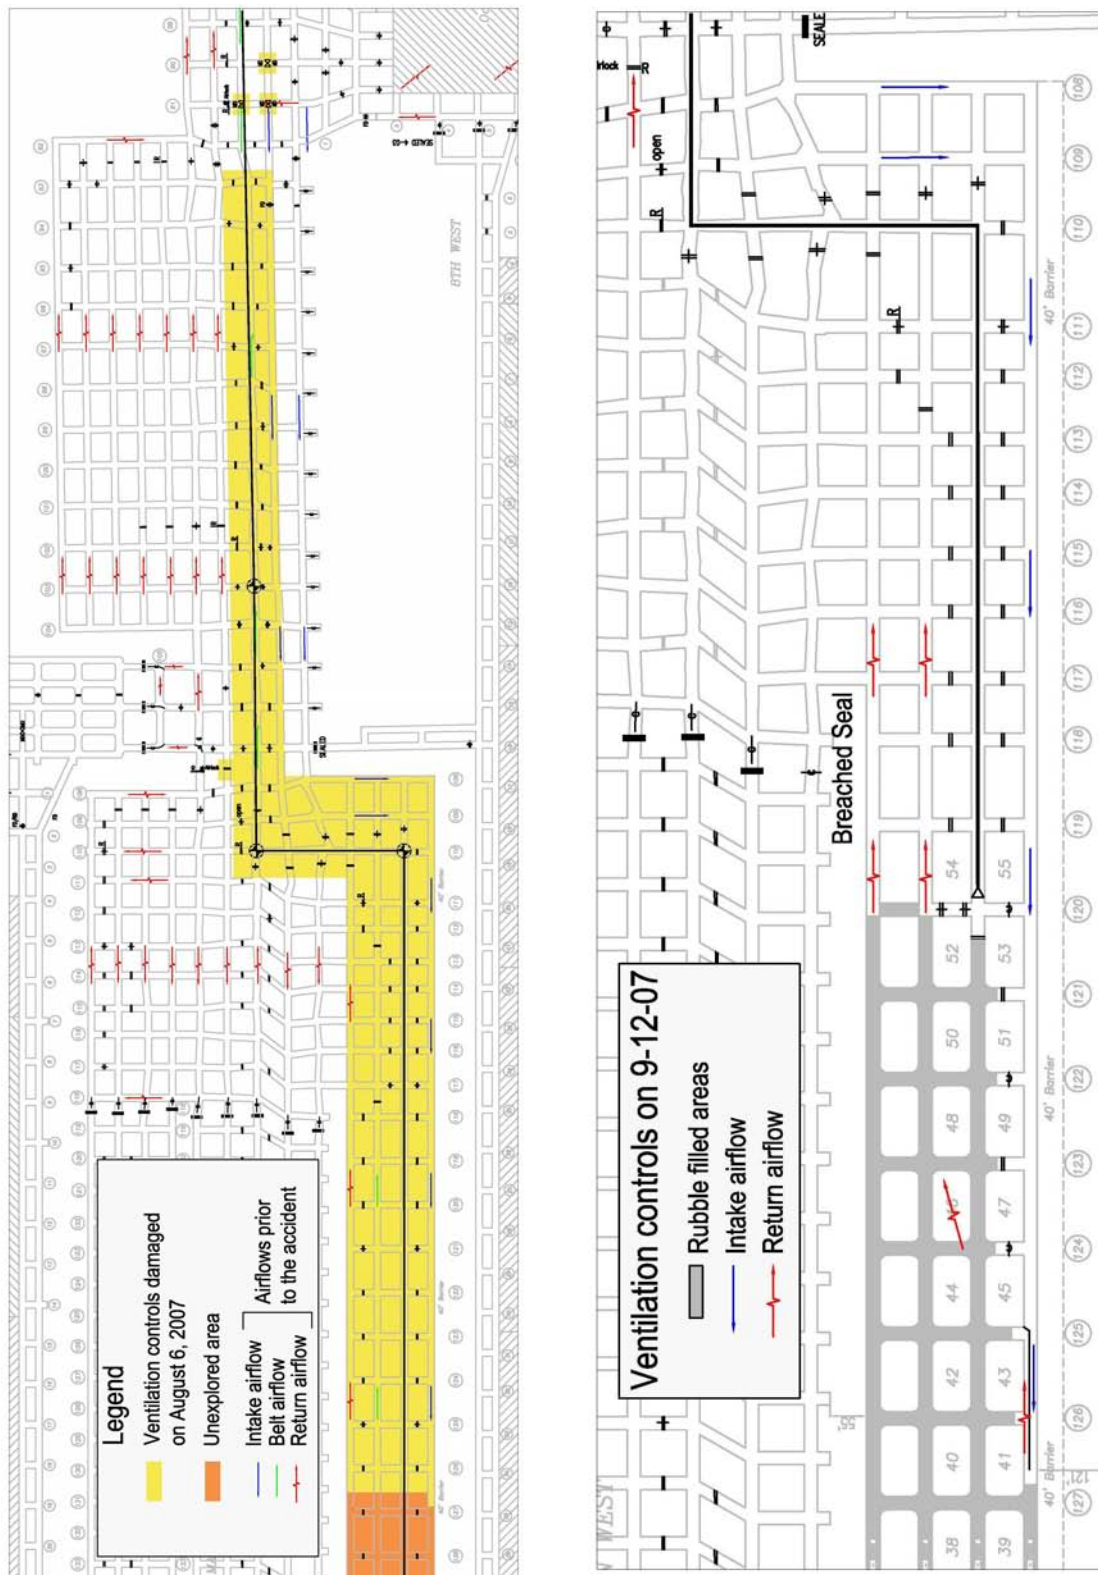
Figure 86 - Ventilation Controls after Accidents

August 7 damaged many of these temporary ventilation controls. The temporary controls were then replaced with permanent stoppings. These permanent stoppings were completed prior to resuming rescue efforts. Figure 86 shows the locations of stoppings damaged in the August 6 accident and the stopping configuration after the August 16 accident.

Originally, the South Barrier section No. 3 entry was in common with the belt entry. As ventilation controls were reestablished, the No. 3 entry was utilized as a return air course. Stoppings were erected between the No. 2 and 3 entries. A feeder was set in the No. 2 entry between crosscuts 119 and 120. The stoppings between the intake and belt entries (No. 1 and No. 2) were reestablished up to crosscut 120. Crosscut 120 was left open to serve as the haul road to the feeder. A stopping was built across the No. 2 entry inby crosscut 120. Inby that point, the No. 1 entry served as the intake and the Nos. 2, 3, and 4 entries served as returns.

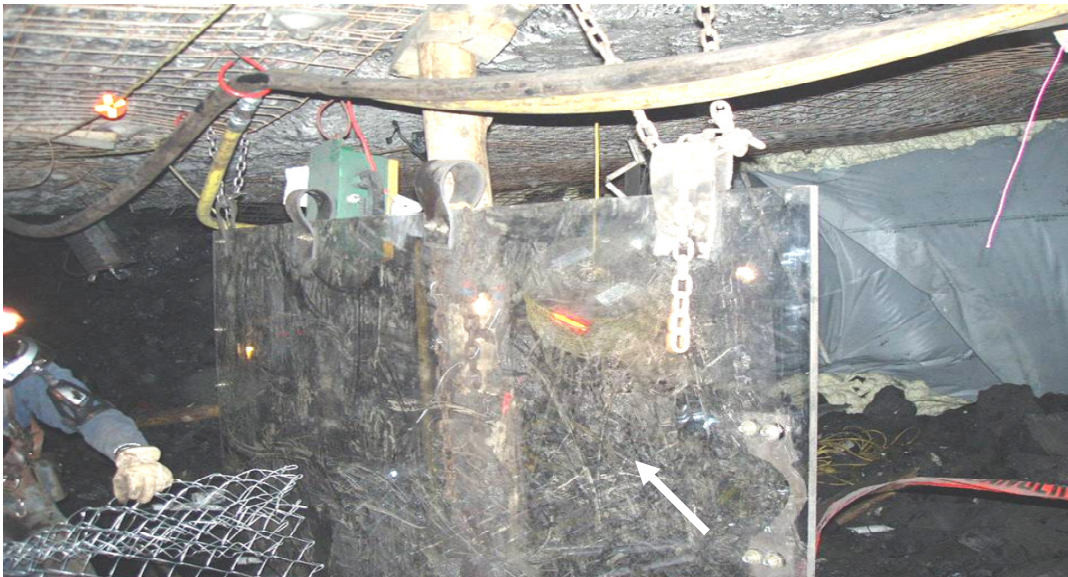
As clean-up advanced in the No. 1 entry, a number of changes were implemented to enhance the support system and/or to reduce worker exposure. For example, a 4 x 8-foot sheet of ½-inch thick Lexan<sup>18</sup> was provided near the face to offer protection to rescue workers in the clean-up area. The sheet was secured to the mine roof by chains attached along one edge. The chain was connected to roof bolt plates (Figure 90). The Lexan sheet served as a shield between personnel and the coal pillar rib.

**Figure 90 - Sheet of Lexan Suspended from Mine Roof**
