REPORT OF INVESTIGATION

Fatal Underground Coal Burst Accidents  
August 6 and 16, 2007

Crandall Canyon Mine  
Genwal Resources Inc  
Huntington, Emery County, Utah  
ID No. 42-01715

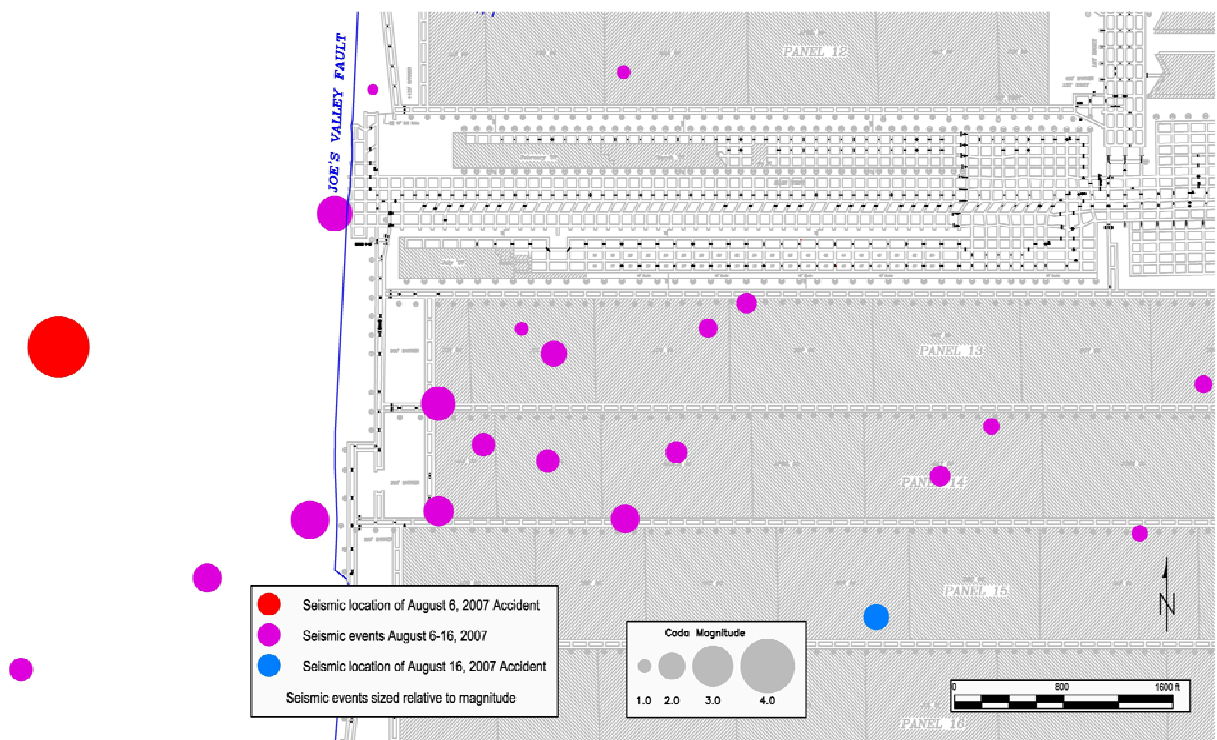
**Figure 91 - Initial Location of Seismic Events August 6-16, 2007**

Initial locations of seismic events lacked sufficient accuracy to be used for decisions affecting rescue efforts. Figure 91 shows the initial locations generated by the UUSS automated system. The red circle depicts the August 6 accident. The blue circle depicts the August 16 accident. The remaining magenta circles depict those events recorded between these accidents. All events plot in regions away from the underground rescue work. The more accurate locations of events shown in Figure 92 were not available until well after the rescue efforts had been suspended. Underground observations were much more representative of actual ground activity.

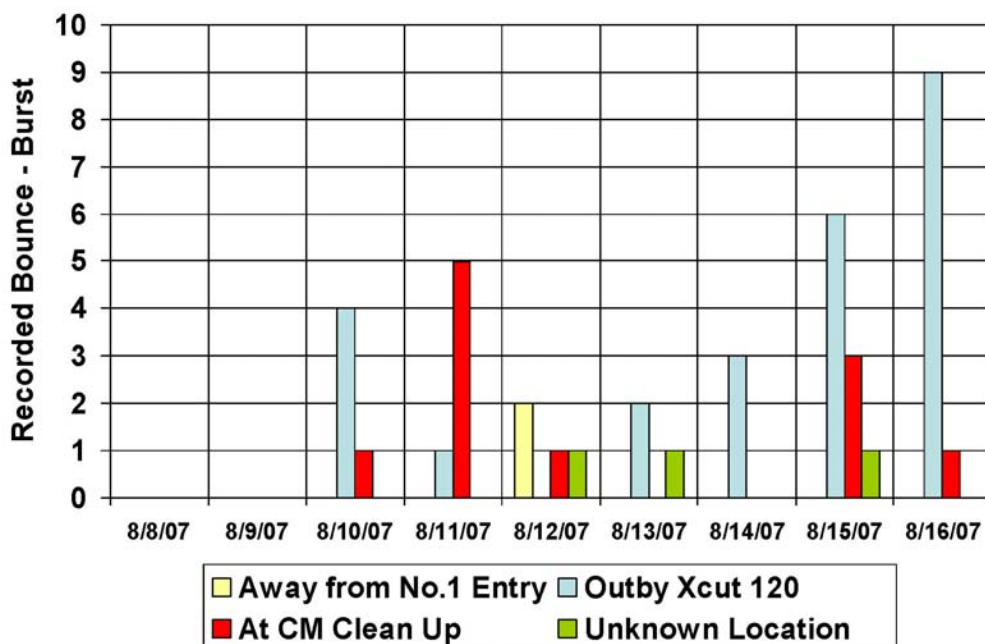
Figure 93 – Bounce or Burst Activity Recorded in Command Center Log Book August 8 to August 16, Prior to August 16 Accident

Prior to the August 16 accident, eleven burst/bounce events were reported to have originated from the north side (right side) section pillars inby crosscut 120 (see Figure 93). These events occurred at the remote-controlled continuous mining machine where the material was being loaded, inby the area of the advancing RocProp system. The approved clean-up plan included procedures that minimized exposure of rescue workers in this area. It was thought that if a significant pillar burst were to occur, it most likely would be in the area where material was being removed. The command center log book noted that events in the clean-up area varied in size with two large pillar bursts in this area recorded prior to the August 16 accident. Prior to August 16, no significant bounces or bursts were recorded within the RocProp support system inby crosscut 120. One burst event was noted outby crosscut 120. Material piled behind the chain-link fencing inby crosscut 120 resulted from unreported bounces or bursts, or from rib sloughage.

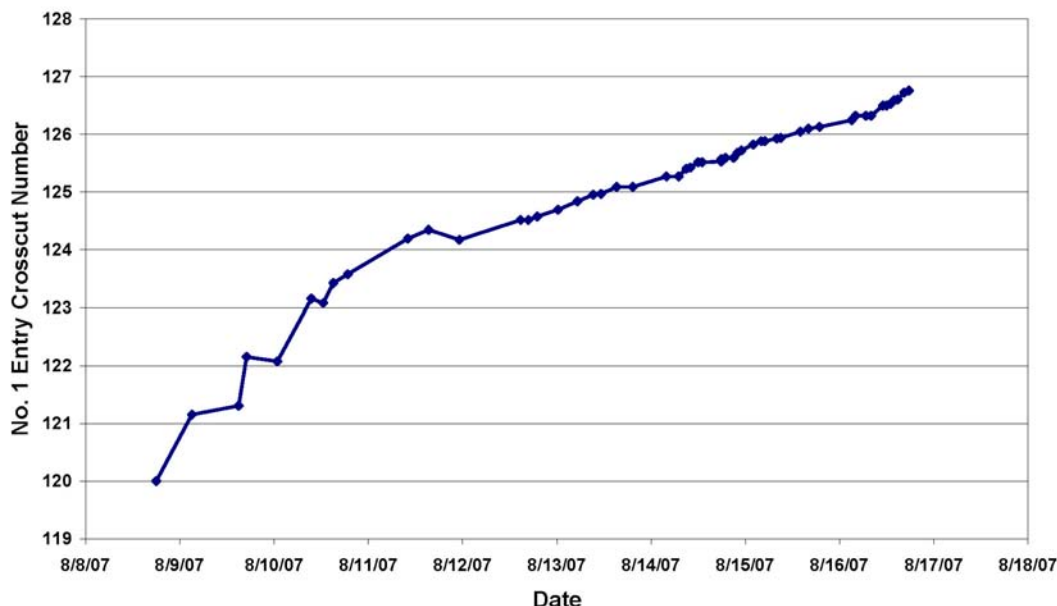
The rescue advance in the No. 1 entry achieved a somewhat steady rate of approximately ½ crosscut (65 feet) per day after August 12 as illustrated in Figure 94. No correlation to rescue advance rate in the No. 1 entry and the burst or bounce frequency could be identified.

Figure 94 - No. 1 Entry Rescue Clean-up Progress Plotted by Day

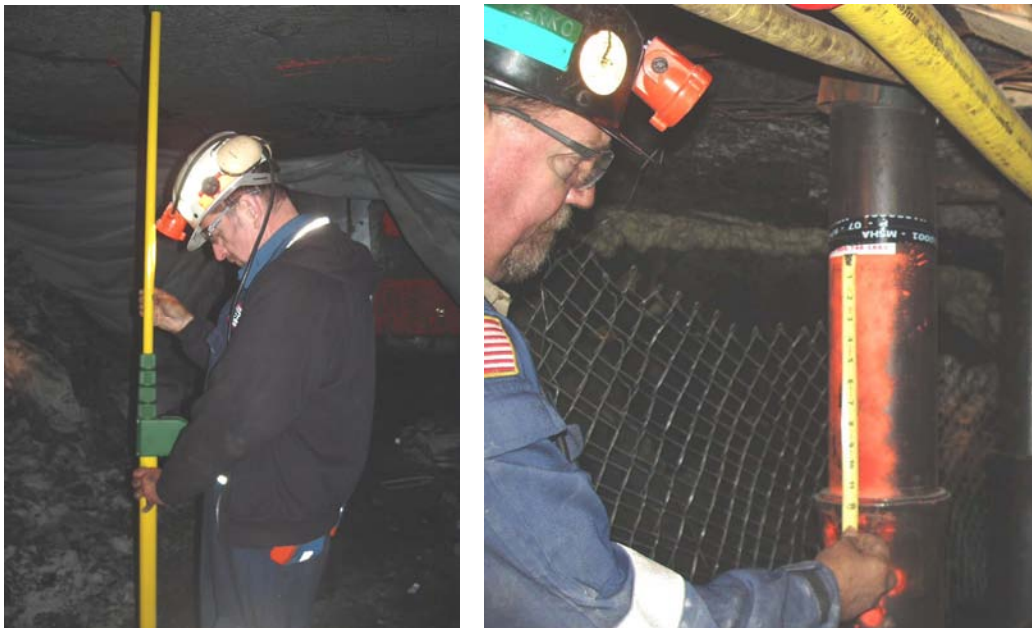
**Figure 95 - Convergence Measurements**  
**Left: Roof-to-floor convergence station. Right: RocProp convergence station.**

The convergence stations were monitored to determine the magnitude, rate, and distribution of roof-to-floor closure. Historically, measurements of this type have been useful in monitoring changing and potentially hazardous ground conditions. Initial (baseline) measurements were taken on August 15 and the stations were measured twice on August 16 prior to the accident. Measurements in this time frame indicated that ground conditions were stable; three of ten stations showed closures of 0.04 inches but this amount of displacement is within the precision of the measuring instrument.

Sixteen monitoring locations were established using RocProps in the No. 1 entry. As shown in the photograph on the right side of Figure 95, these monitoring locations were established by painting a line on installed RocProps, 12 inches above the locking ring. Entry convergence could be monitored at these locations simply by measuring the distance between the lock ring and paint line using a tape measure. Although not as exact as a convergence rod, these measurements were intended to provide a convenient method for determining convergence between the mine roof and floor that anyone with a tape measure could perform.
