Workplace Health and Safety Fatality Report

**PICKUP TRUCK AND DRIVER CRUSHED BY
HEAVY HAULER**
Date of Incident: April 26, 2008
Type of Incident: Fatality

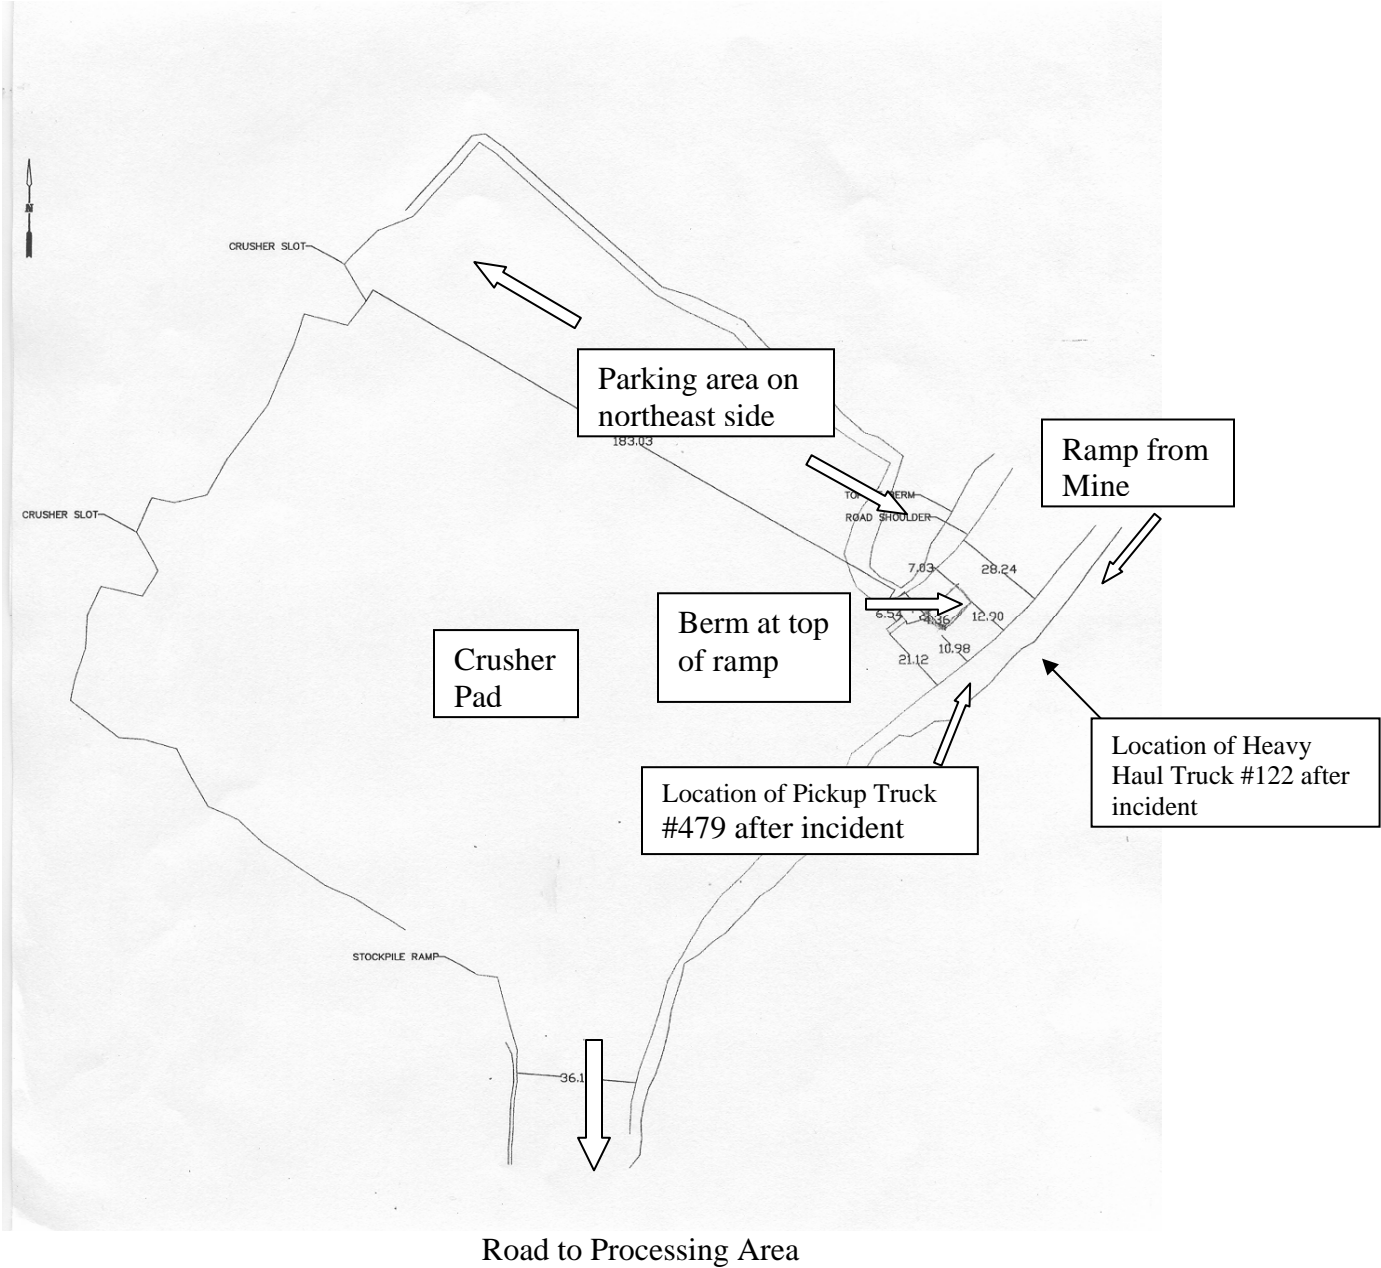
- 4.1 Albian Sands Energy Inc. Muskeg River Mine is located approximately 75 km north of Fort McMurray, Alberta. The incident occurred at the top of a ramp leading from the mine to the Crusher Pad, at the intersection where the ramp enters the Crusher Pad. (Attachment "A", Map). (Attachment "B", Diagram) (Attachment "C", Photograph #1)

Survey drawing of Crusher Pad
Dimensions shown are in Meters.
