SAFETY ALERT

Grinder Injury

January 06, 2004

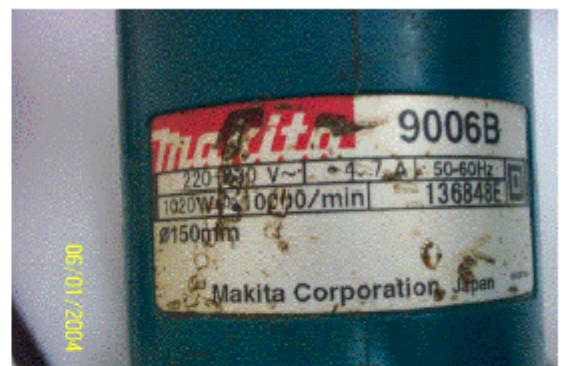
Based on manufacturer specification, Makita grinder model 9006B should use 6" grinding wheel, speed load 10,000 RPM.

9.5" grinding wheel was used instead of using 6" grinding wheel. This wheel was over sized and allowed only to be run at 3400 RPM.

Grinding wheel was running at 10,000 RPM (over rated speed) causing the wheel fly apart and hit the mechanic's face.

- Utilised improper tool.
- No grinder safety guard.
- Not using face shield for PPE.
- Mechanic has been warned but he ignored it.
