MINE WATER AND THE ENVIRONMENT, VOL. 14, ANNUAL ISSUE, PAPER 9, 1995, PP 107-130

Mine Inundation-Case Histories

by V.S. Vutukuri * and R.N. Singh**

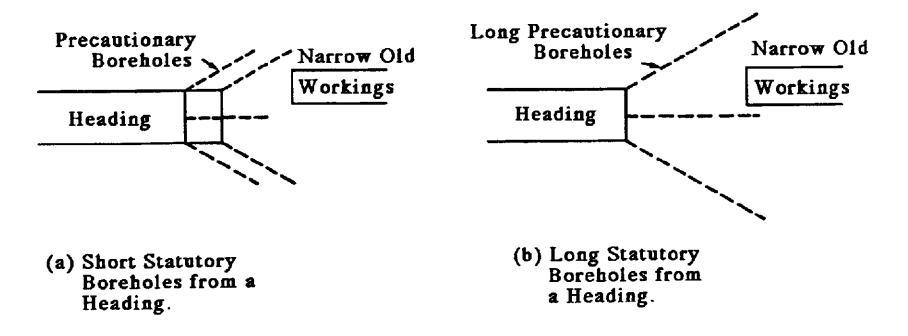
- Short advanced bore holes may leave an inadequate barrier between the blind end of the bore holes and the old workings which may subsequently fail (Figure 1).
- Long advanced bore holes may completely miss a narrow old workings containing an accumulation of water.
- (iii) An advanced bore hole through highly stressed ground or an outburst prone ground may completely close due to strata pressure thus giving wrong impression that the old mine workings are free of water.
- (iv) There are no statutory provisions for controlling the inflow of water through precautionary bore holes once they have intersected the old workings.

Figure 1 Statutory bore holes when current workings approach water logged workings
