U.S. CHEMICAL SAFETY AND HAZARD INVESTIGATION BOARD

INVESTIGATION REPORT

LITTLE GENERAL STORE – PROPANE EXPLOSION

REPORT NO. 2007-04-I-WV

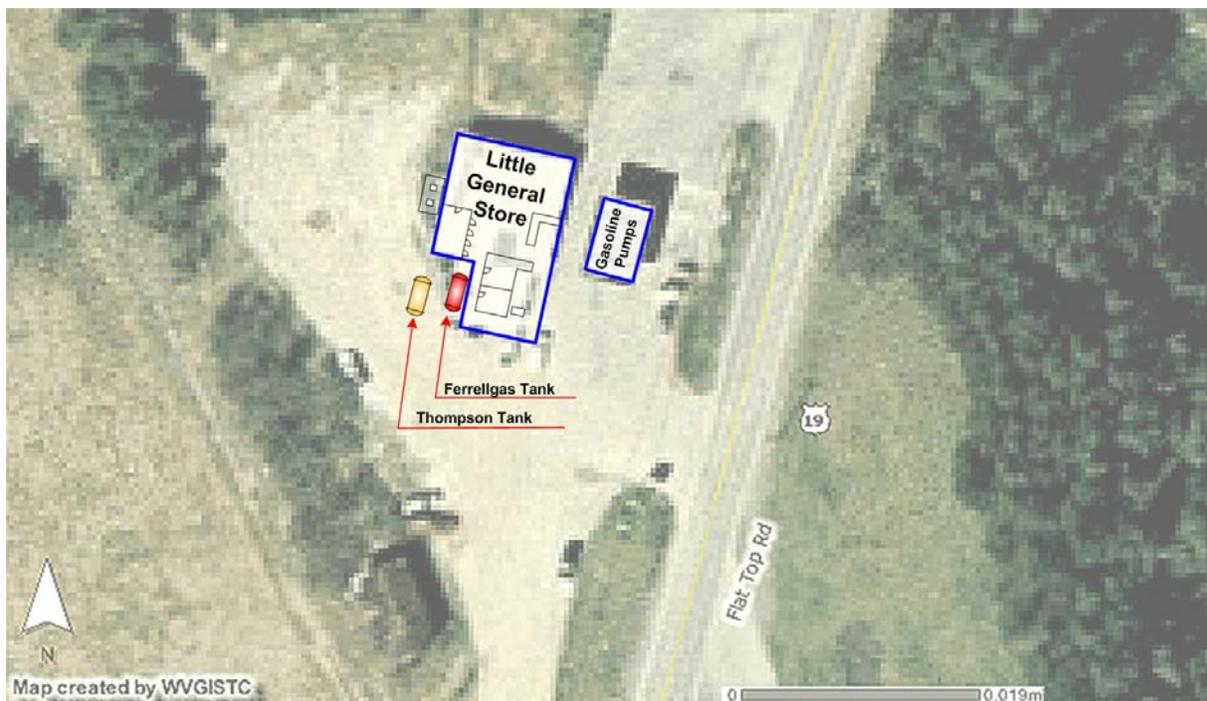
Figure 1. Aerial photograph of Little General store and surrounding plot.

At 10:53 am on January 30, 2007, a propane explosion leveled the Flat Top Little General Store (Little General) in Ghent, Raleigh County, West Virginia (Figure 1). The explosion killed four and injured six. The dead included two emergency responders (a fire department captain and an emergency medical technician, both from the Ghent Volunteer Fire Department) and two Appalachian Heating propane service technicians. The injured included the four Little General employees who remained inside the store, and two other Ghent Volunteer Fire Department emergency responders.

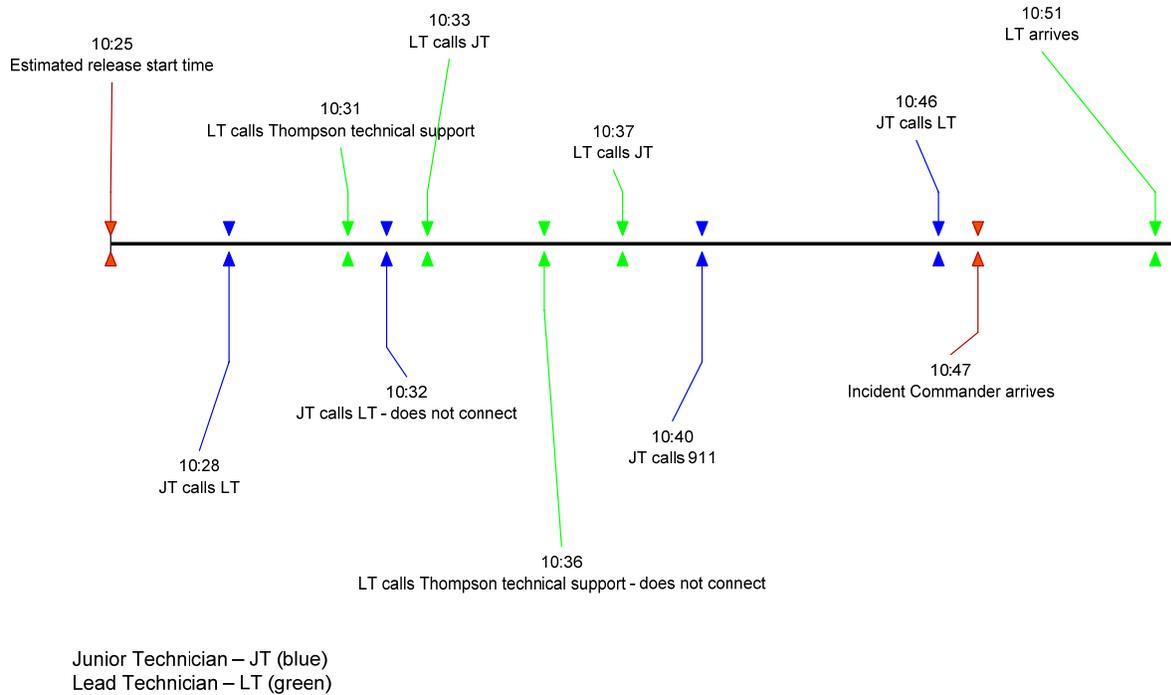
Figure 4. Timeline of initial events

At 10:40 am, the junior technician called 911 to summon help from emergency services (see transcript in Appendix B). He reported to the 911 operator that he had a leaking propane tank at the Little General in Ghent and needed the fire department's assistance to secure the area. The 911 operator collected this information, clarified the location, and ended the call.

After the 911 call, the junior technician called the lead technician again. The cashier checked on the junior technician a second time, finding him in the same location between the tank and truck. Figure 4 is an event timeline prior to the lead technician's return.

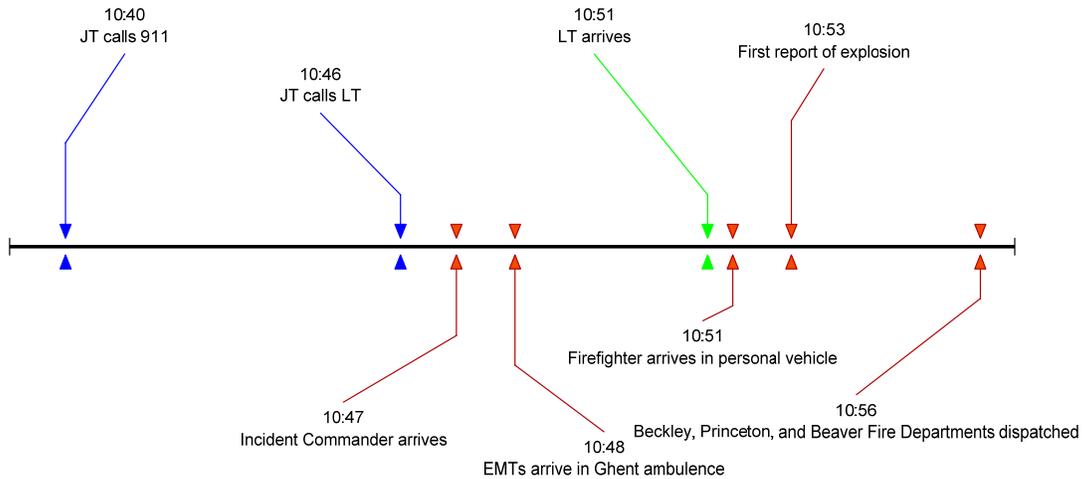
Figure 5. Timeline of incident response.

The explosion killed four near the tanks (the two technicians, the IC, and one EMT). The four workers inside the building and the firefighter survived but sustained serious injuries. The EMT, who was directing traffic and customers, suffered an arm injury.

The explosion leveled the building, destroyed a Ghent Volunteer Fire Department ambulance (cover photograph), and damaged many parked vehicles. The force of the blast threw the Ferrellgas tank about 80 feet and the Thompson tank about 50 feet. Figure 5 is an event timeline of the initial emergency response.

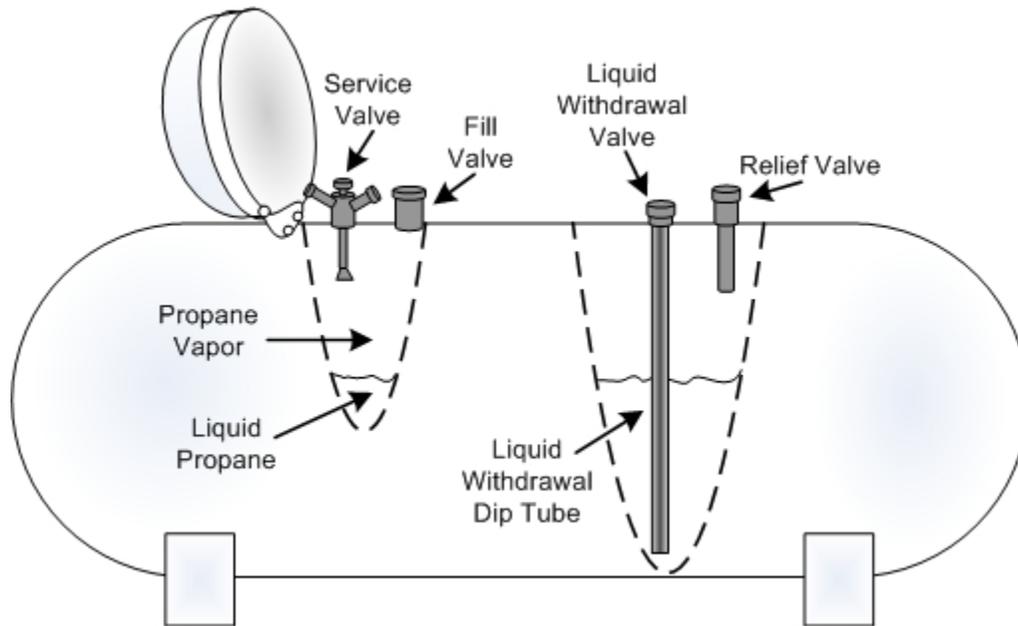
Figure 6. Typical ASME propane tank.

The propane system at Little General consisted of a stationary 500-gallon storage tank (Figure 6) and two supply regulators to reduce the pressure of the propane for pizza ovens used in the store. The storage tank had five connections:

1. A fill connection fitted with an internal check valve;
2. A liquid level gage to measure the quantity of propane in the tank;
3. A relief valve (safety device) to prevent over-pressurization of the tank;
4. A service valve to supply gaseous propane to the regulators; and

5. A liquid withdrawal valve fitted to an internal dip tube for removing liquid propane when necessary.
