## Shot firers injured by air blasts

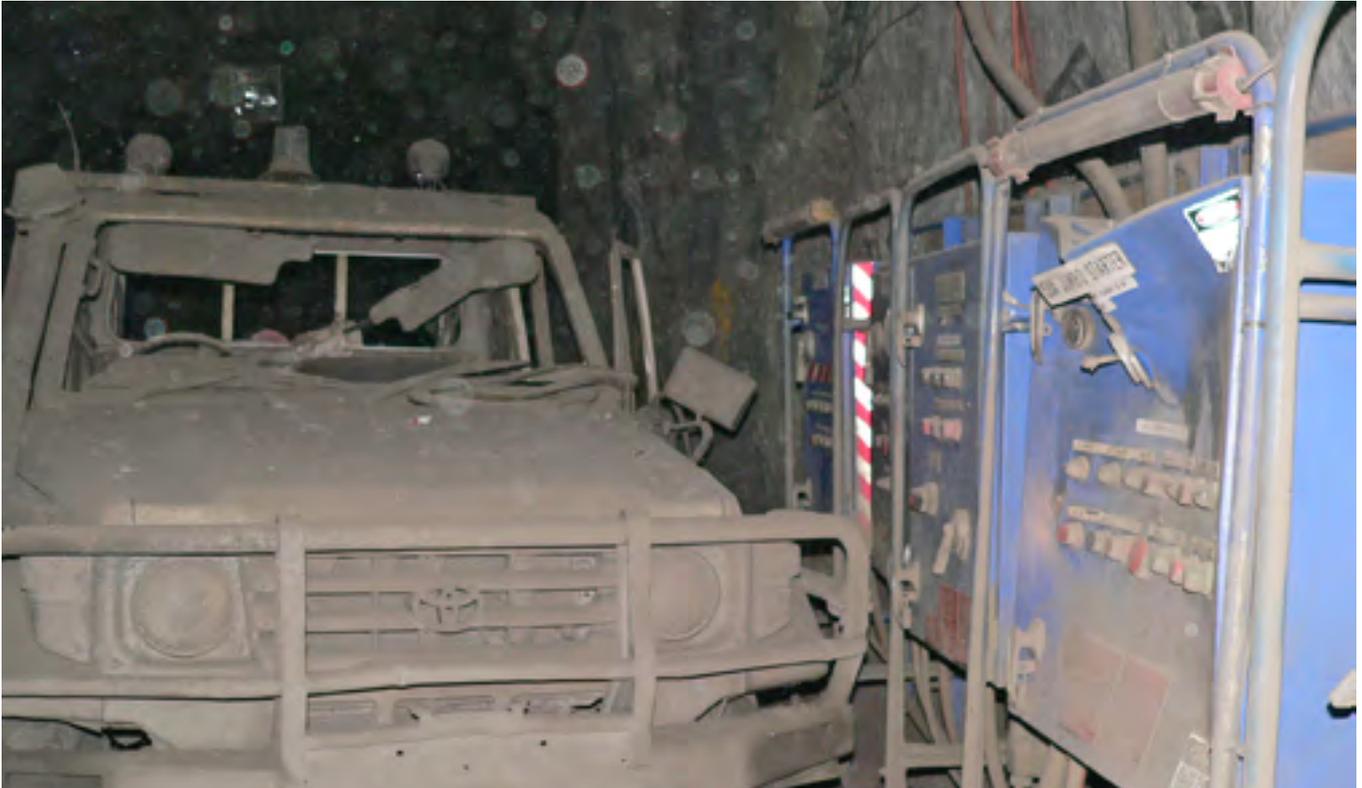
*This photo shows the air blast damage to the shot firer's car, which was 80 metres away from the blast*

Two serious incidents have occurred recently in Tasmanian mines, where shot firers and their assistants have been injured by an air blast. Both incidents could easily have resulted in serious injuries or fatalities; and both caused significant damage to the shot firers' vehicles and to mine infrastructure. The shot firers were also exposed to large quantities of firing fumes and dust following initiation of the shots.

In both incidents, the most likely cause of the air blast was the unconfined detonation of a large quantity of ammonium nitrate fuel oil (ANFO) that had fallen out of the upholes.

- the shot firers did not consider the possibility of an air blast occurring when selecting the firing locations
- problems were experienced with the pressure reducing valves on the charge up units, resulting in ANFO failing to pack sufficiently in the upholes
- in one incident, spiders were not used to hold the primers in position
- spilled ANFO may not have been adequately dissolved before firing the shots.

- Consider the possibility of air blast when selecting firing locations. If possible, fire all shots from a location remote from the blast.
- Ensure that adequate compressed air pressure is available at the charging hose to pack the ANFO in upholes. This may require additional maintenance or checking of the pressure regulators.
- Ensure that when ANFO is spilt during charging, it is dissolved with water before the shot is initiated.
- Ensure that devices such as spiders are used to secure the primers in upholes.
- Communicate the dangers of air blast to charge crews and supervisors.
