## **URGENT SAFETY ALERT (2008/006)**

## **SCISSOR LIFT FAILURE**

An incident recently occurred on one of our sites involving a 1999 model SKYJACK TYPE 8841 SCISSOR LIFT MEWP.

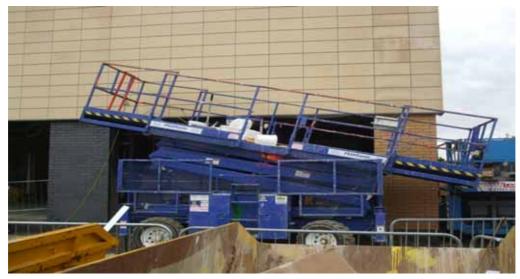
Fig 1

The MEWP was being raised from its base position with two men on board when a noise was heard and the machine was stopped. Those on board and a third workmate observing at ground level looked for any obstruction etc. Having found nothing they attempted to continue to raise the platform when a loud bang was heard, at the same time the front end collapsed into the position shown in *Fig 1*. Fortunately the working platform had been raised less than 2 meters at the time and although the operatives were pitched forward, they were not seriously hurt and were able to climb down to ground level.

- All examples of the SKYJACK 8841 model of MEWP are to be identified and taken out of service immediately, pending inspection by an engineer and written confirmation from the owner/supplier of being fit for use.

- All other scissor lifts on Kier Group sites are to be subject to an inspection, paying particular
  attention to scissor arm base connections prior to further use. Inspection being undertaken by
  the competent operator and findings recorded in the Project Register. Should there be any
  cause for concern identified the MEWP is to be taken out of service, pending a thorough
  examination to be arranged by the owner/supplier of the equipment.

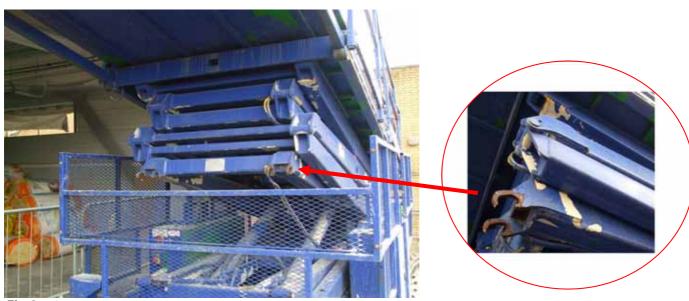
Fig 2

The rear end of the scissor packs' scissor arms had sheared from their base pivot–pin connectors as shown in *Fig 2*, the close up shows one of these two failures.

Initial examination identified oxidization, a suggestion of developing fatigue and final stress fractures as shown in *Fig 3*.
