EQUIPMENT SAFETY ALERT

Caterpillar D10T TRACK-TYPE TRACTORS (Dozer)

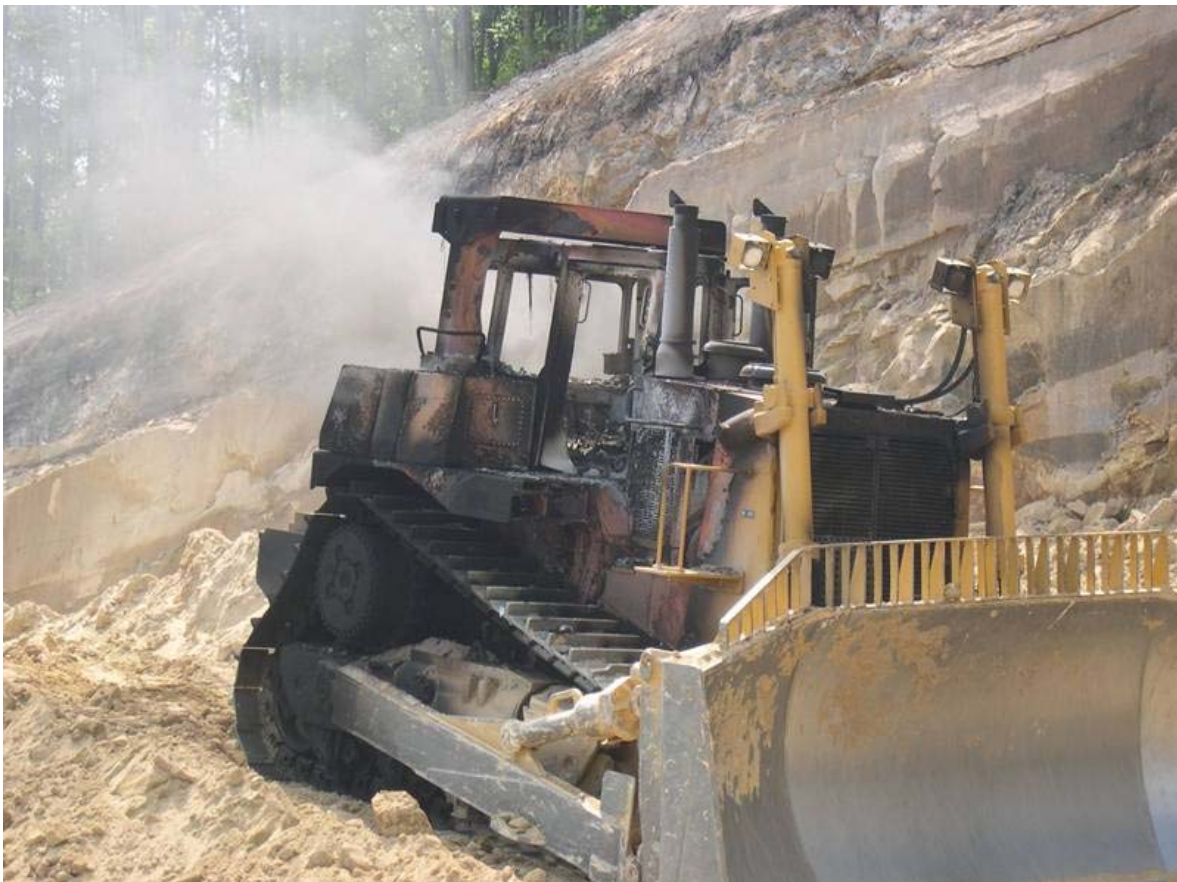
A potential for chafing has been identified on the product listed above with the 265-3955 Fuel Line and the 213-7009 Alternator Cable on the left side of the engine and the 265-3965 Fuel Line and the engine harness assembly on the right side of the engine. These chafing points could cause premature failure of the fuel lines and result in a fire with the potential for injury or death.

Contact your local Caterpillar dealer immediately to schedule service. The dealer will advise you of the time required to complete this service. Please refer the dealer to their service letter dated June 17, 2005 when scheduling this service. You will not be charged for the service performed.
